Technical Memo

Date: January 13, 2017

Subject: Annual Inspection SKB Environmental, Cloquet Landfill Inc., f/n/a Shamrock Landfill, Inc.- Report of CCR Landfill Inspection
Wenck Project # B3053-0058

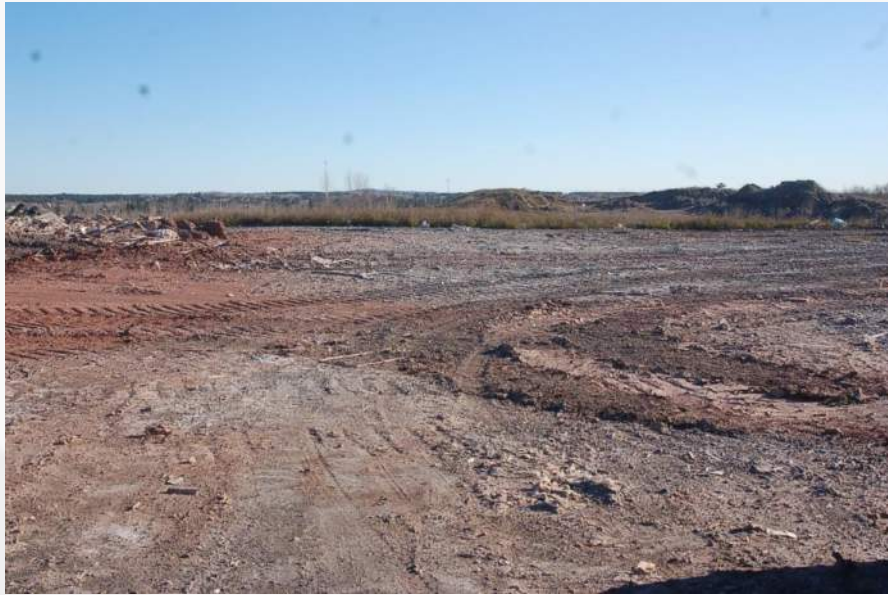
Photo 1 - Phase 1 and 2 Upper Active Area

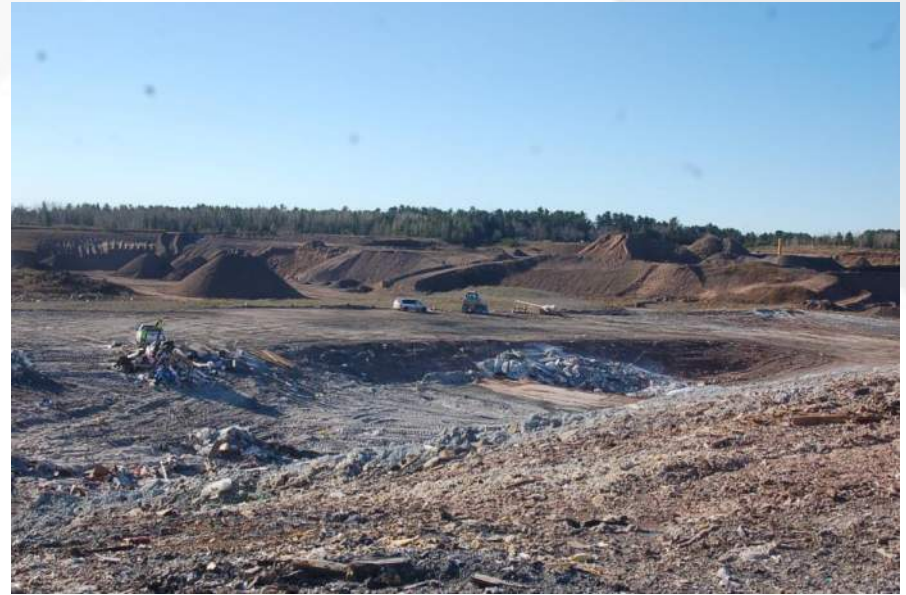
Photo 2 - Phase 3 and 4 Lower Active Area

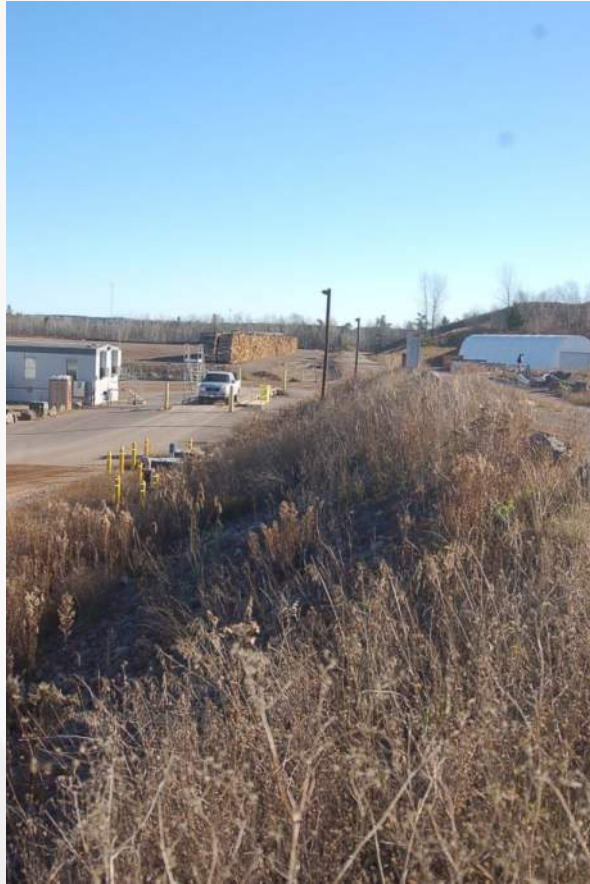
Photo 3 - Phase 1 and 2 North Exterior Slope

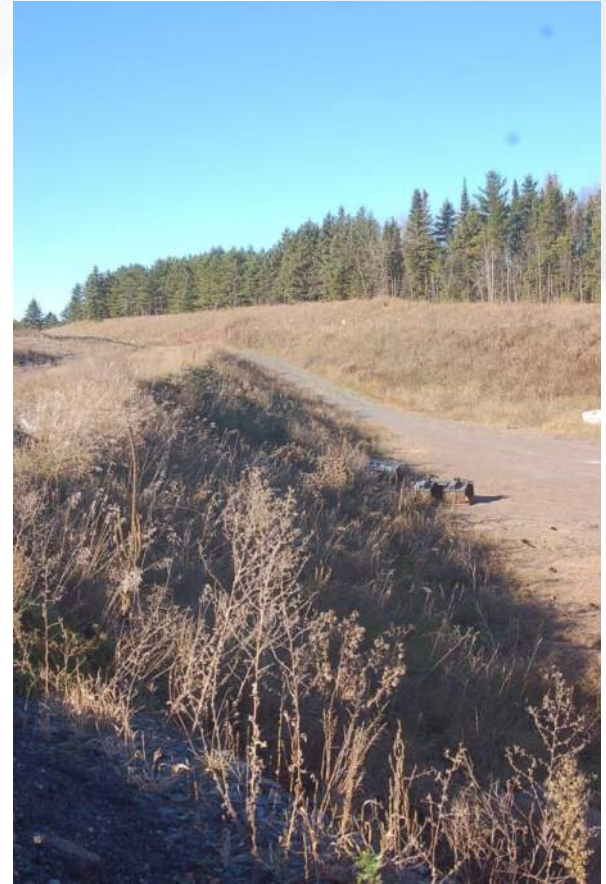
Photo 4 - Phase 1 and 2 North Exterior Slope

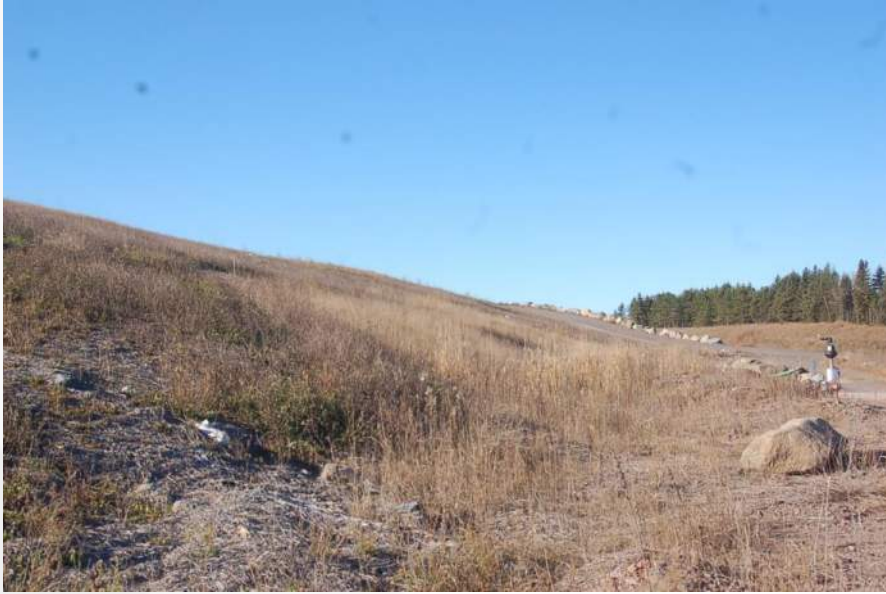
Photo 5 - Phase 1 North Waste Slope

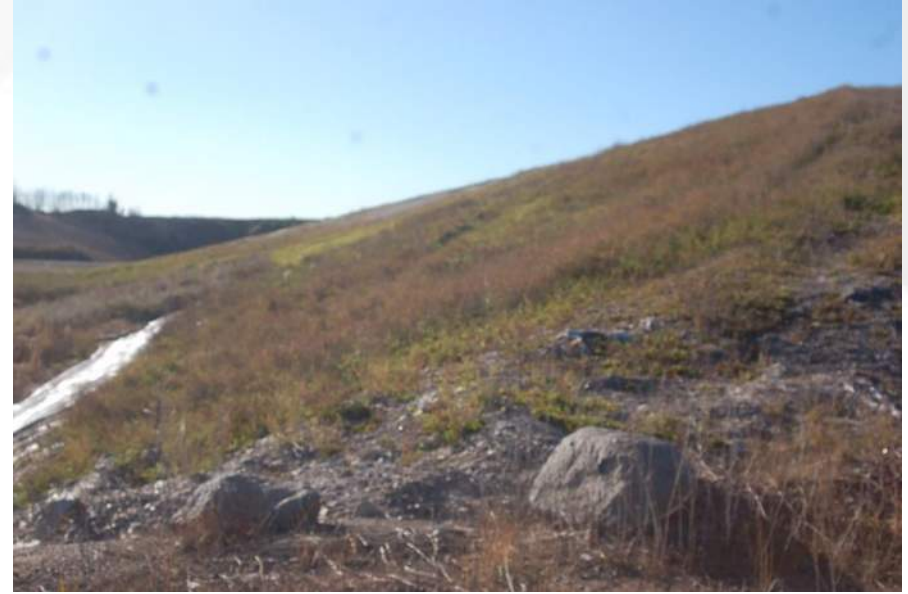
Photo 6 - Phase 1 East Waste Slope

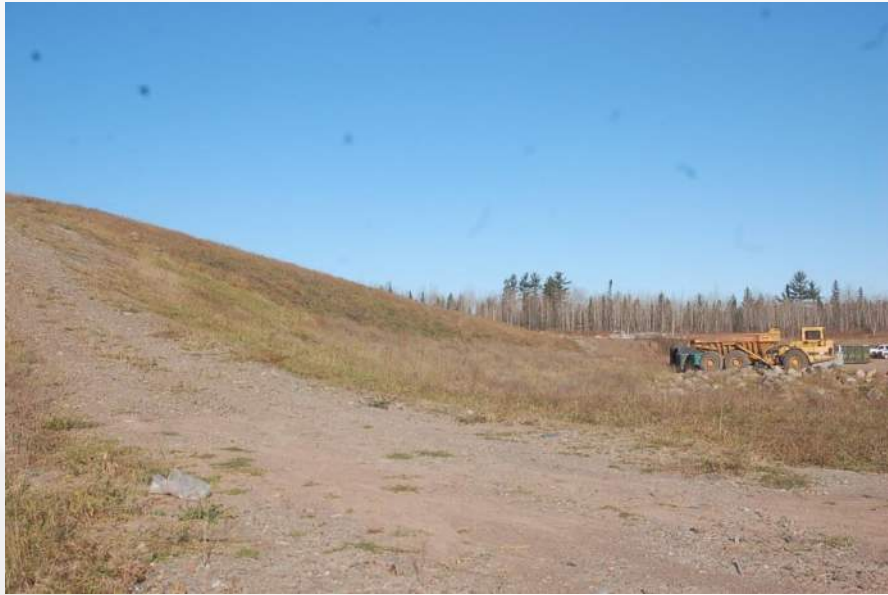
Photo 7 - Phase 1 East Waste Slope

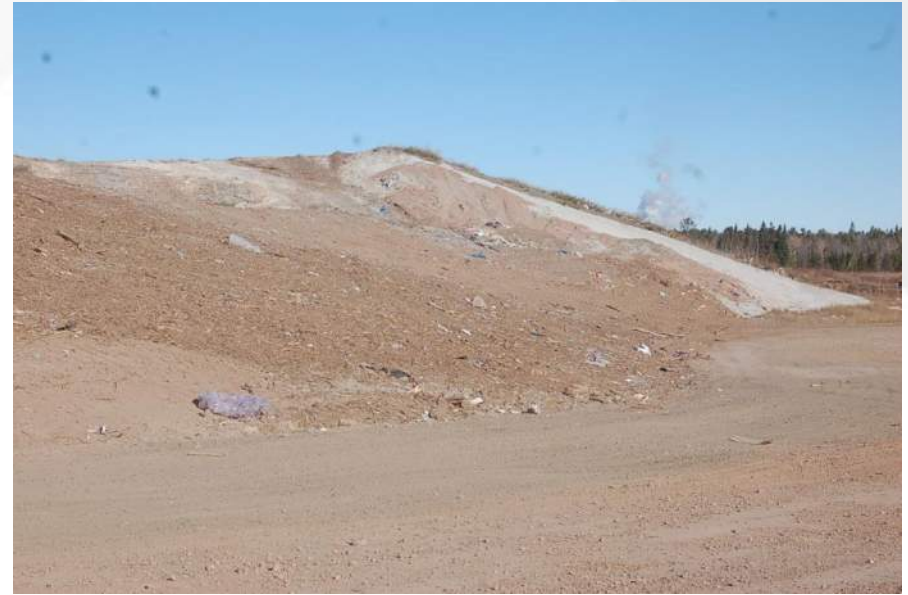
Photo 8 - Phase 1 Active Area

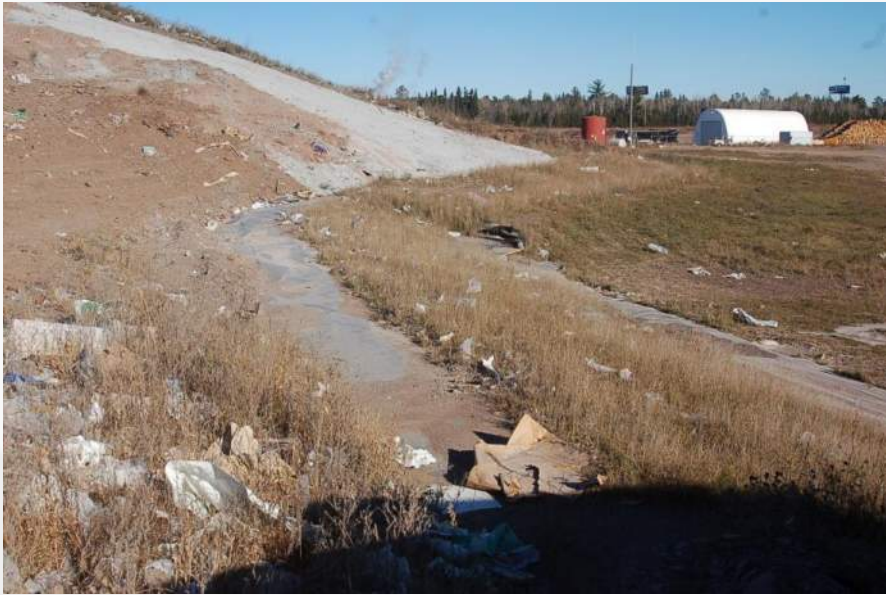
Photo 9 - Phase 3 East Slope

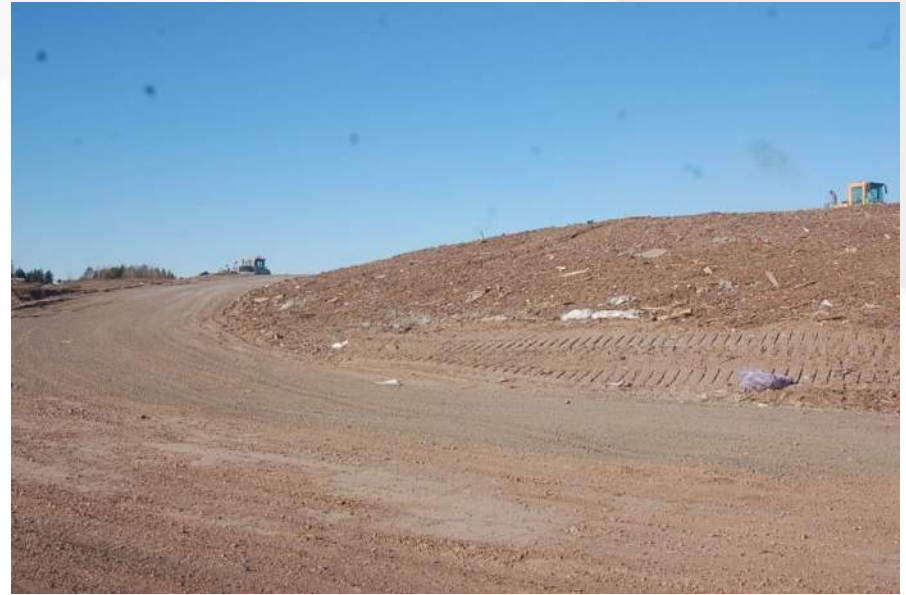
Photo 10 - Phase 3 East Working Face

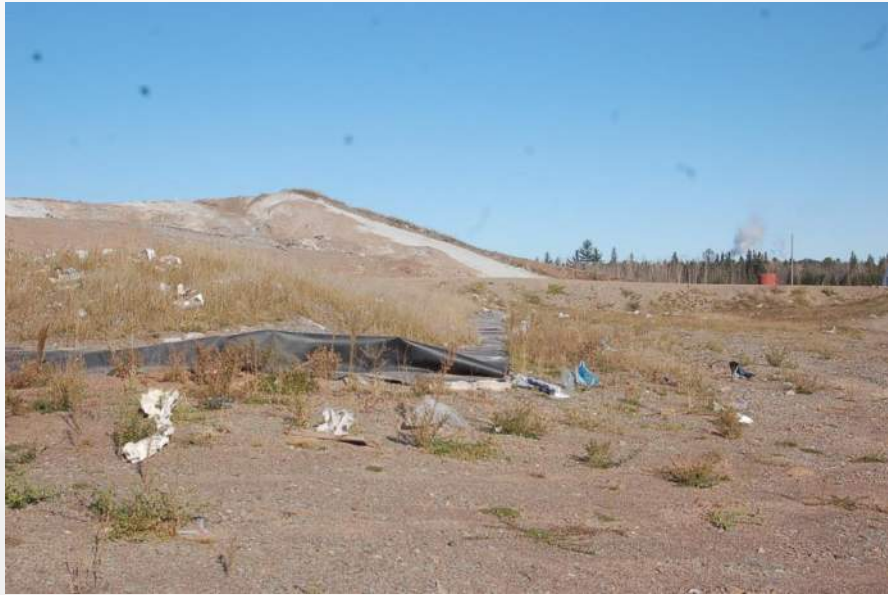
Photo 11 - Phase 3 East Exterior Slope

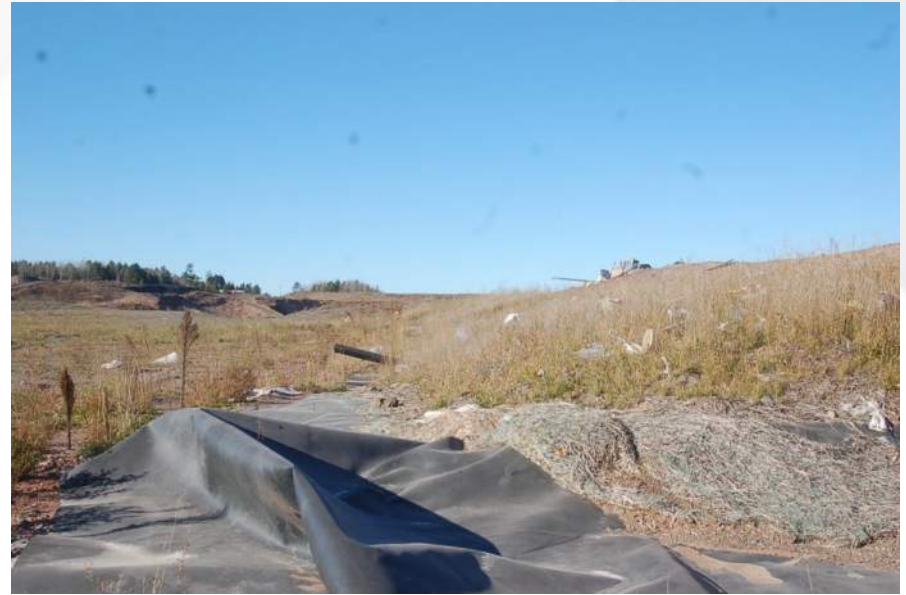
Photo 12 - Phase 3 South Exterior Slope

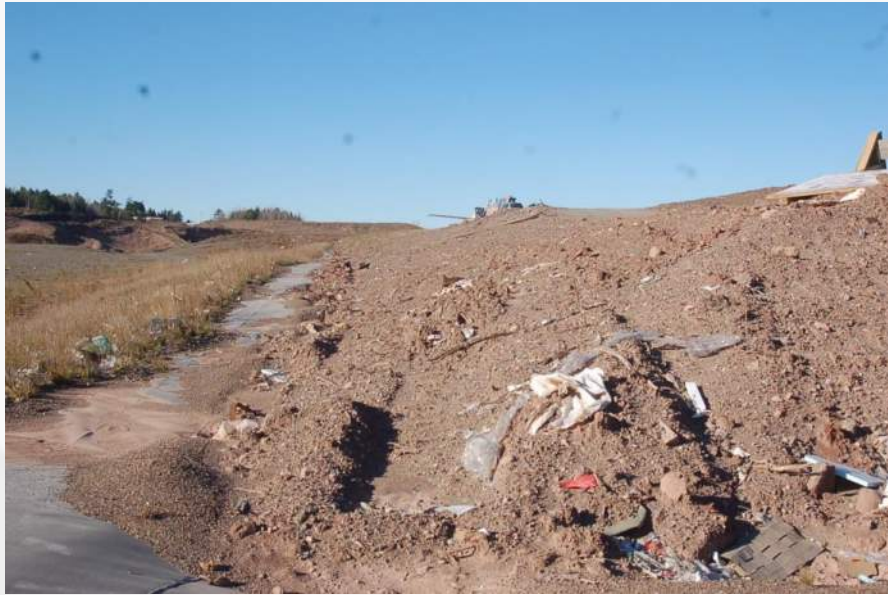
Photo 13 - Phase 3 South Working Face

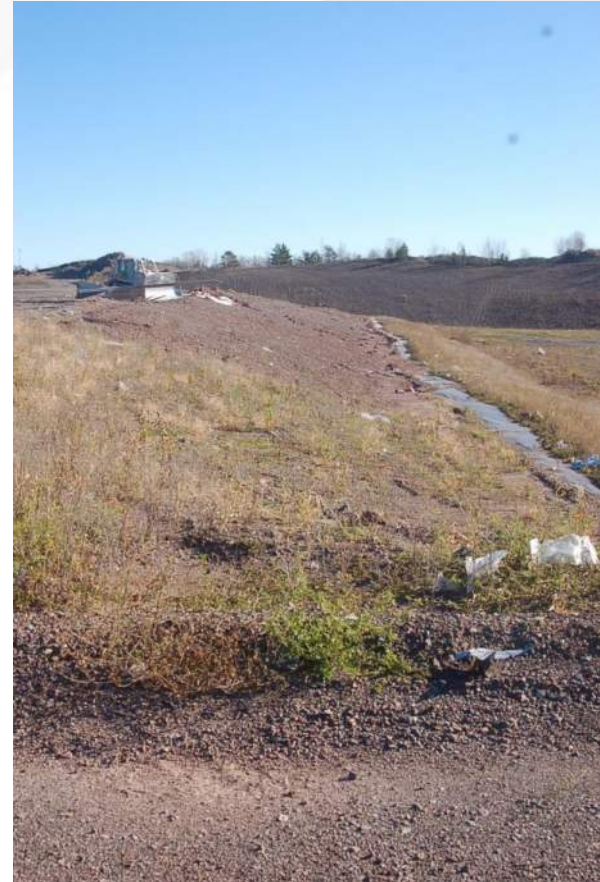
Photo 14 - Phase 3 and 4 South Working Face

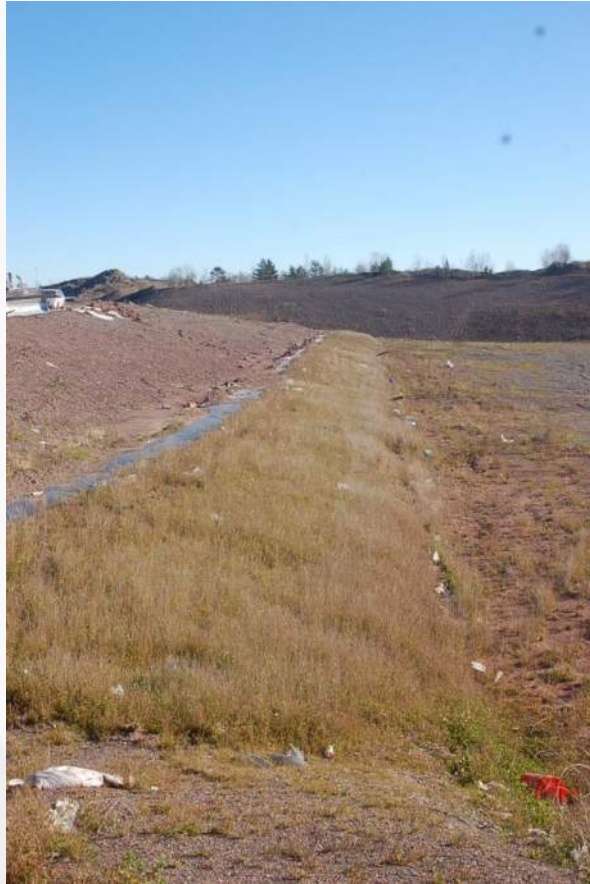
Photo 15 - Phase 3 and 4 South Exterior Slope

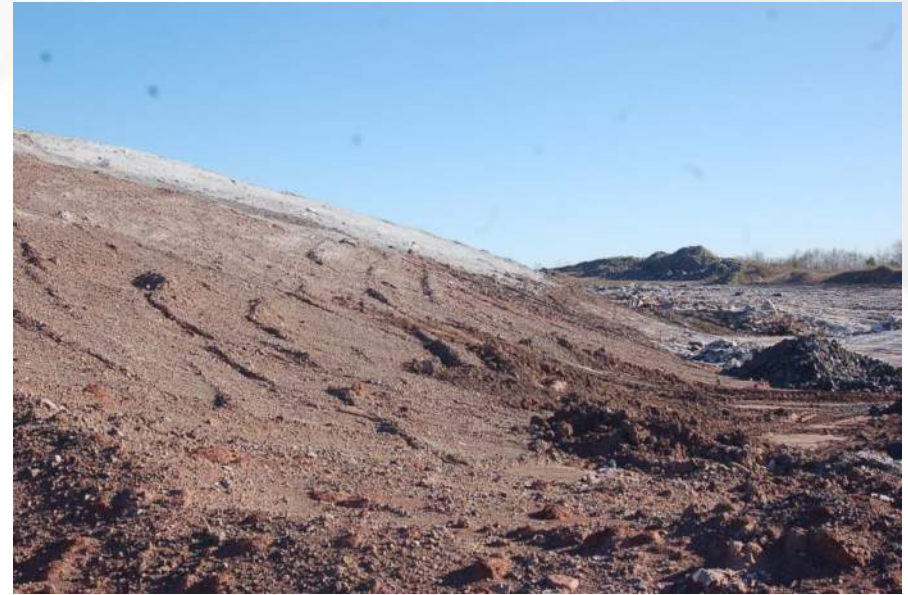
Photo 16 - Phase 1 and 2 South Internal Working Slope

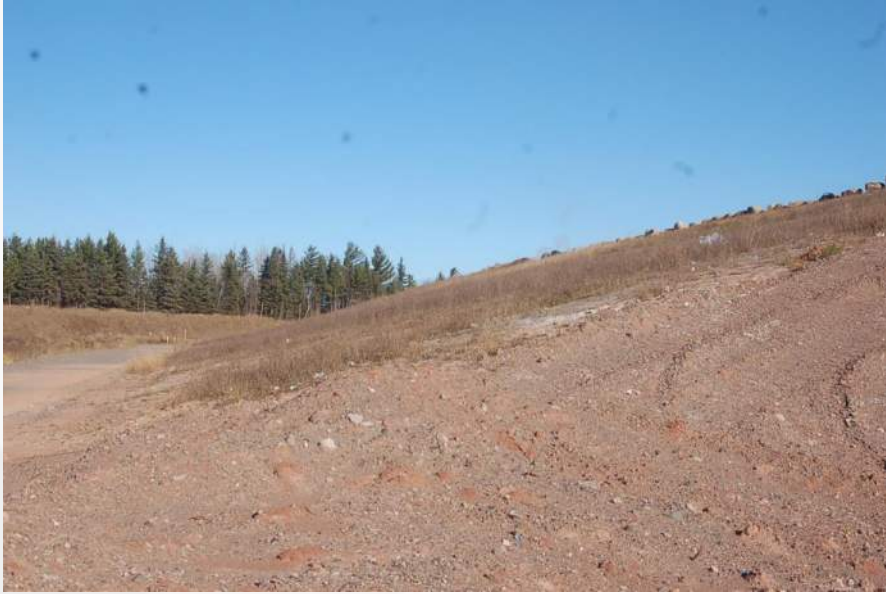
Photo 17 - Phase 2 West Waste Slope

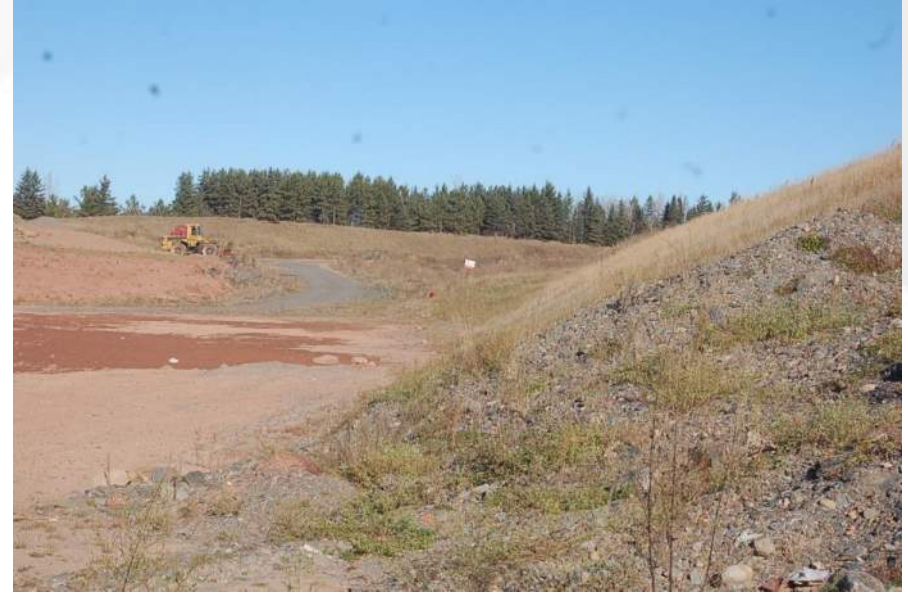
Photo 18 - Phase 2 West Exterior Slope

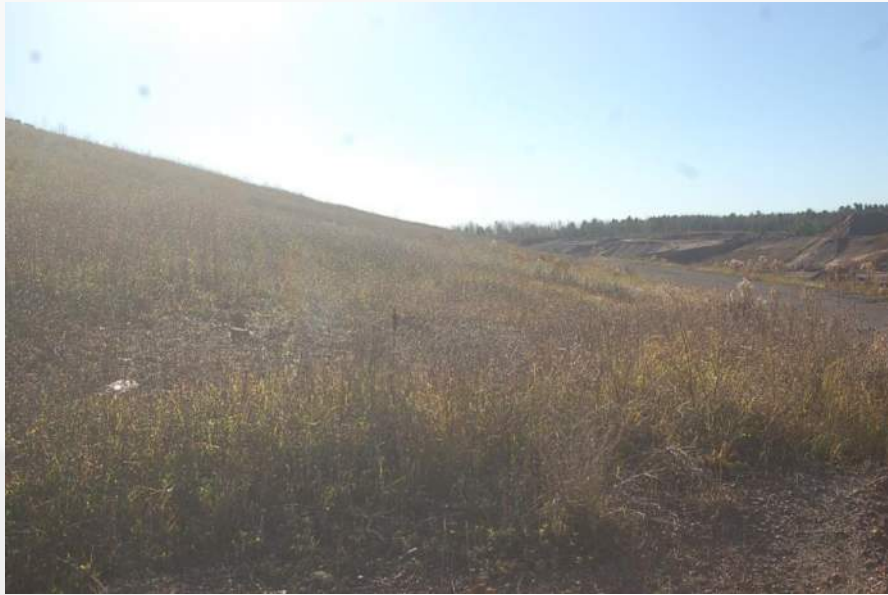
Photo 19 - Phase 2 West Waste Slope

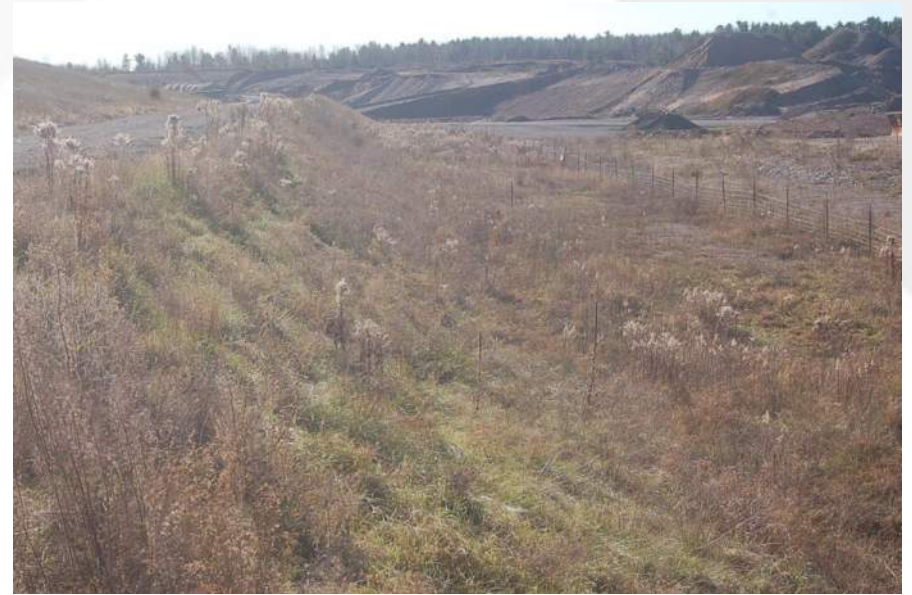
Photo 20 - Phase 2 West Exterior Slope

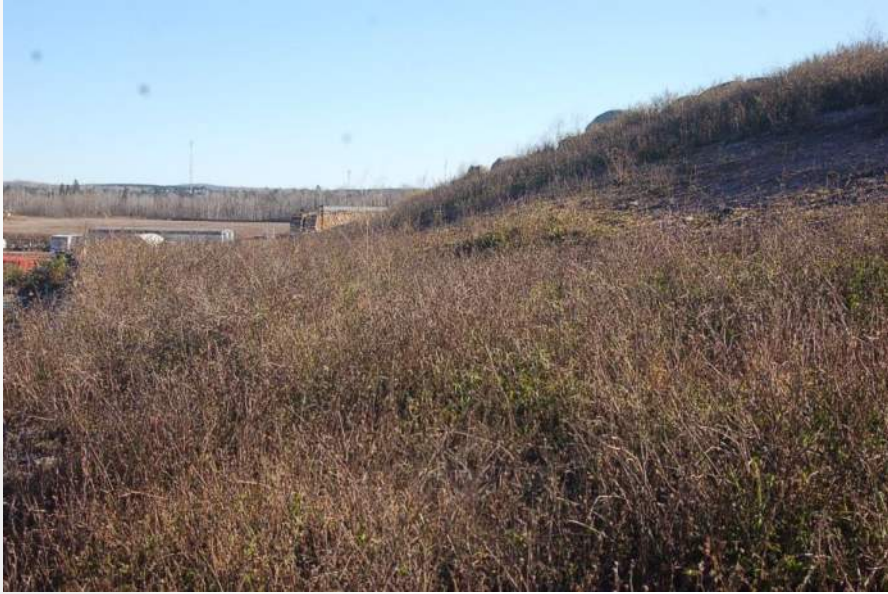
Photo 21 - Phase 1 and 2 North Waste Slope

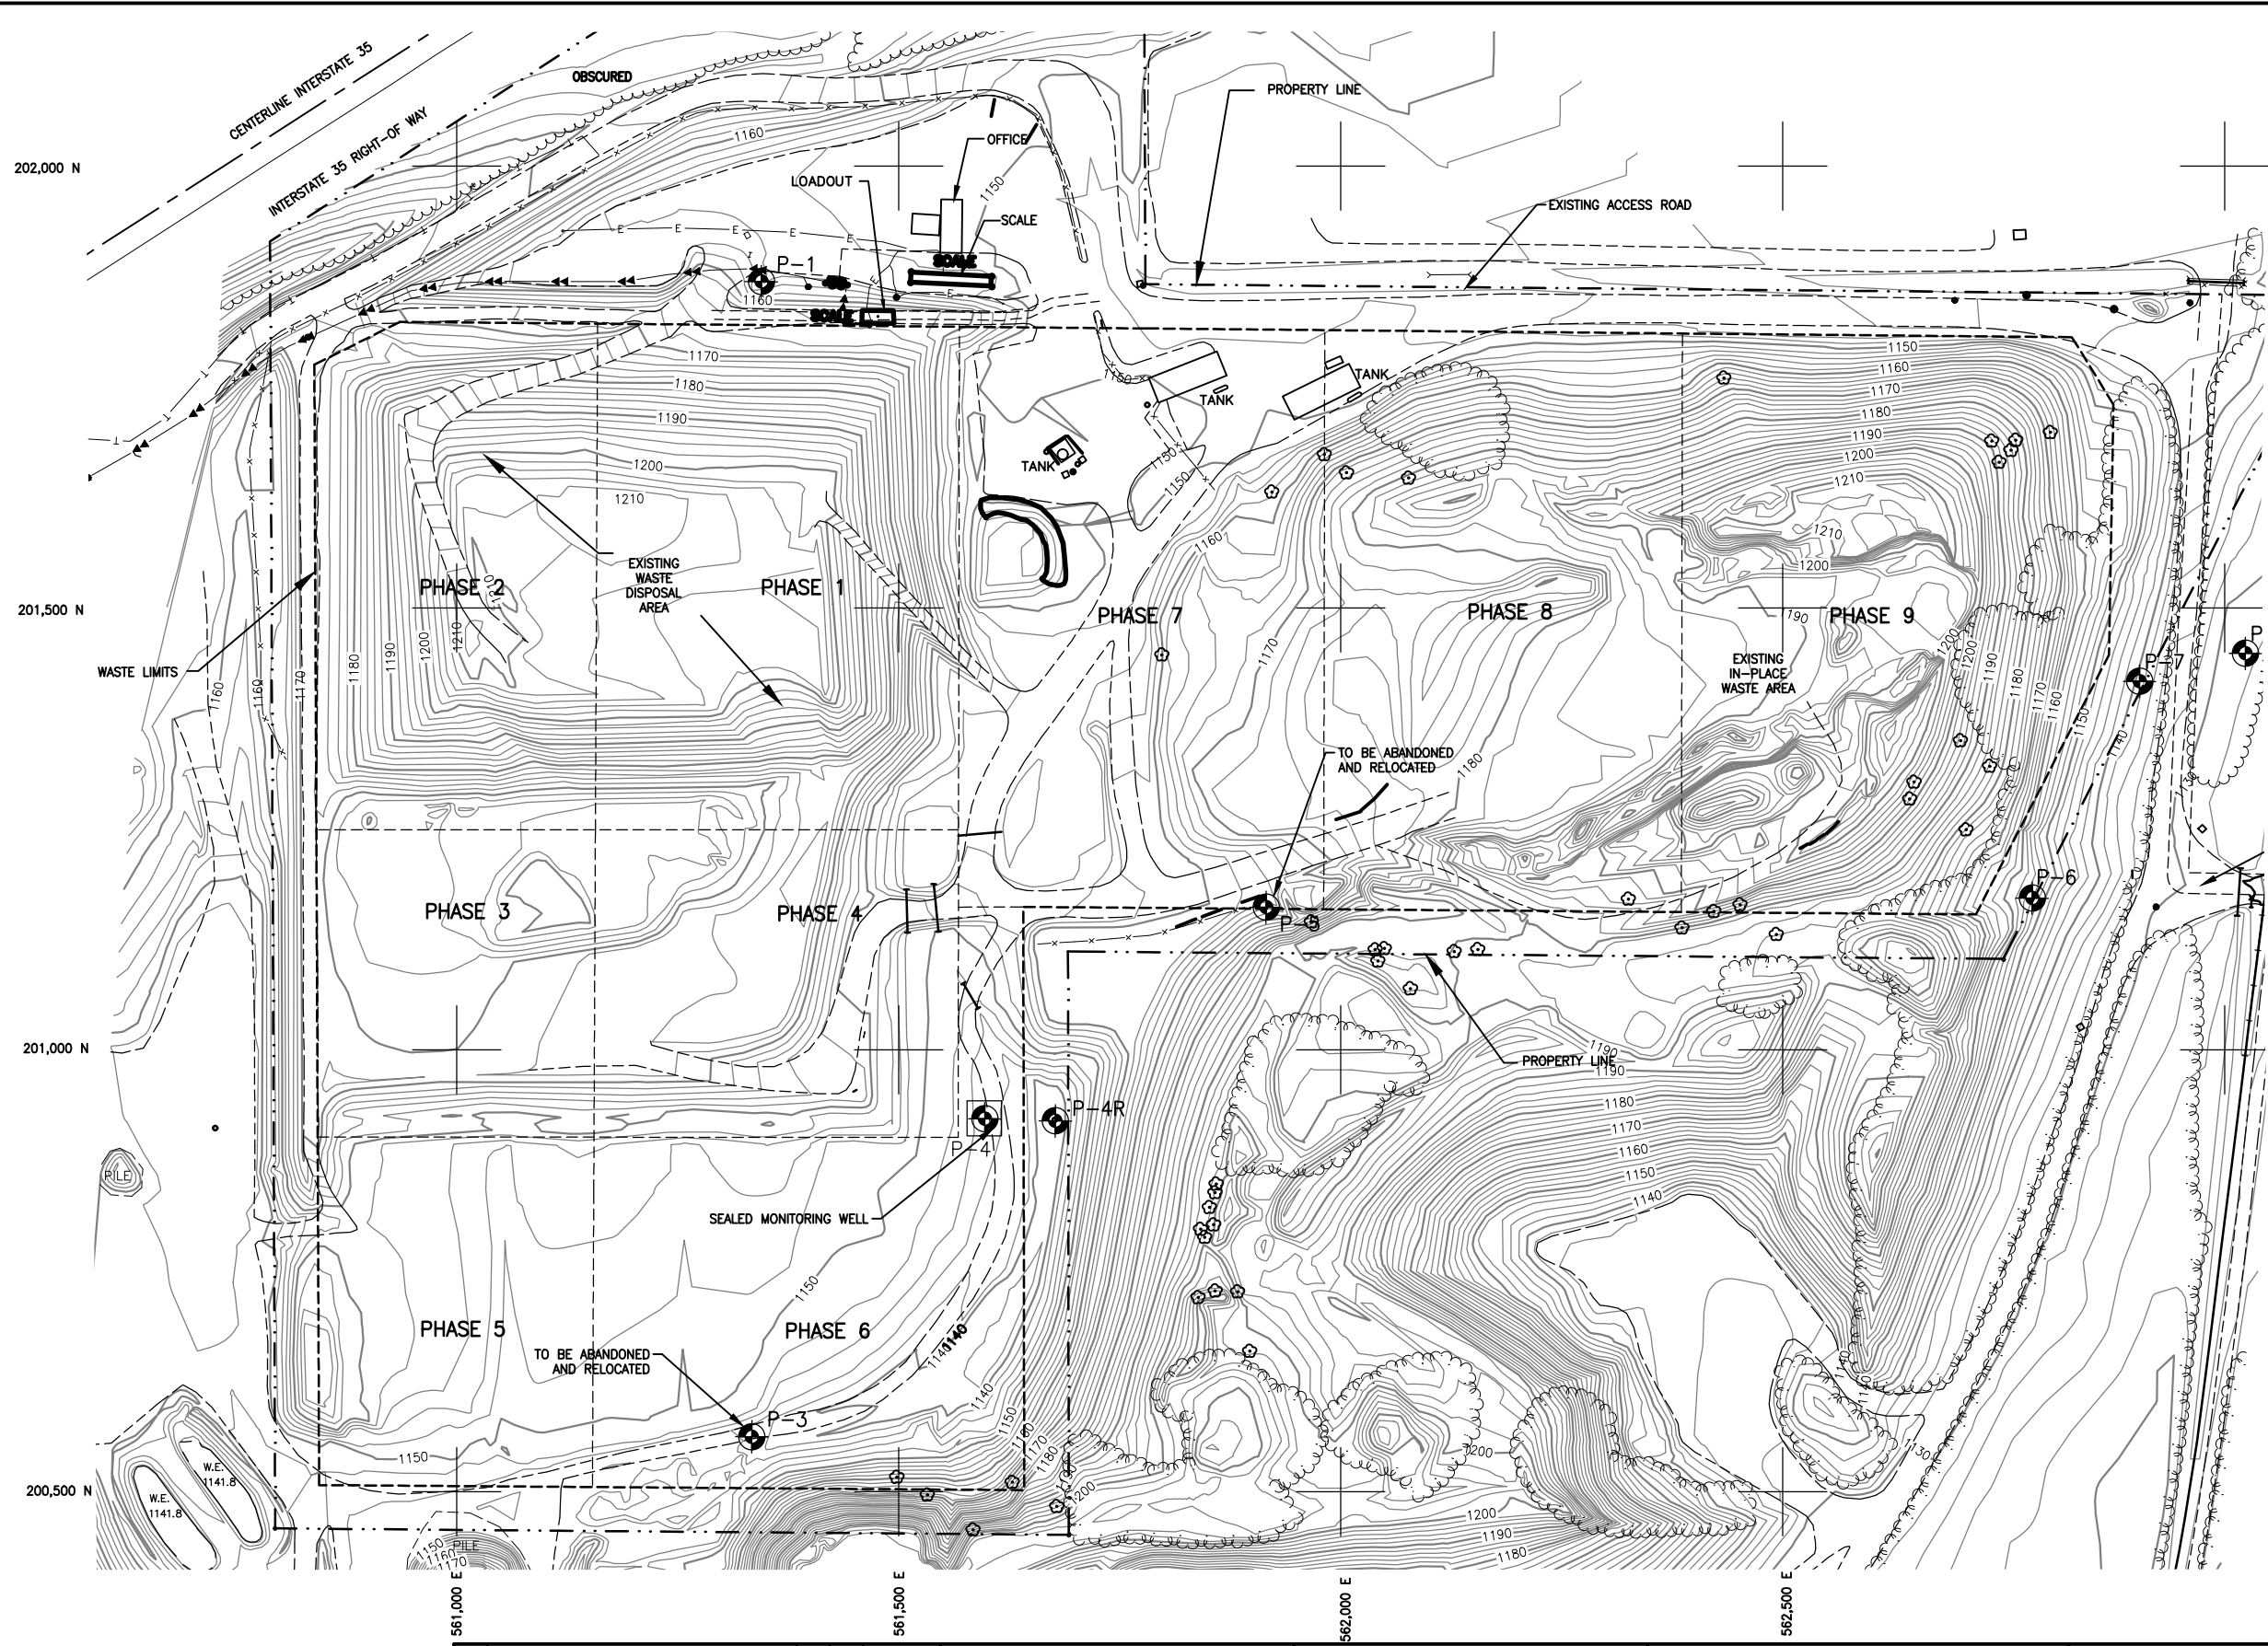
SHEET TITLE NOVEMBER 2016 TOPOGRAPHY			
DWN BY JVB	CHK'D SH	APP'D TJS	DWG DATE DEC. 2016
PROJECT NO. 3053-0058		SHEET NO. SCALE AS NOTED	
		REV NO. FIGURE 3

There were no apparent changes from the geometry of the impoundment when compared to the permit drawings or the past construction documentation reports. Also, the recent aerial survey done in November, 2016 shows that the topography of the embankments has stayed straight and true. This is shown on Figure 3.
