# Technical Memo

**Subject:** Annual Inspection SKB Environmental, Cloquet Landfill Inc., f/n/a Shamrock Landfill, Inc.- Report of CCR Landfill Inspection  
Wenck Project # B3053-98

On December 1, 2017, Dave Parenteau conducted the on-site inspection of the CCR Landfill. During the inspection the following activities were performed.

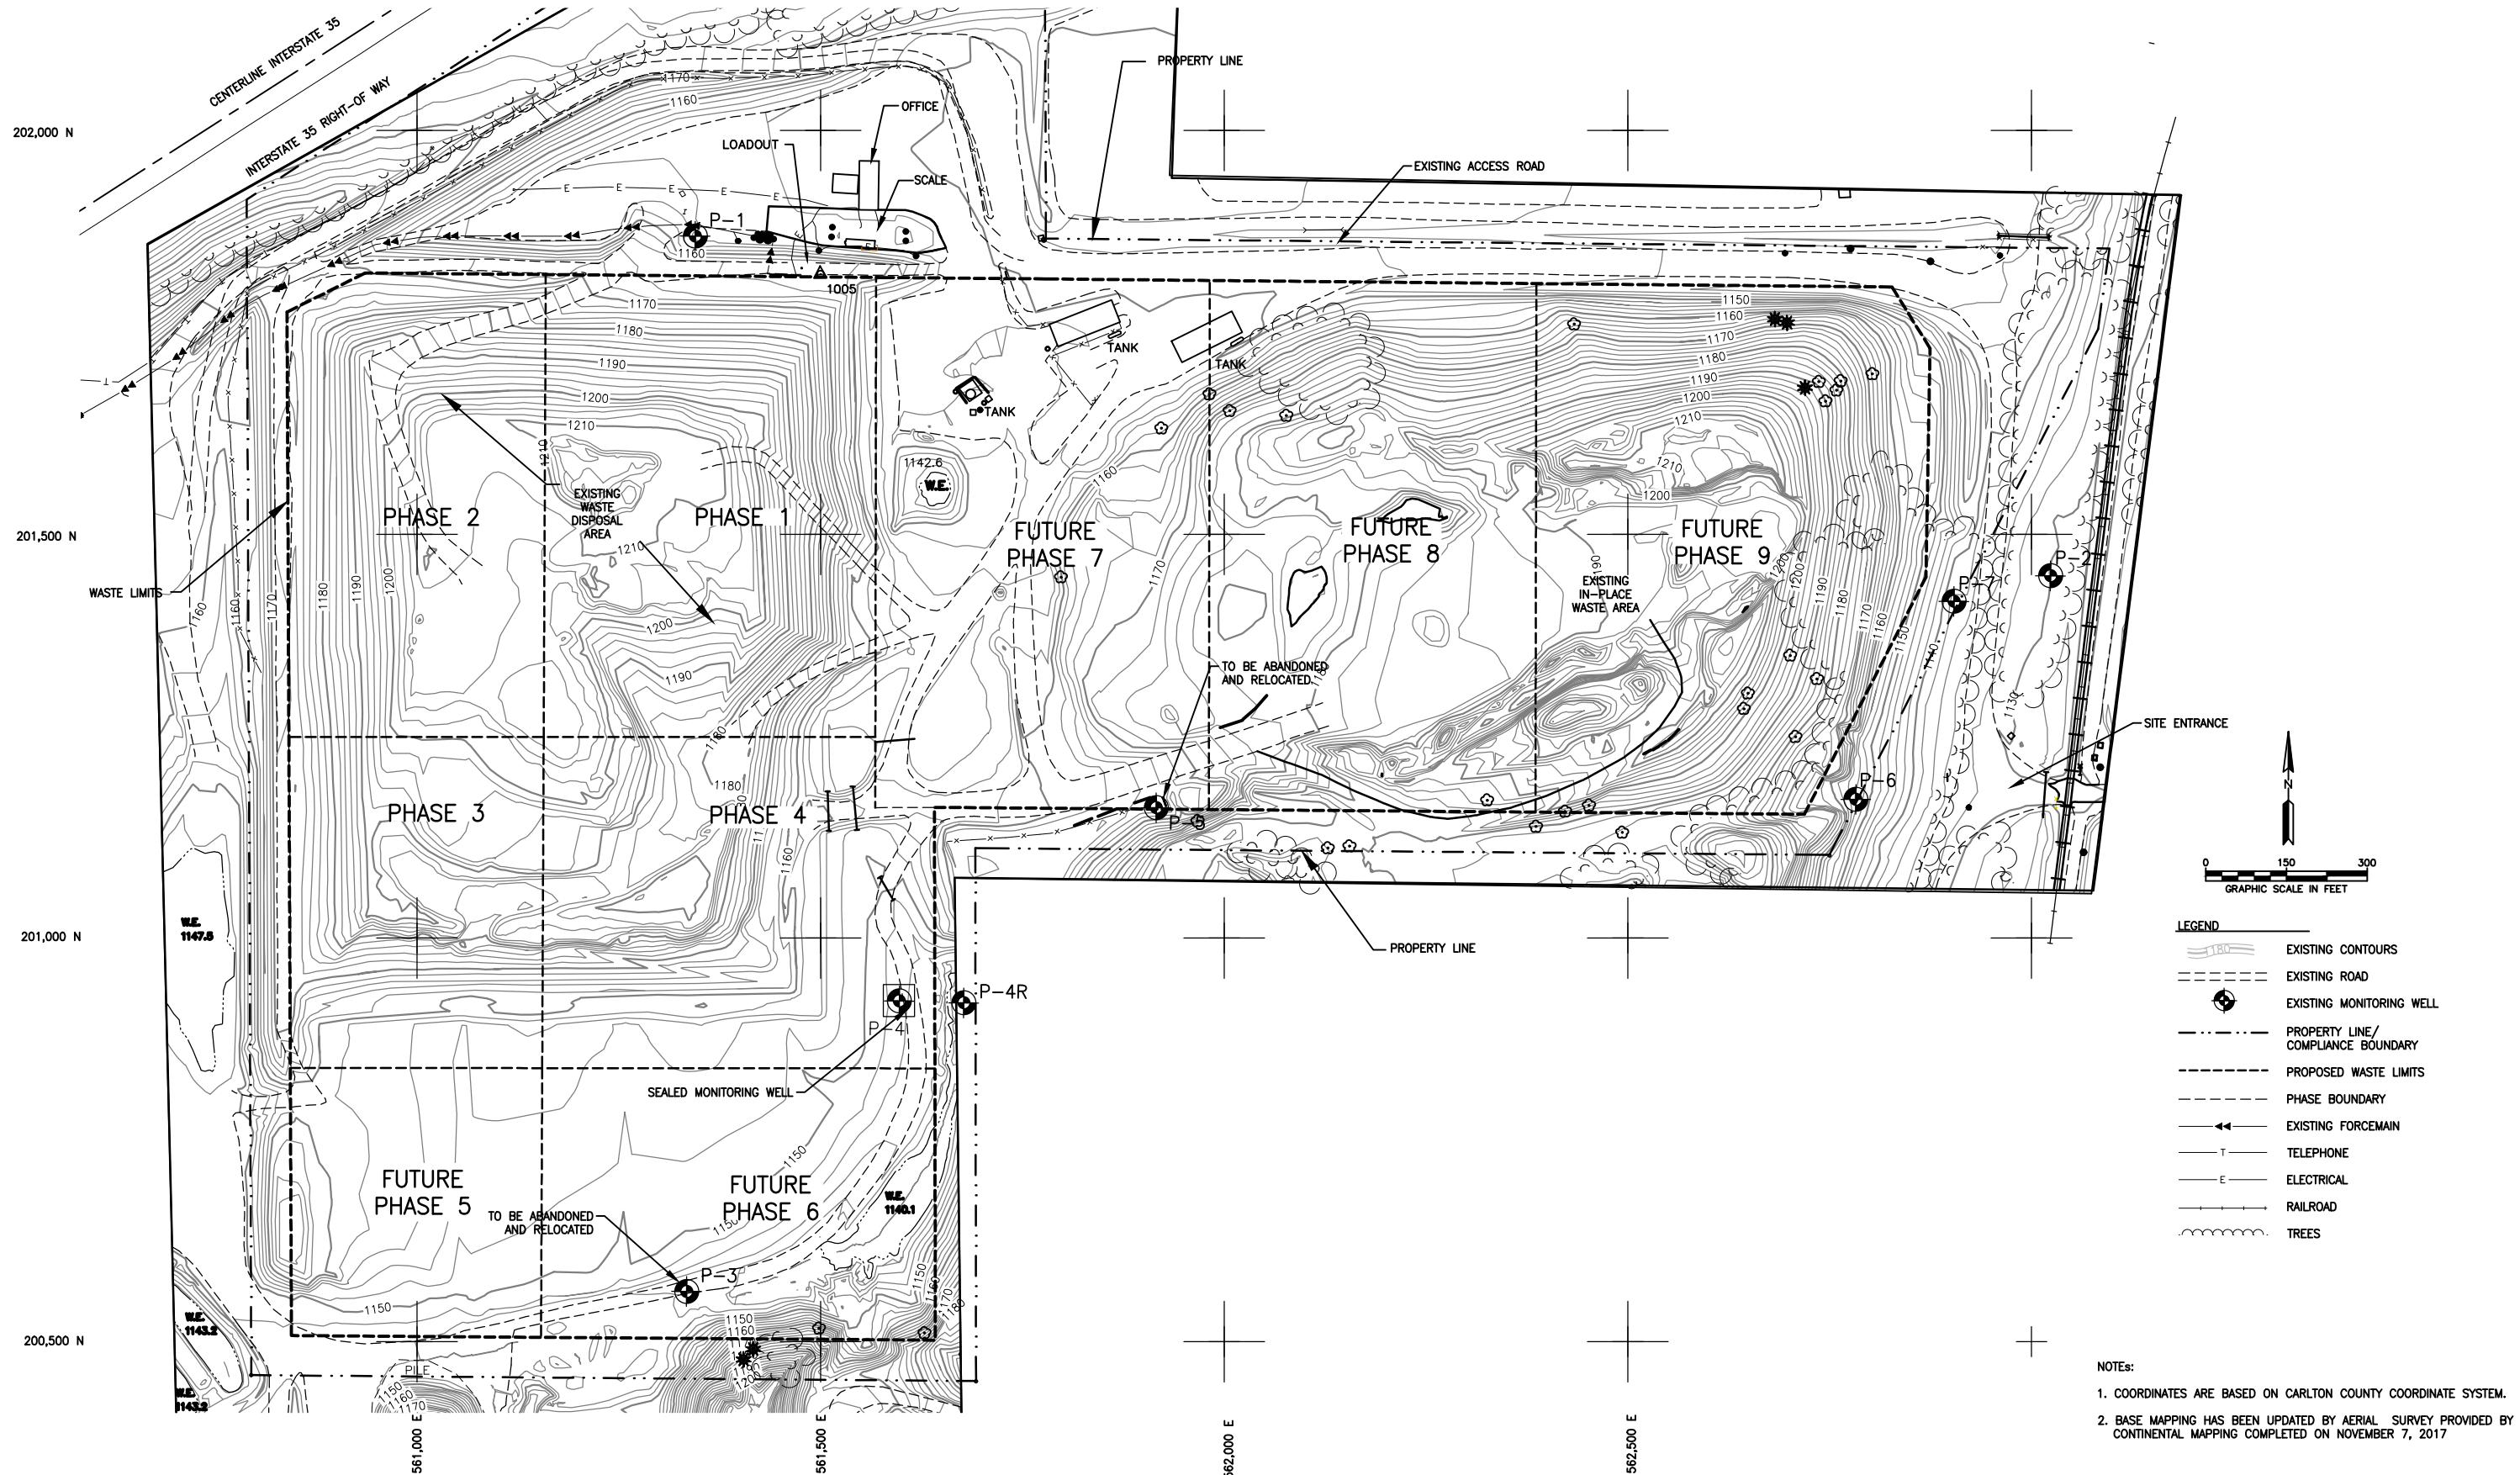
SHEET TITLE <b>NOVEMBER 2017 TOPOGRAPHY</b>			
DWN BY JVB	CHK'D SH	APP'D TJS	DWG DATE DEC. 2017
PROJECT NO. 3053-0098	SHEET NO. FIGURE 3	SCALE AS NOTED	REV NO. 0

There were no apparent changes from the geometry of the impoundment when compared to the permit drawings or the past construction documentation reports. Also, the recent aerial survey done in November, 2017 shows that the topography of the embankments has stayed straight and true. This is shown on Figure 3.
