# Technical Memo

**Date:** January 9, 2019

**Subject:** SKB Environmental Cloquet Landfill – 2018 Annual CCR Inspection  
Wenck Project # B3053-0137

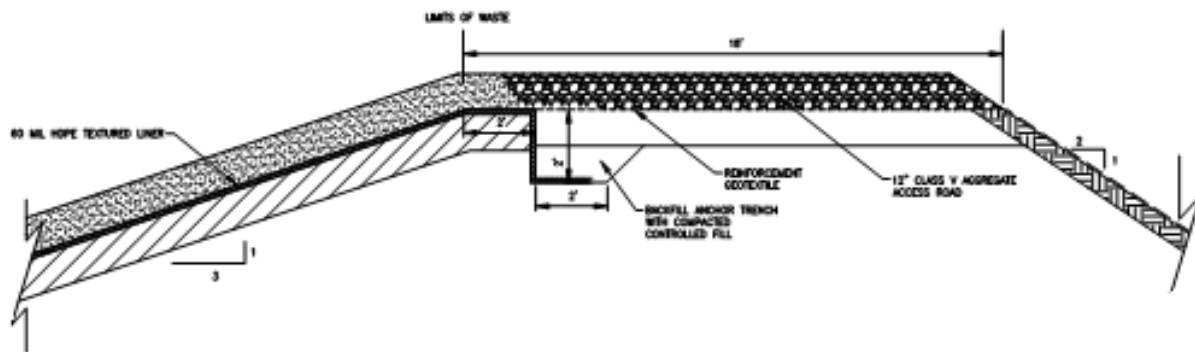
Typical Landfill Berm Detail

Most of the facility's landfill cell embankments were constructed using on-site borrow material, which consisted of silty clay and clayey sand type soils. The fill was placed and compacted to 95% of Standard Proctor Dry Density in lift thicknesses ranging from 8 inches to 12 inches. The final subgrade surface was proof rolled prior to geosynthetics installation. A typical perimeter section taken from the Phase 3 and 4 Construction Documentation Report prepared by Wenck in September 2015 is shown below.

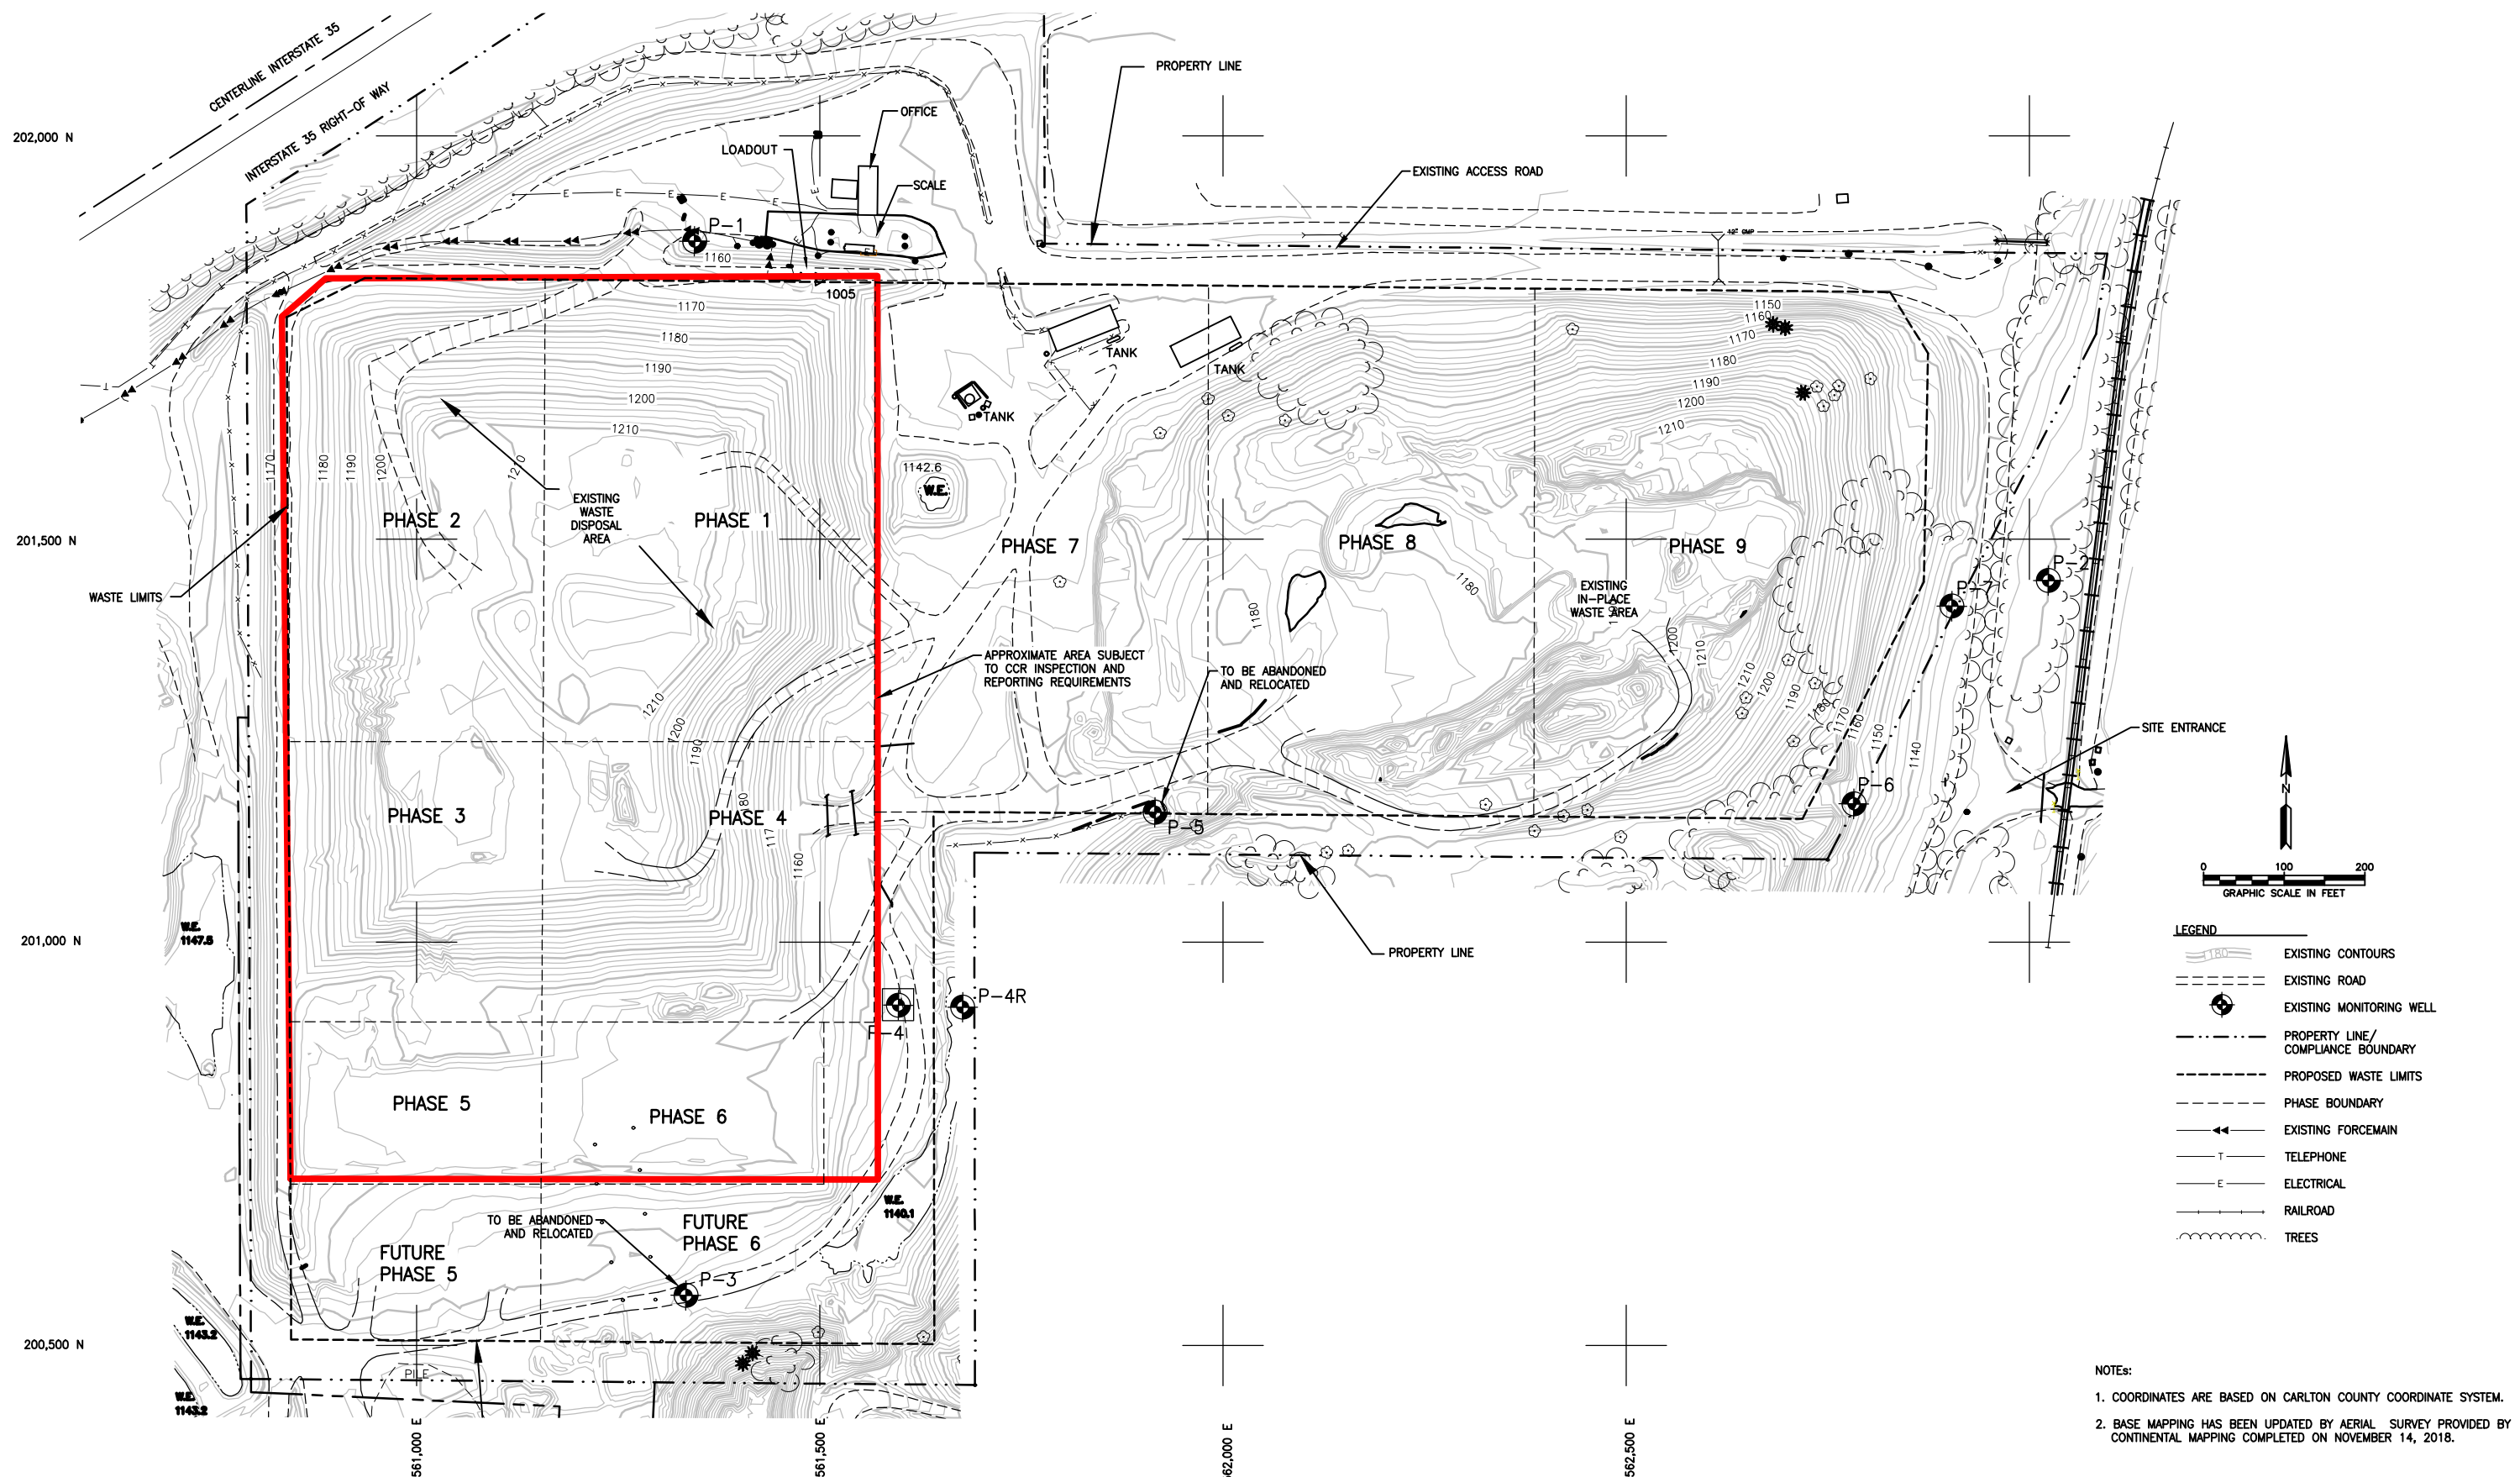
SHEET TITLE			
<b>SITE MAP</b>			
DWN BY	CHK'D	APP'D	DWG DATE
JVB	SH	TJS	JAN. 2019
PROJECT NO.		SCALE	
3053-0137		AS NOTED	
SHEET NO.		REV NO.	
FIGURE 2		0

There were no apparent changes to the embankment geometry of Cells 1, 2, 3, or 4 when compared to the permit drawings or the past inspection reports. The annual aerial photogrammetry survey was performed on November 12, which the estimated in-place volume is based on. A comparison 2018 and 2017 aerial survey confirm that the embankment and slope topography is substantially unchanged with no significant movement. The 2018 aerial survey is included as Figure 2.

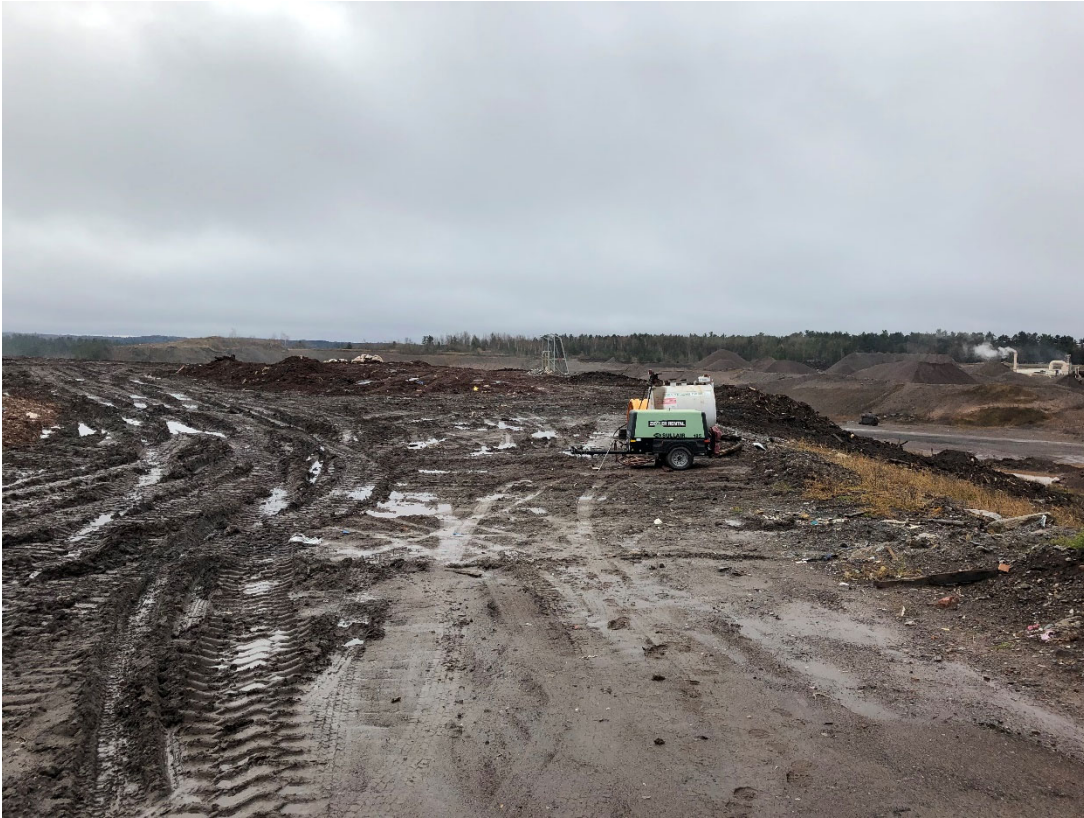
Photo 1: Location 1 – Looking South, Phase 2/3 Upper Lifts

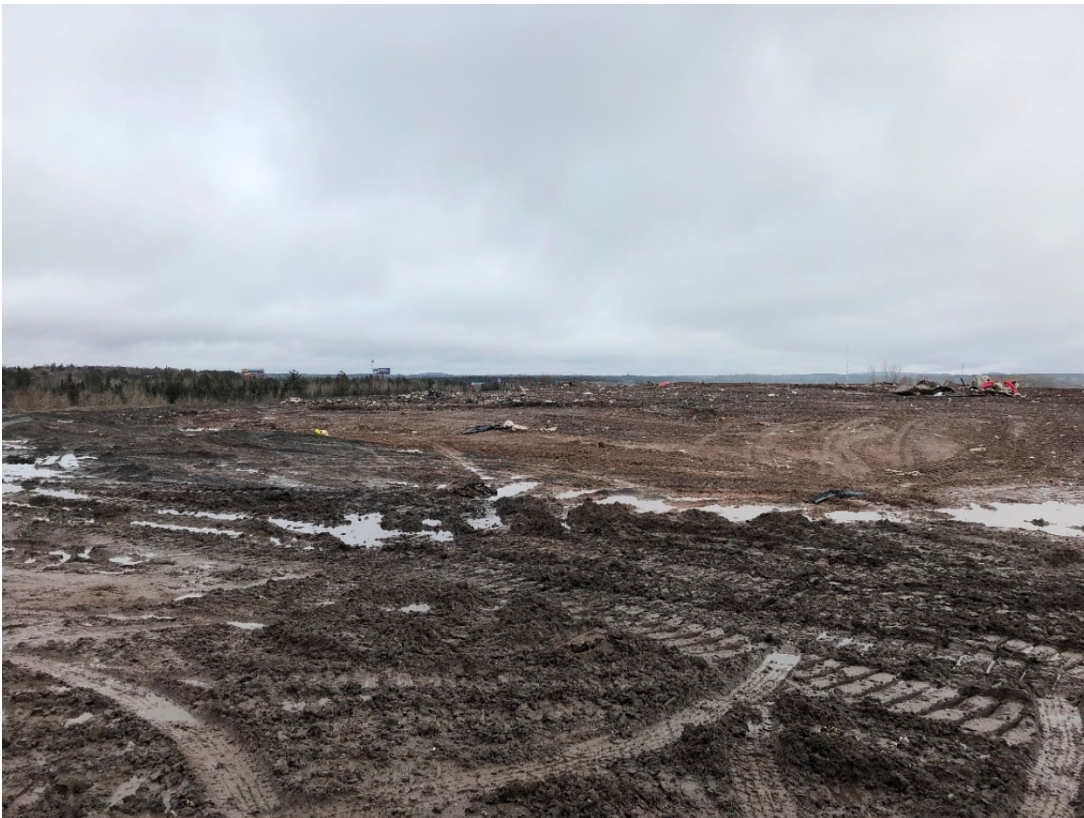
Photo 2: Location 1 – Looking Northeast, Phase 2/1 Upper Lifts

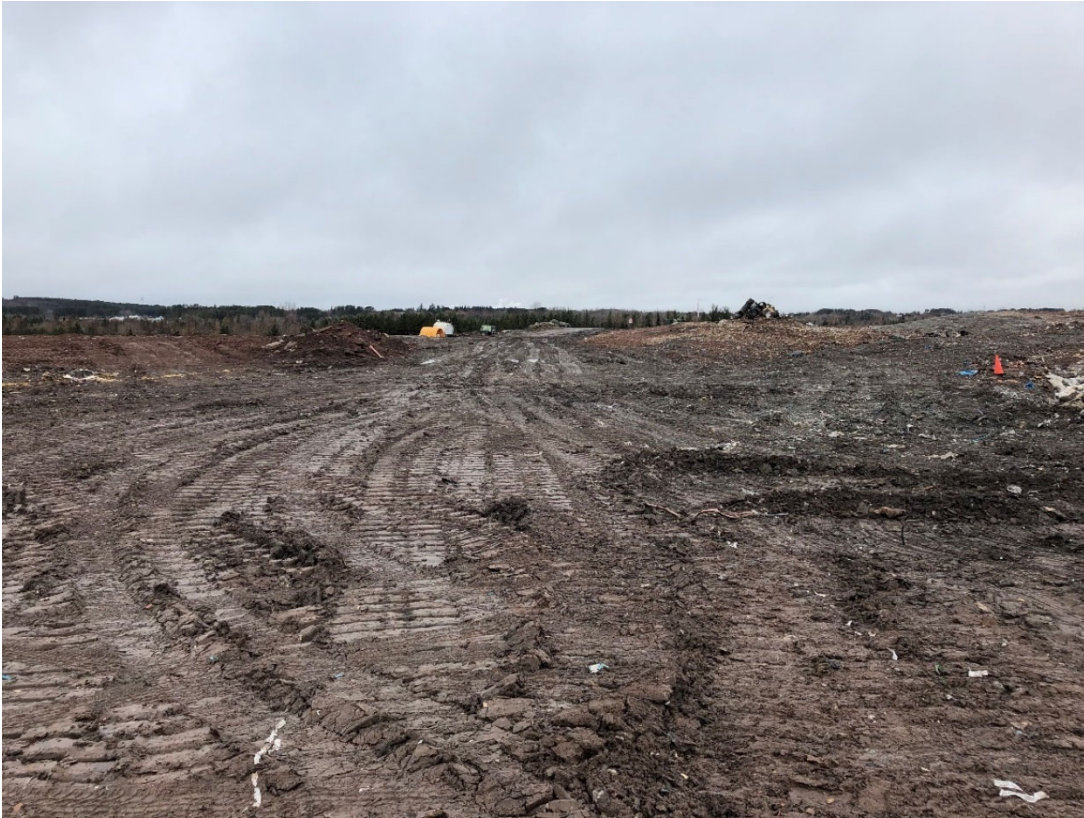
Photo 3: Location 2 – Looking North, Phase 3/4 Upper Lifts

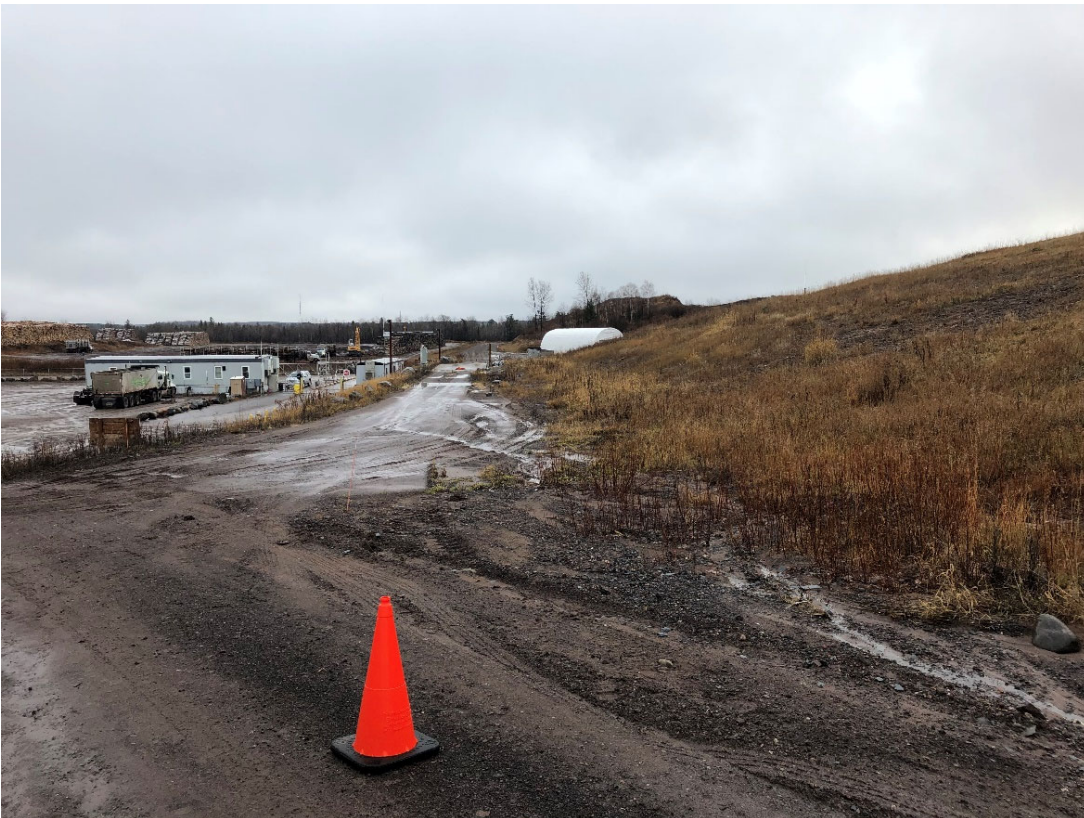
Photo 4: Location 3 – Looking East, Phase 1 Northern Waste Slope

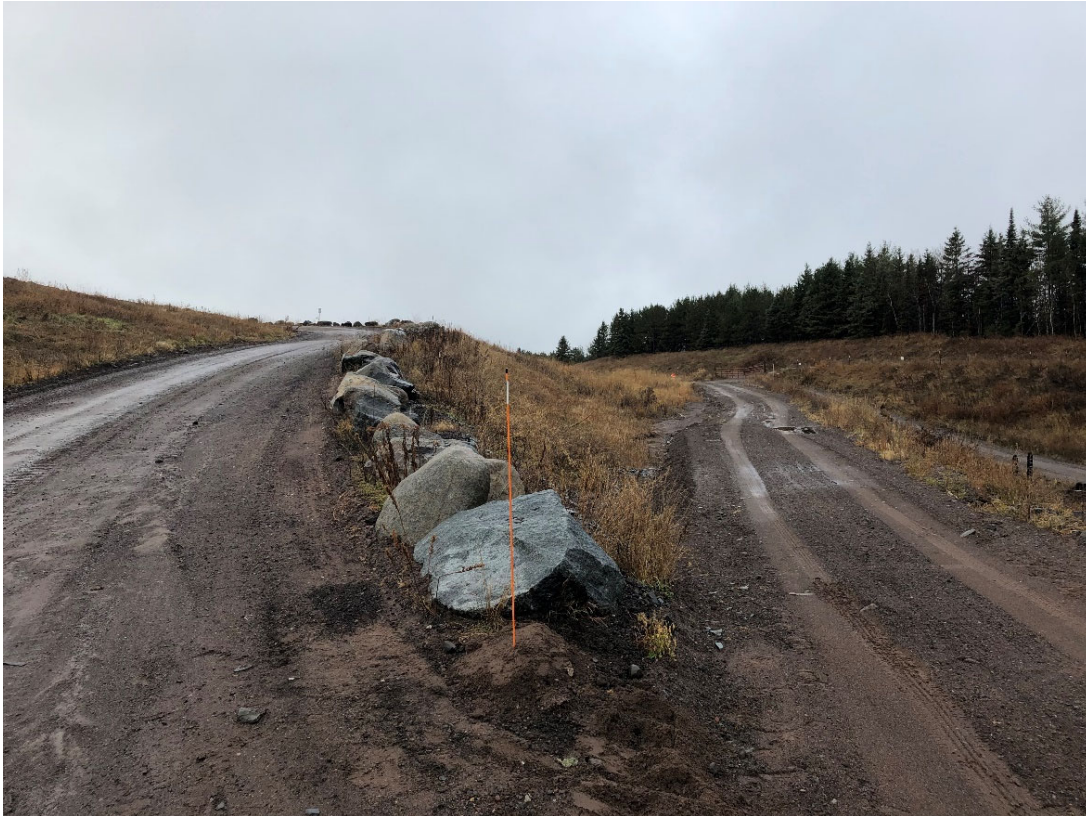
Photo 5: Location 3 – Looking West, Phase 2 Northern Waste Slope & Berm

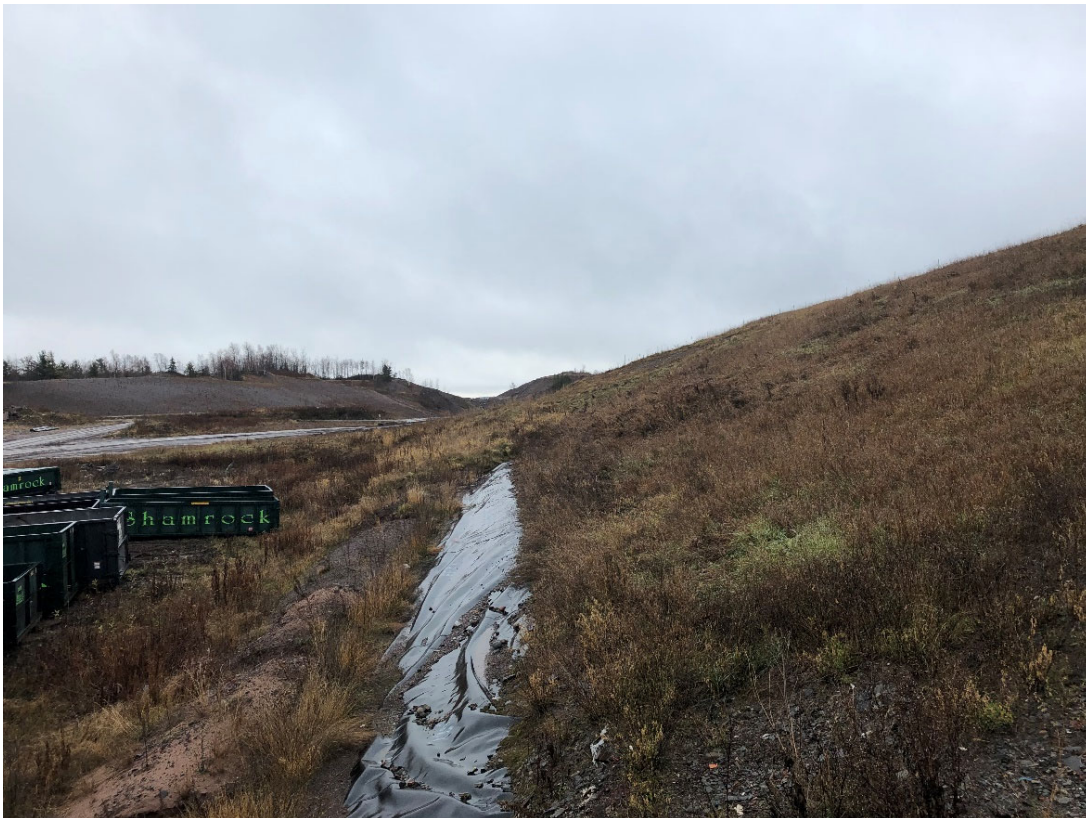
Photo 6: Location 4 – Looking South, Phase 1 Eastern Berm

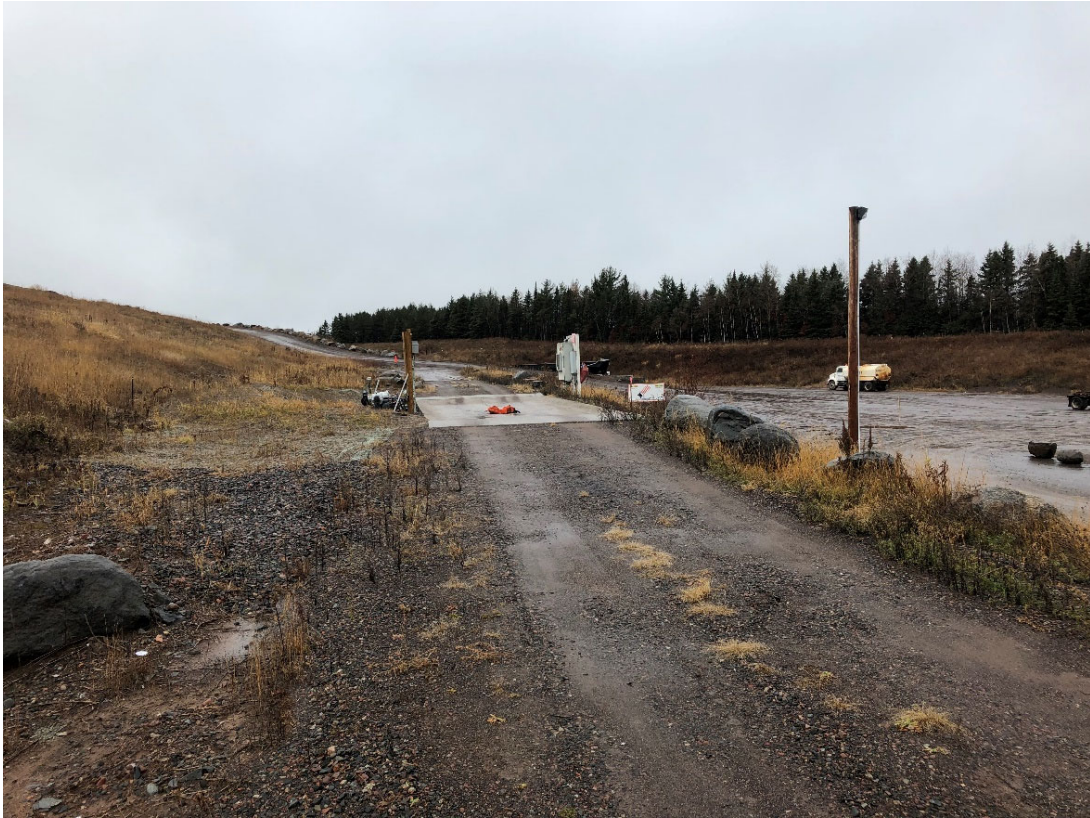
Photo 7: Location 4 – Looking West, Phase 1 Northern Berm

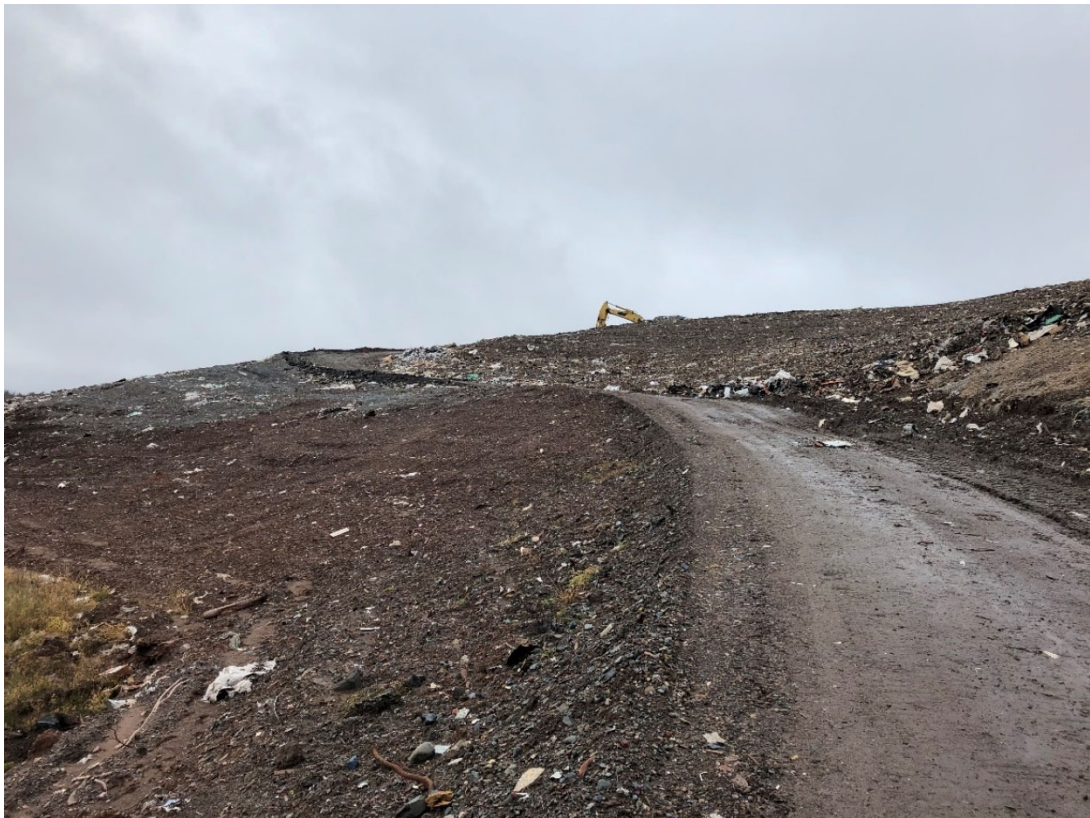
Photo 8: Location 5 – Looking Southwest, Phase 1 Southern Access Road

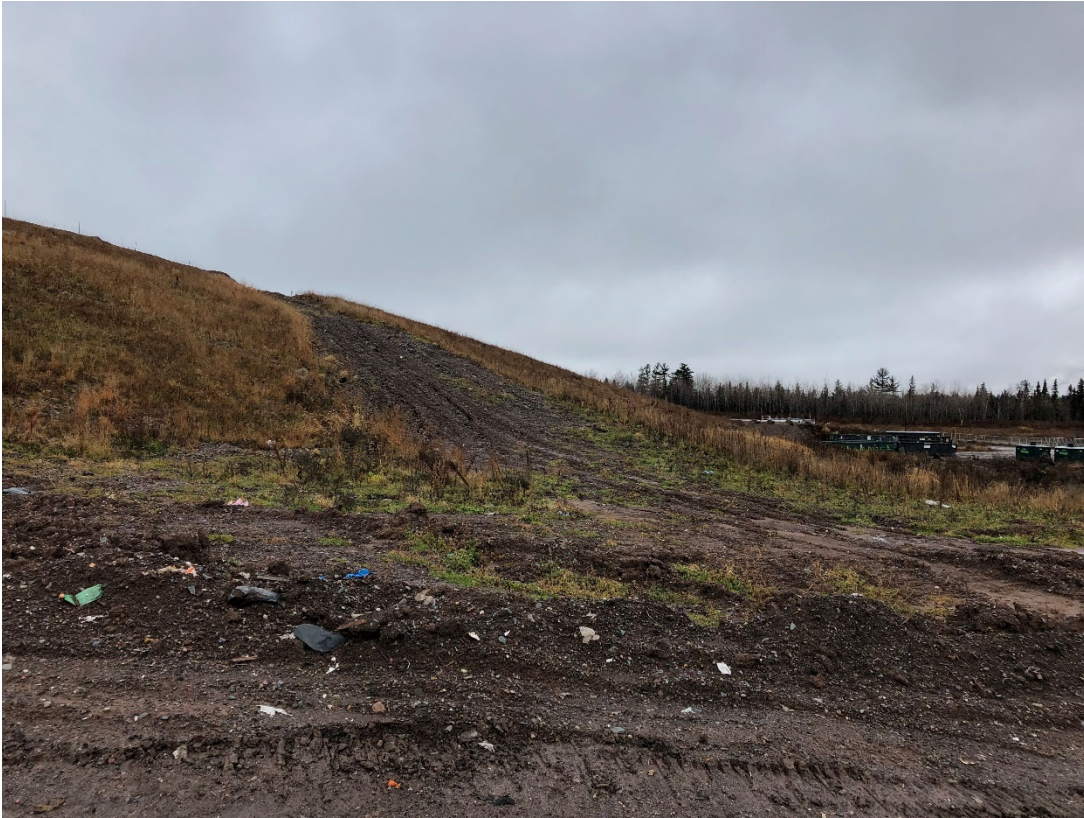
Photo 9: Location 5 – Looking North, Phase 1 Northern Access Road

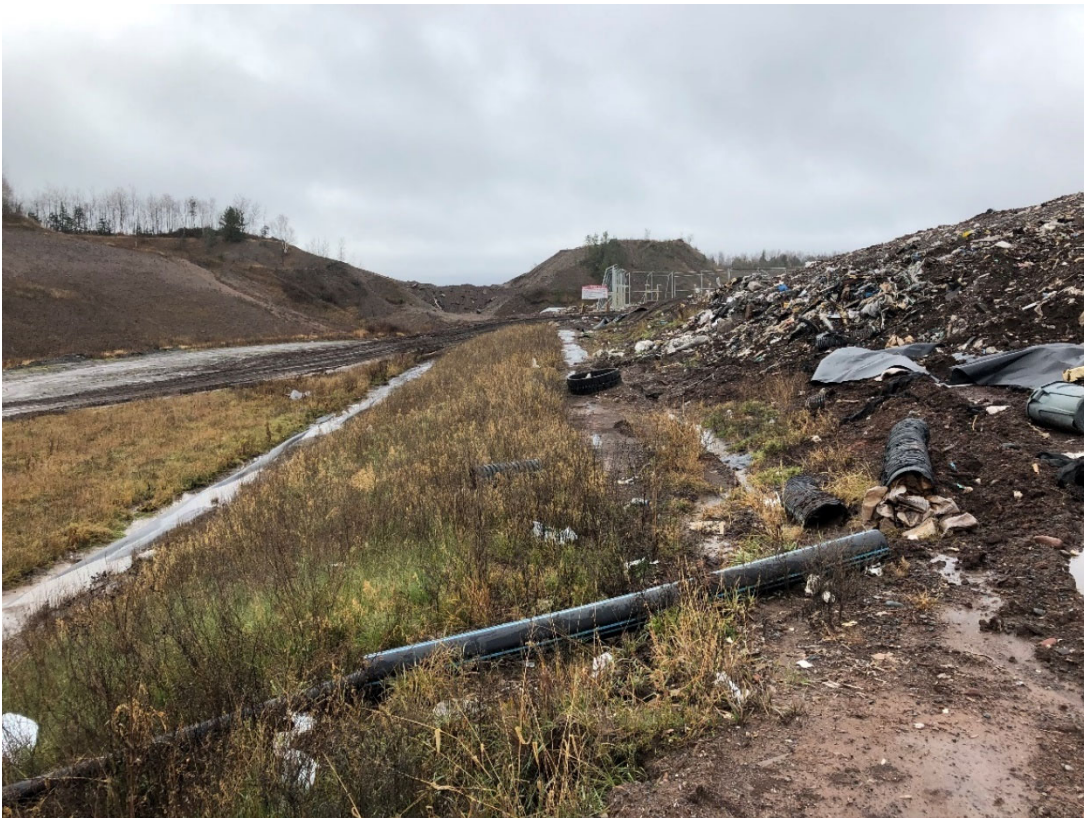
Photo 10: Location 6 – Looking South, Phase 4 Eastern Berm and Waste Slope

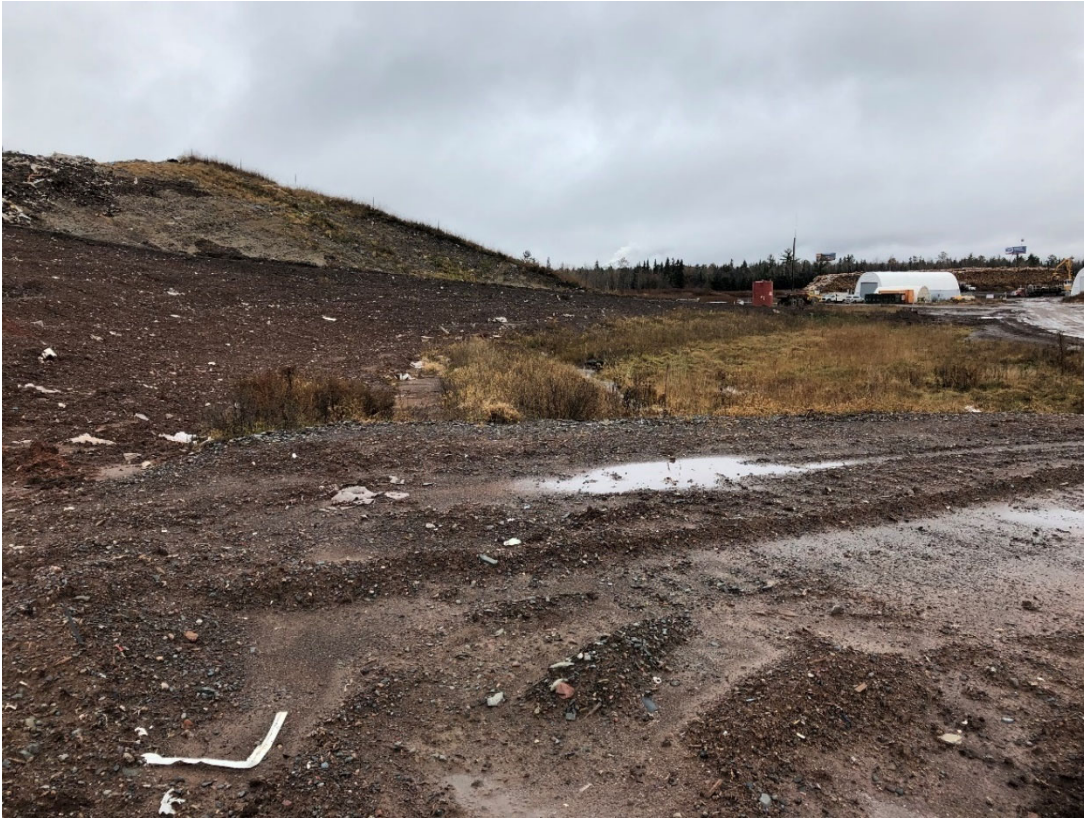
Photo 11: Location 6 – Looking North, Phase 4 Eastern Berm & Phase 1 Southeast Corner

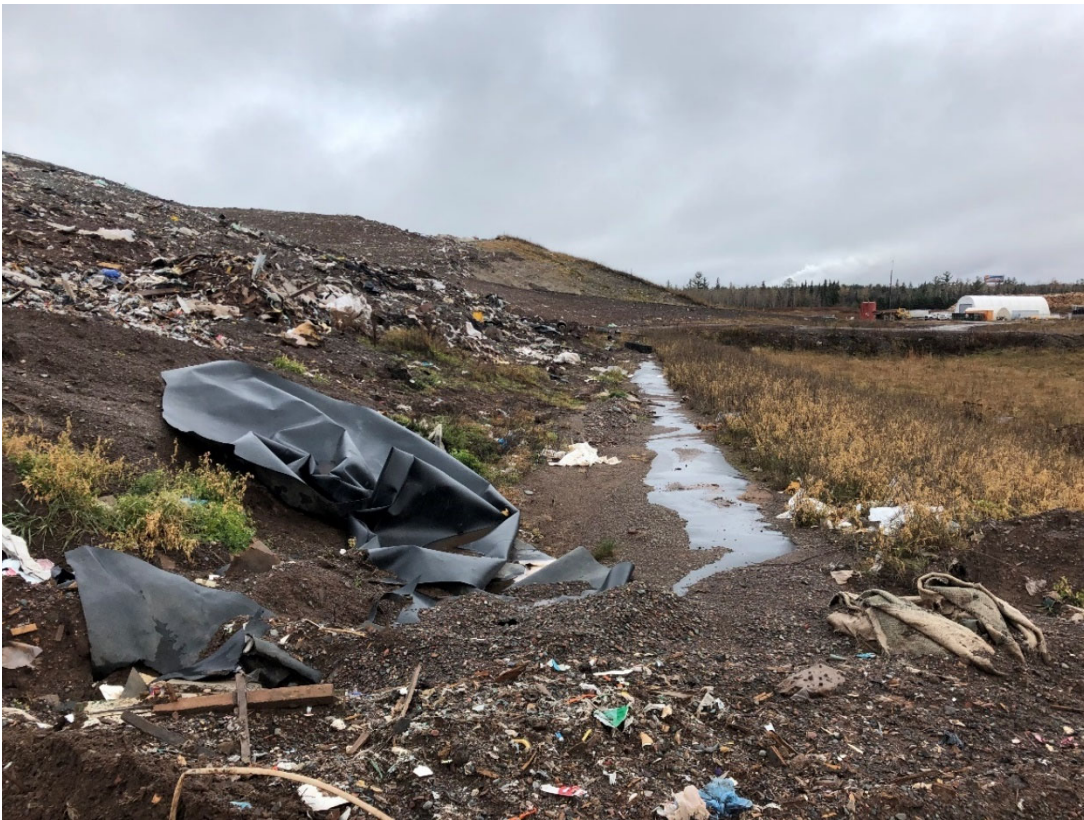
Photo 12: Location 7 – Looking North, Phase 4 Eastern LF Berm and Waste Slope

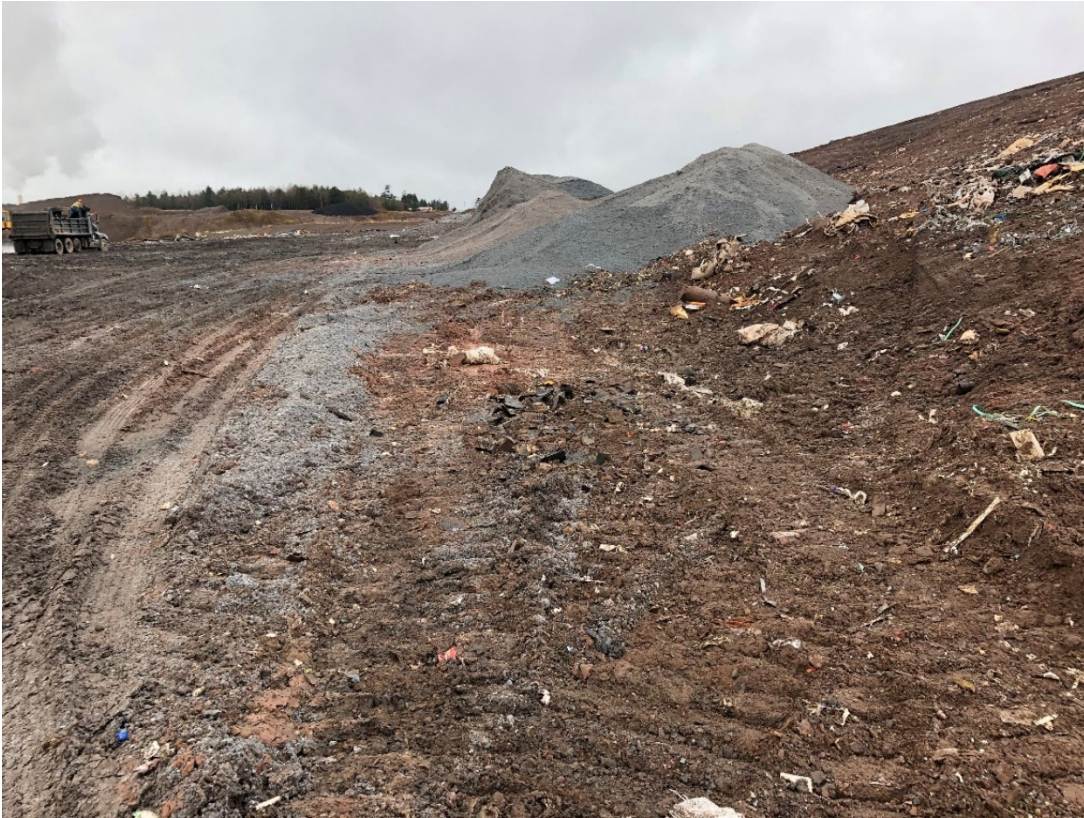
Photo 13: Location 7 – Looking West, Phase 4 Southern Waste Slope / 7A Interior Active Filling

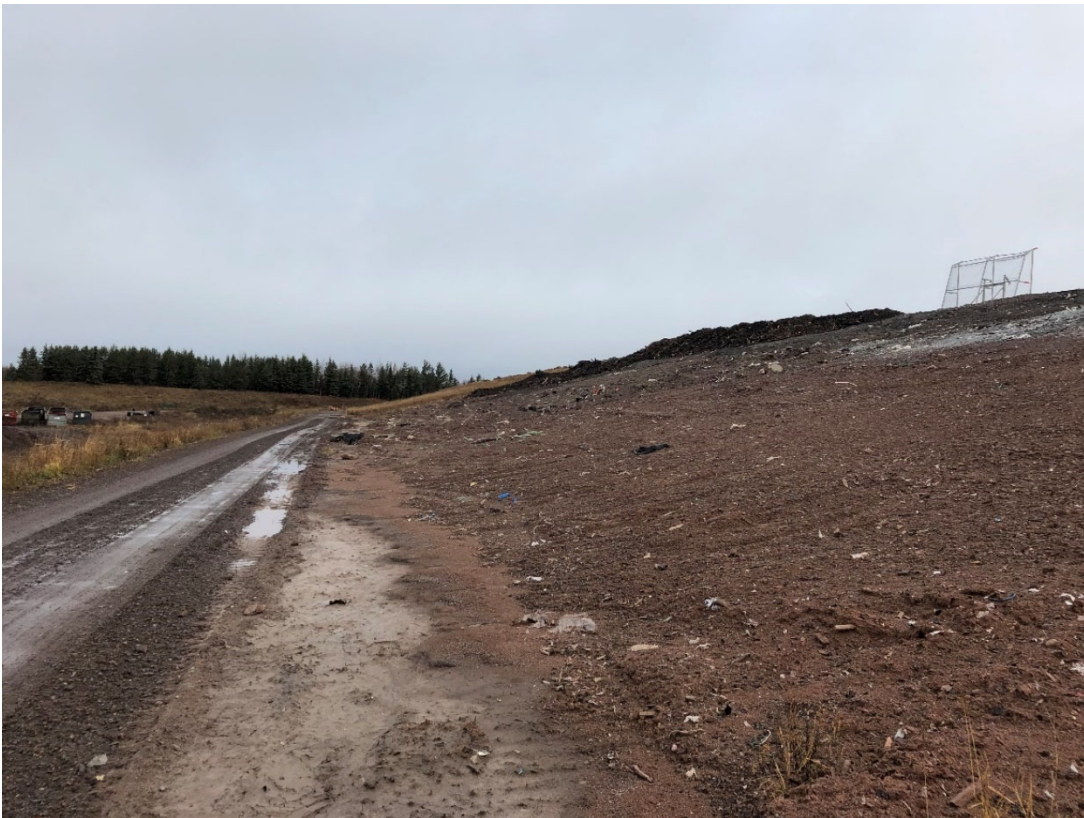
Photo 14: Location 8 – Looking North, Phase 3 Western Waste Slope

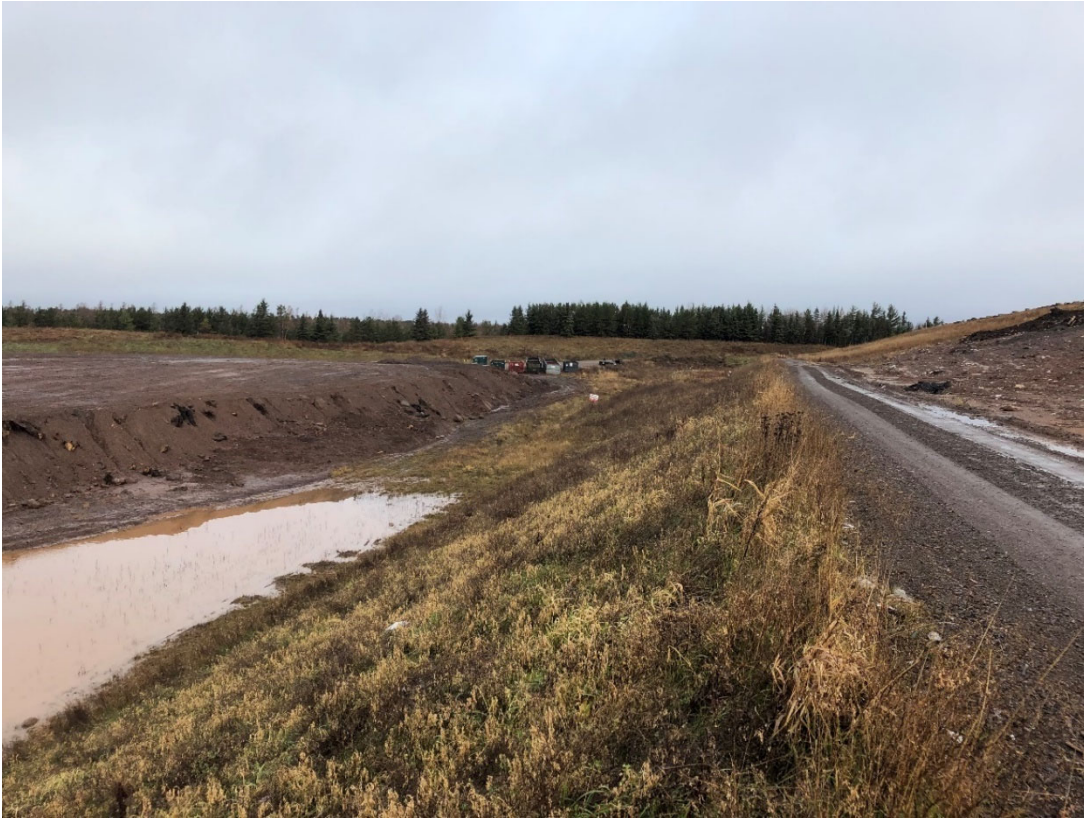
Photo 15: Location 8 – Looking North, Phase 3 LF Western Berm

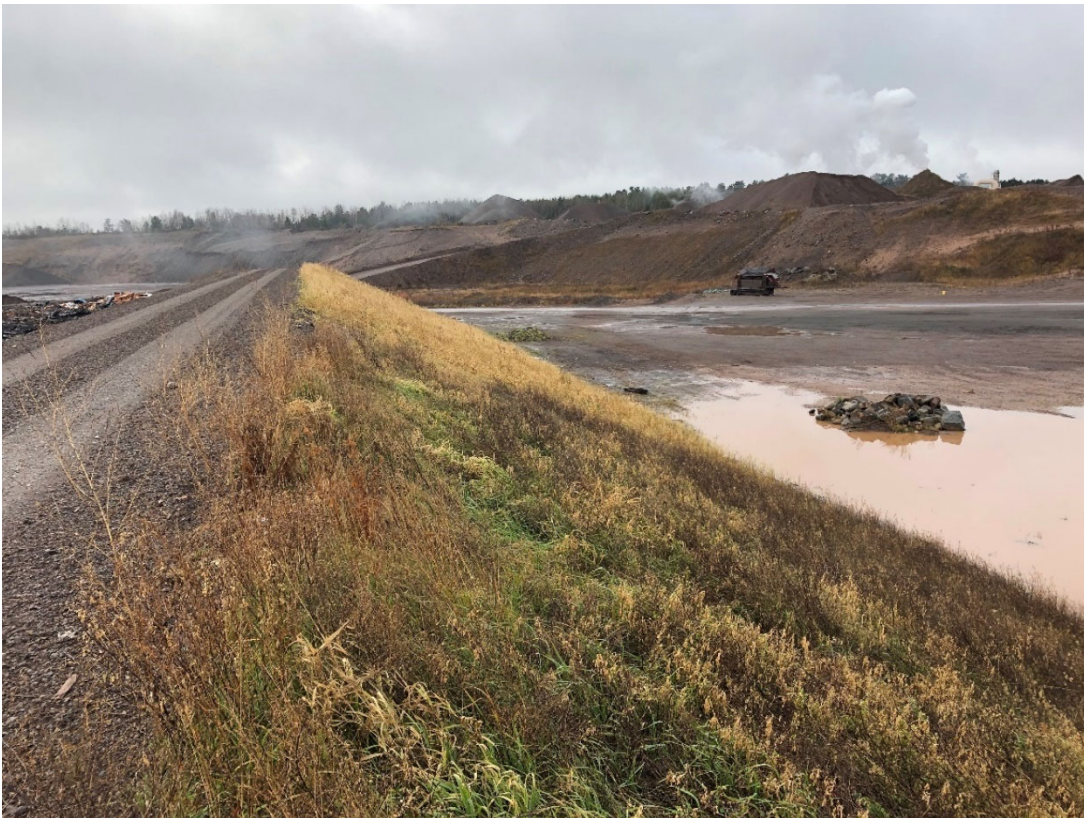
Photo 16: Location 8 – Looking South, Phase 6 Western LF Berm

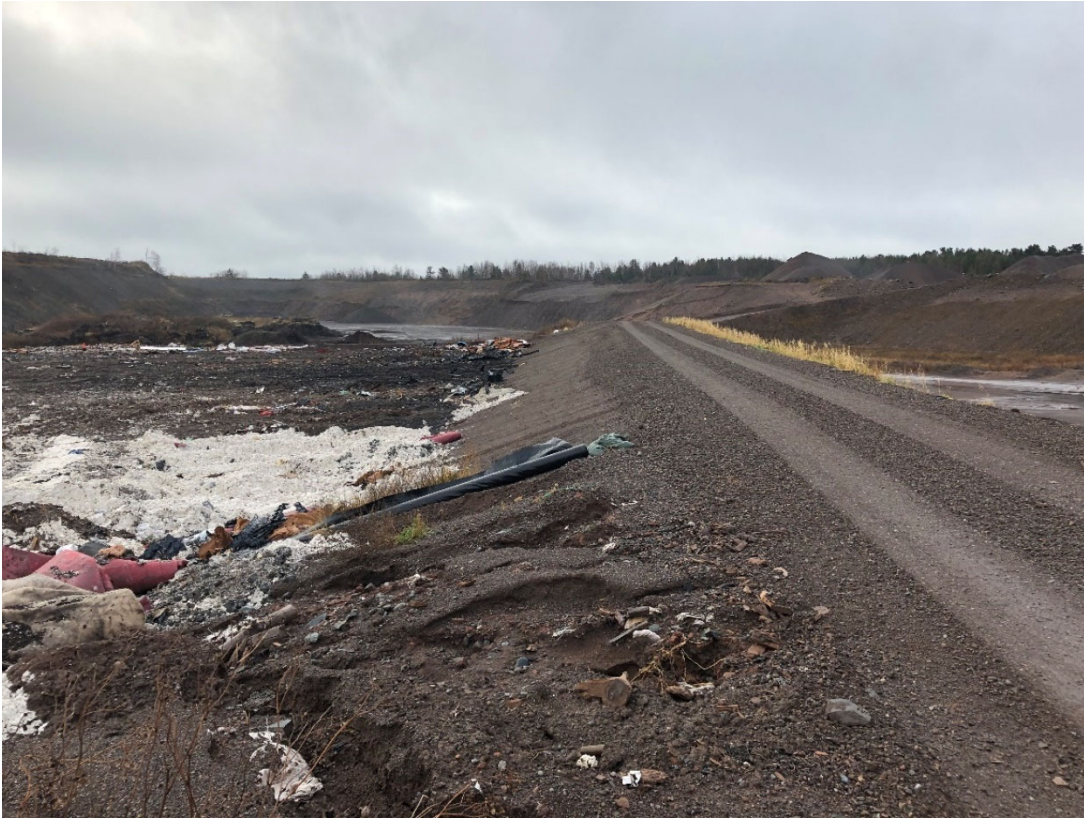
Photo 17: Location 8 – Looking South, Phase 6 Interior (Future Western Waste Slope)

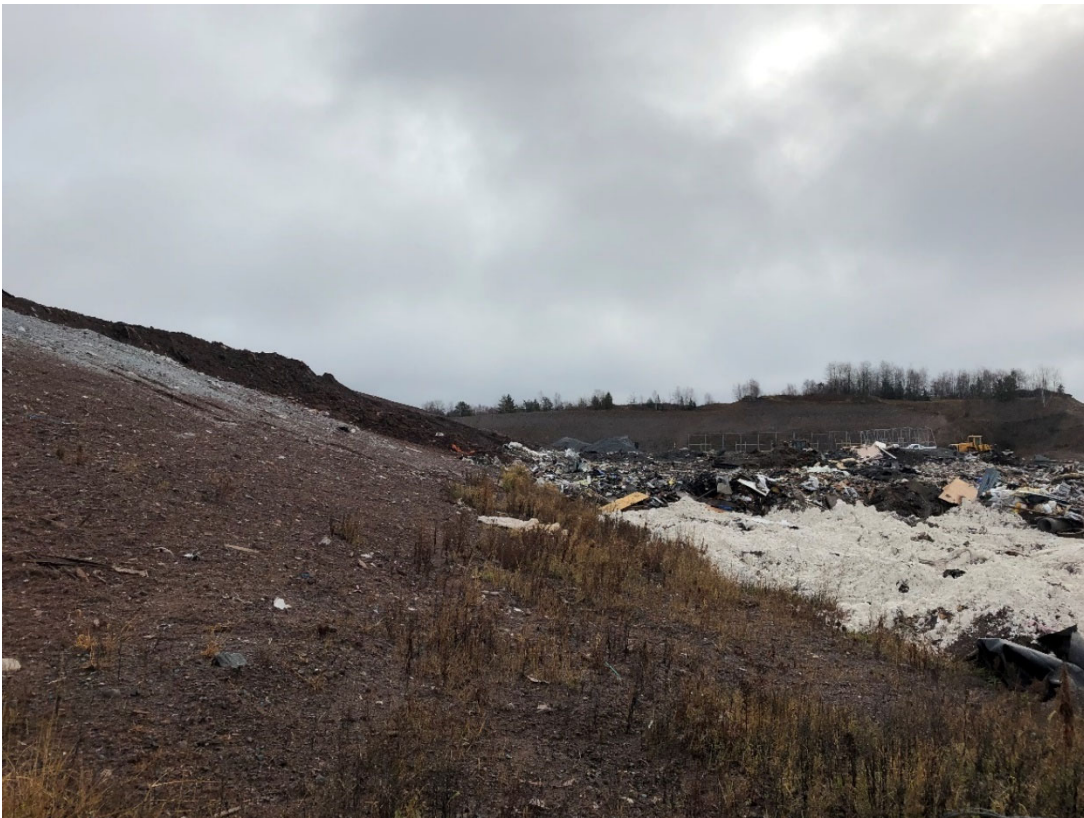
Photo 18: Location 8 – Looking East, Phase 3 Southern Interior Waste Slope

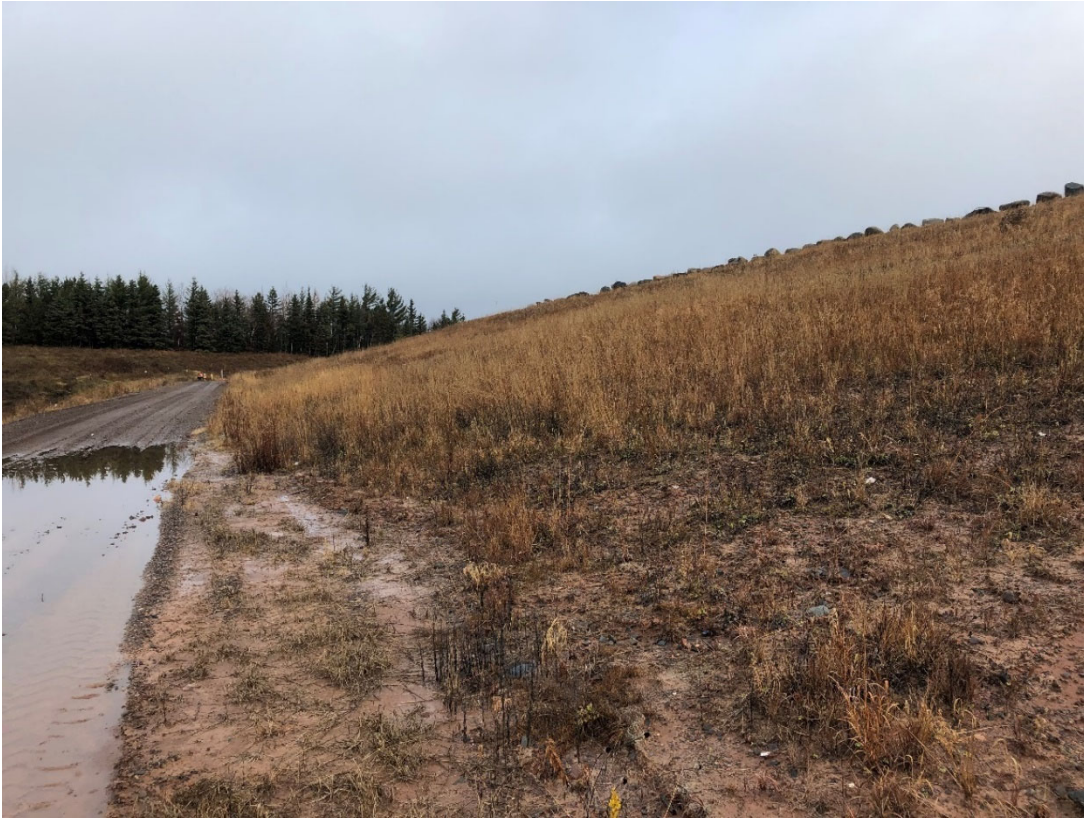
Photo 19: Location 9 – Looking North, Phase 2 Western Waste Slope & Road

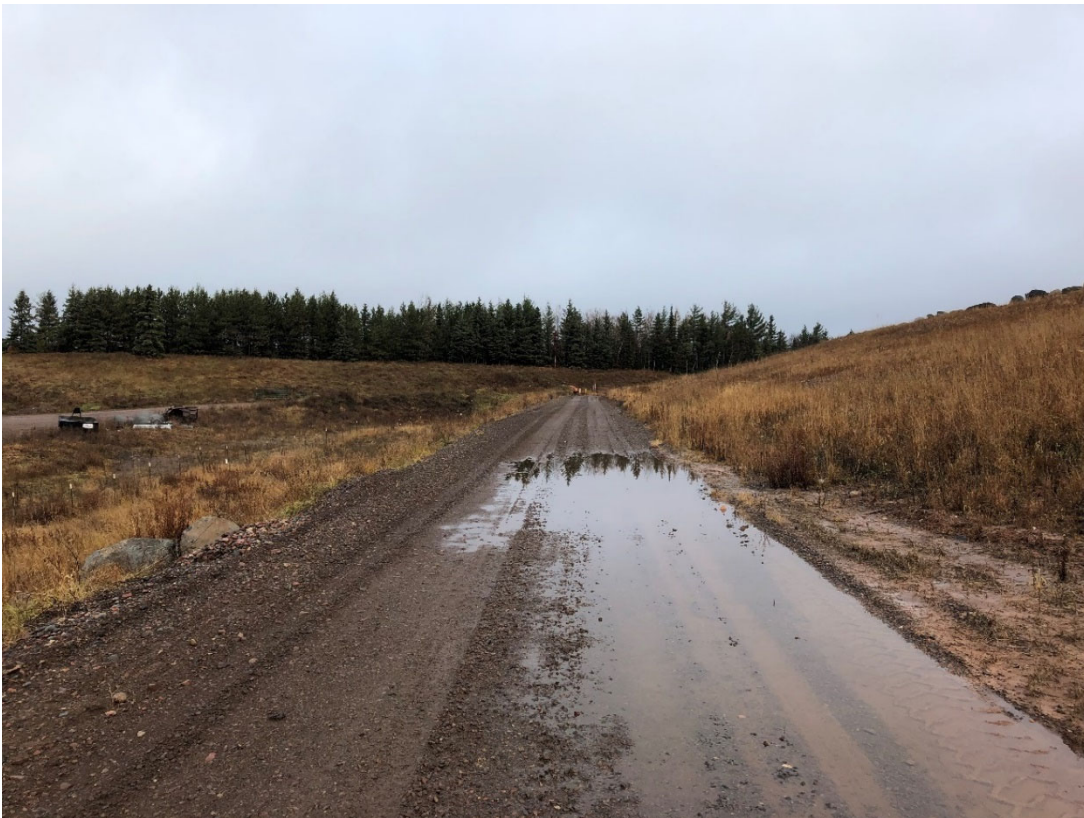
Photo 20: Location 9 – Looking North, Phase 2 Perimeter Road
