# Technical Memo

**Date:** January 9, 2019

**Subject:** SKB Environmental Cloquet Landfill – 2018 Annual CCR Inspection  
Wenck Project # B3053-0137

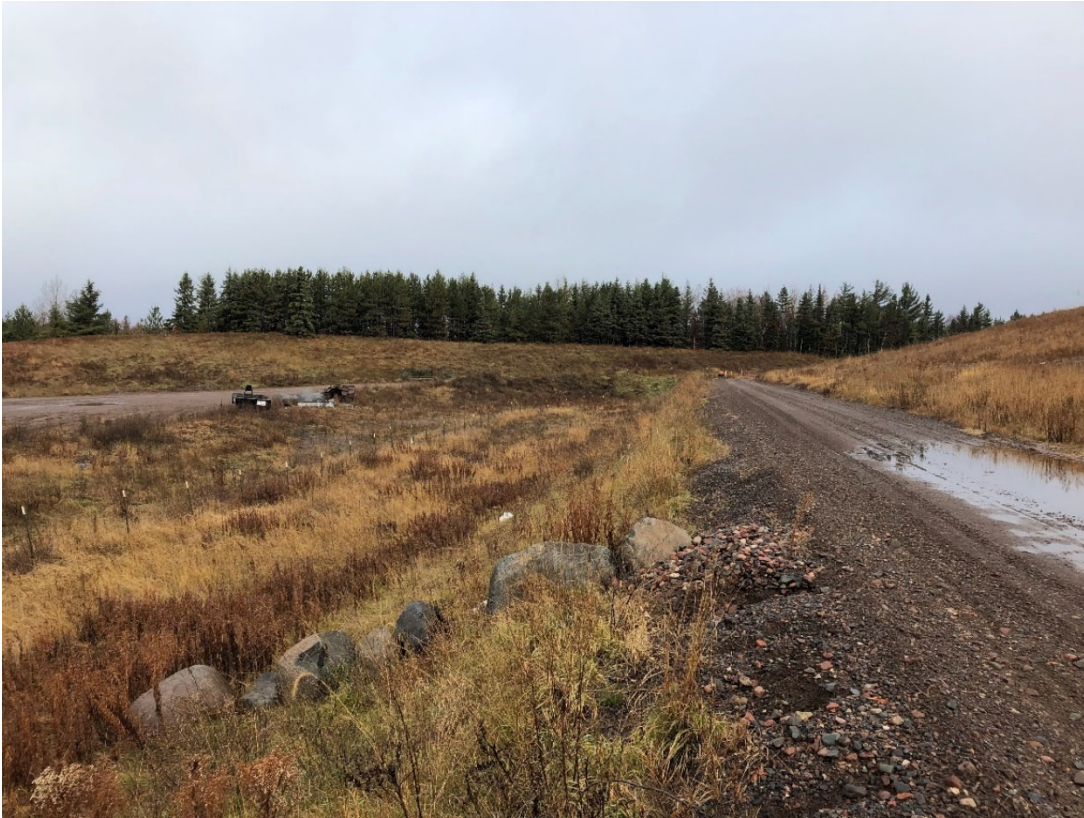
Photo 21: Location 9 – Looking North, Phase 2 Western Berm

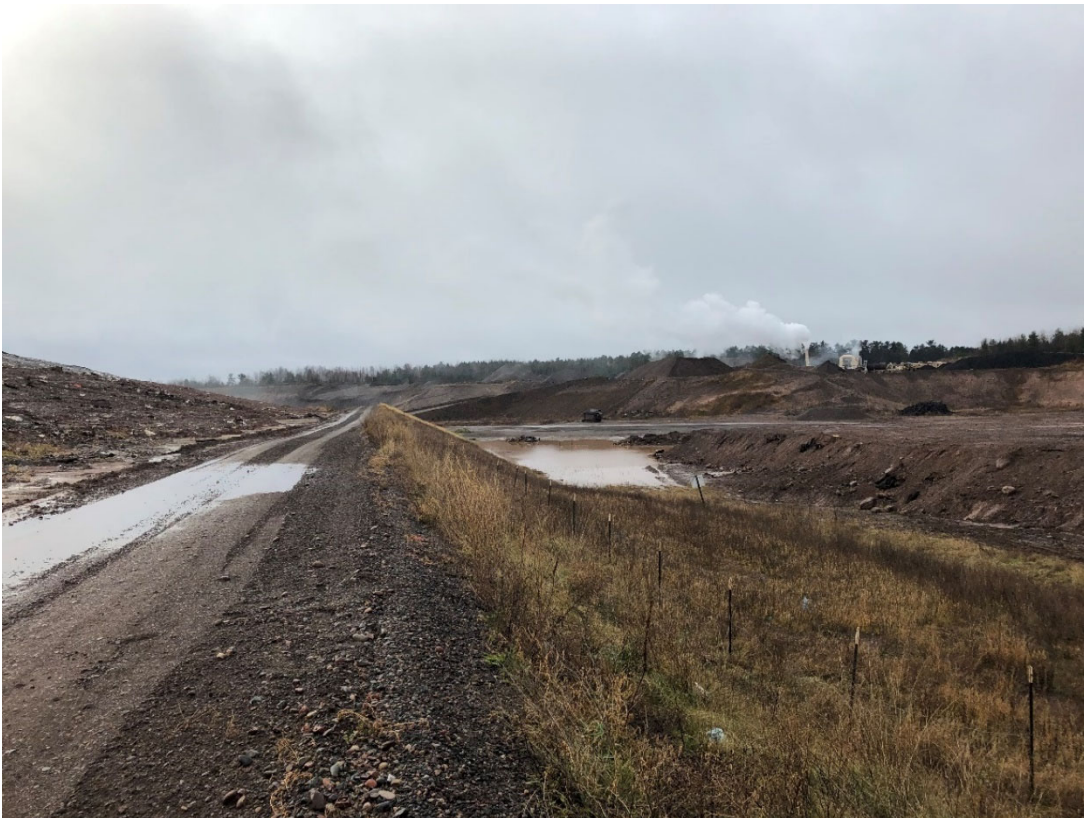
Photo 22: Location 9 – Looking South, Phase 3 Western Berm

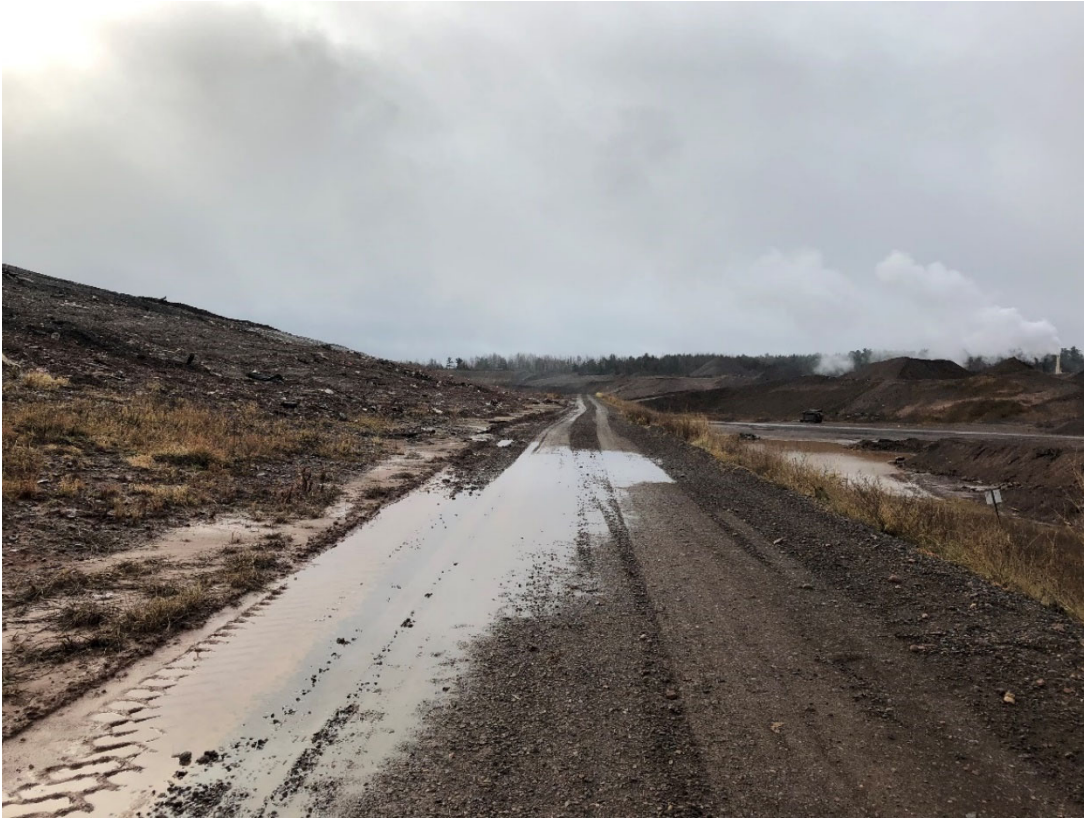
Photo 23: Location 9 – Looking South, Phase 3 Perimeter Road

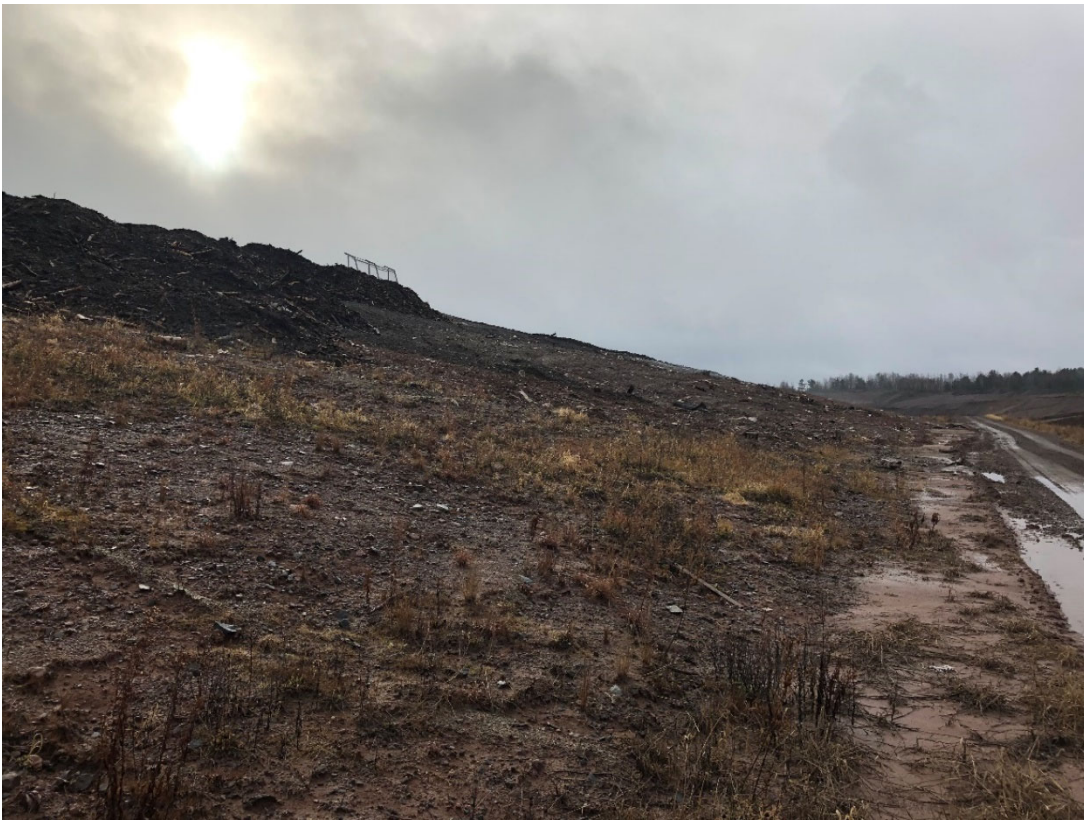
Photo 24: Location 9 – Looking South, Phase 3 Waste Slope

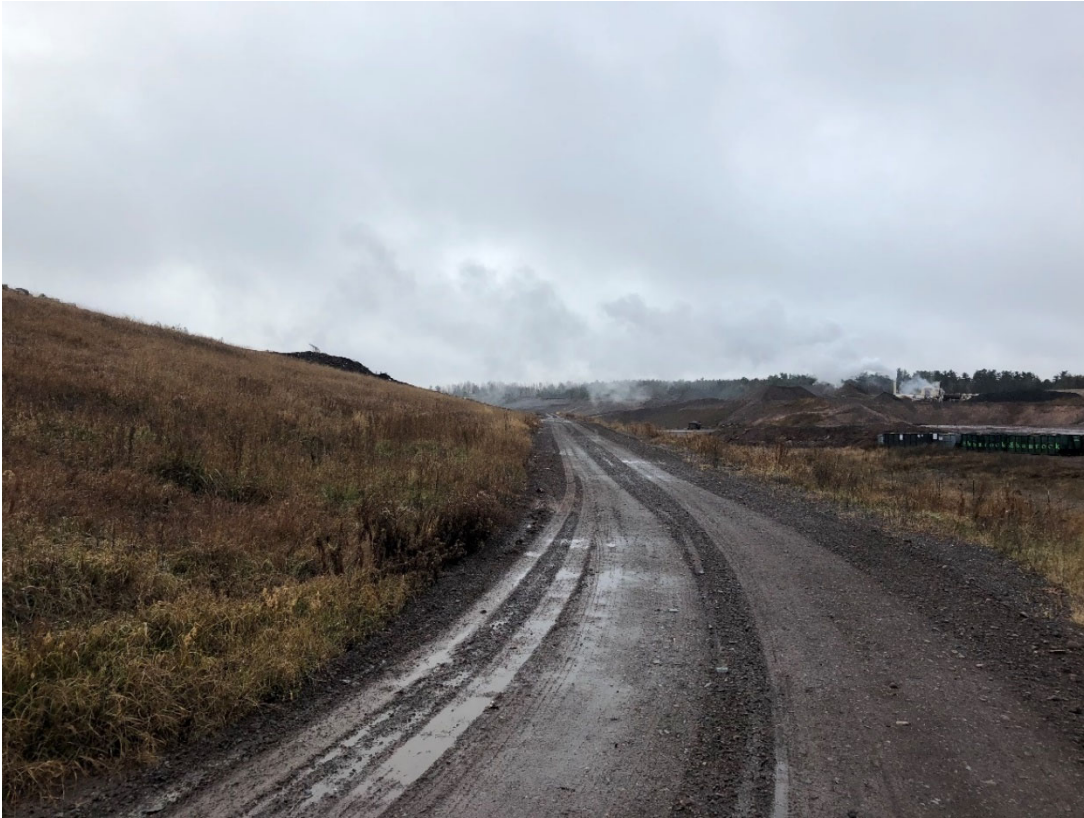
Photo 25: Location 10 – Looking South, Phase 2 Perimeter Road

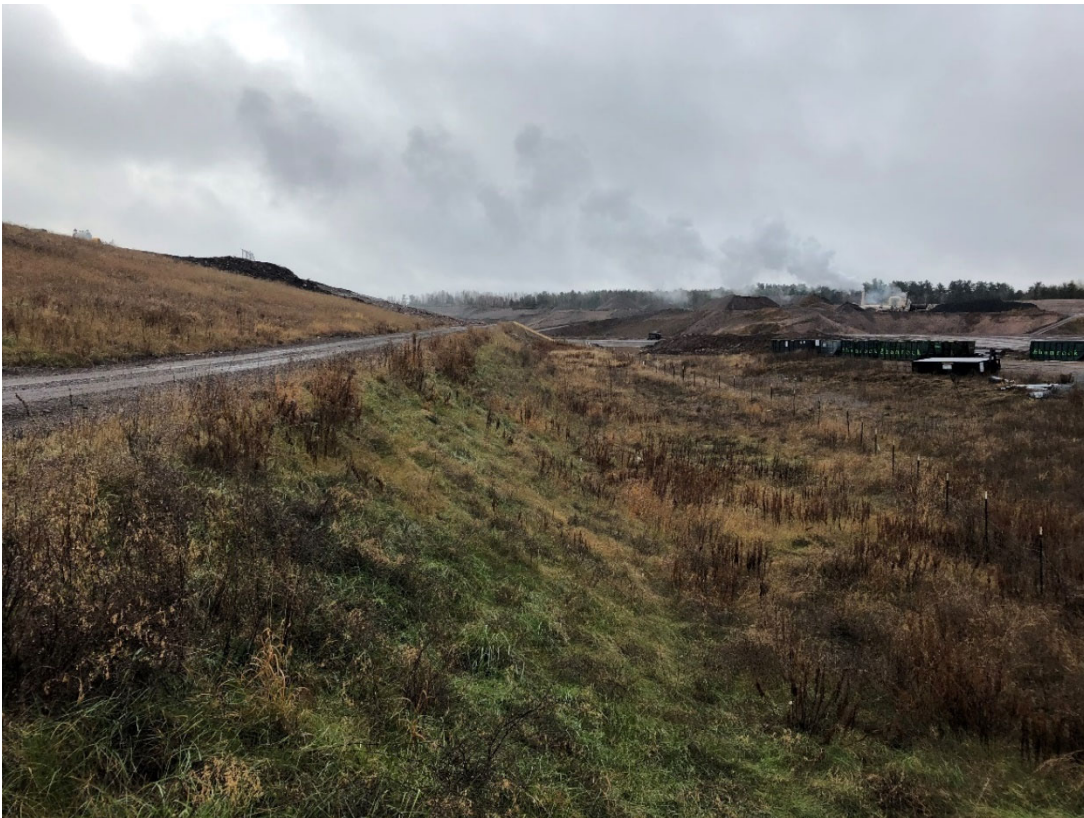
Photo 26: Location 10 – Looking South, Phase 2 Western Berm

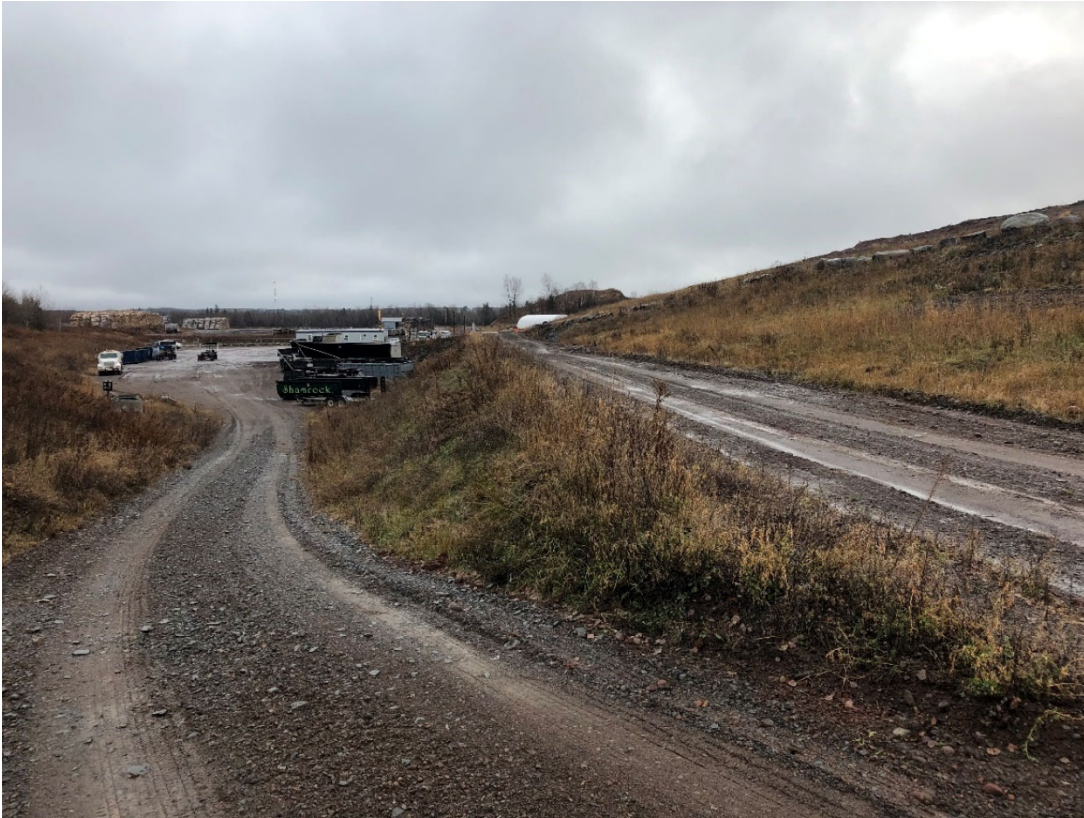
Photo 27: Location 10 – Looking East, Phase 2 Road & Berm

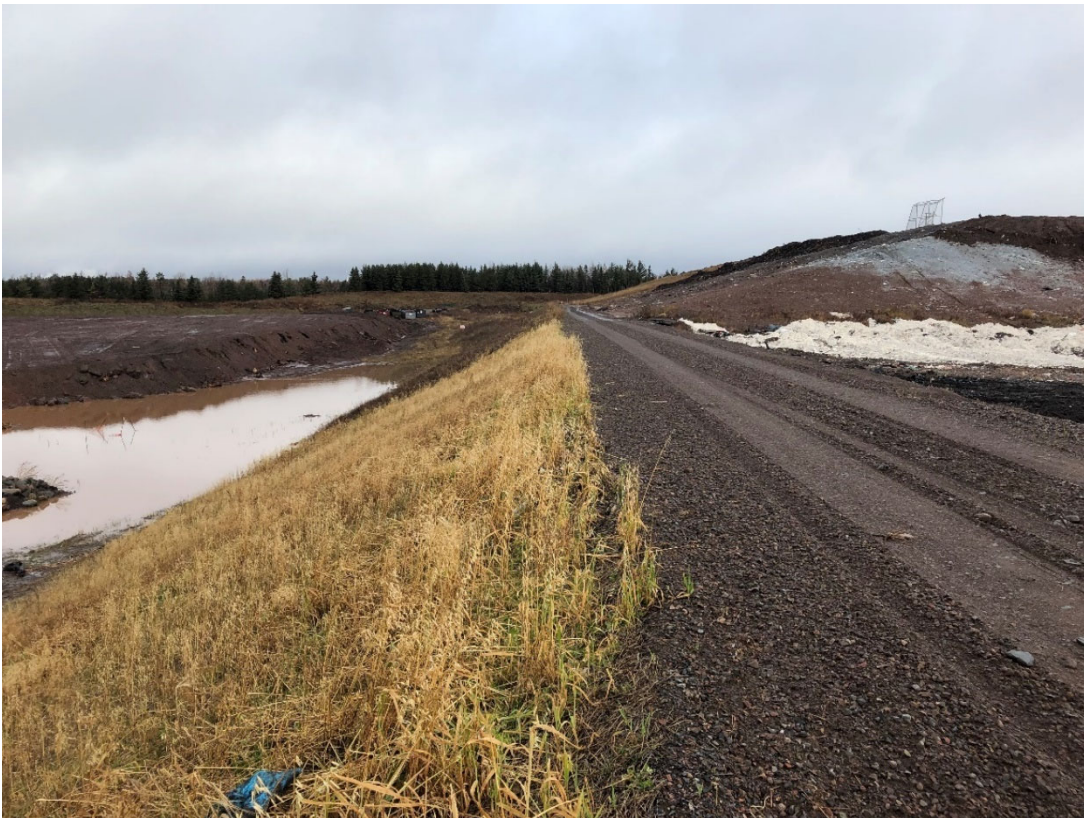
Photo 28: Location 11 – Looking North, Phase 6 Western LF Berm

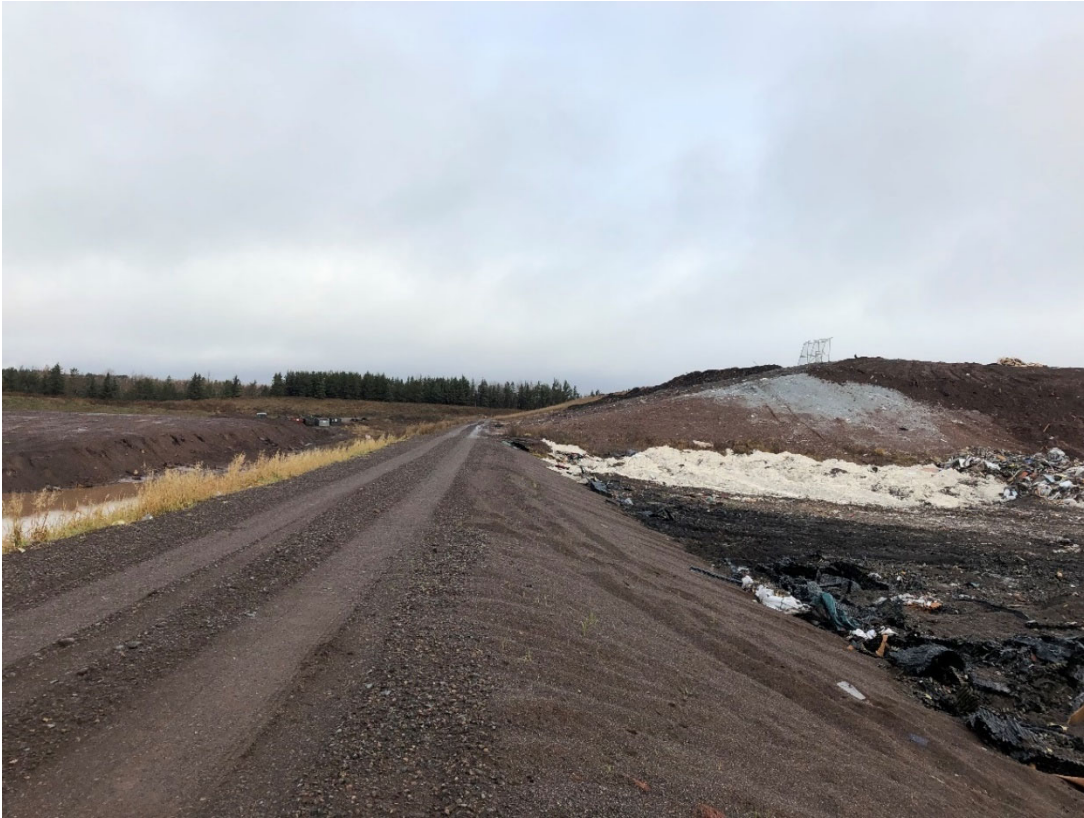
Photo 29: Location 11 – Looking North, Phase 6 Interior (Future Waste Slope)

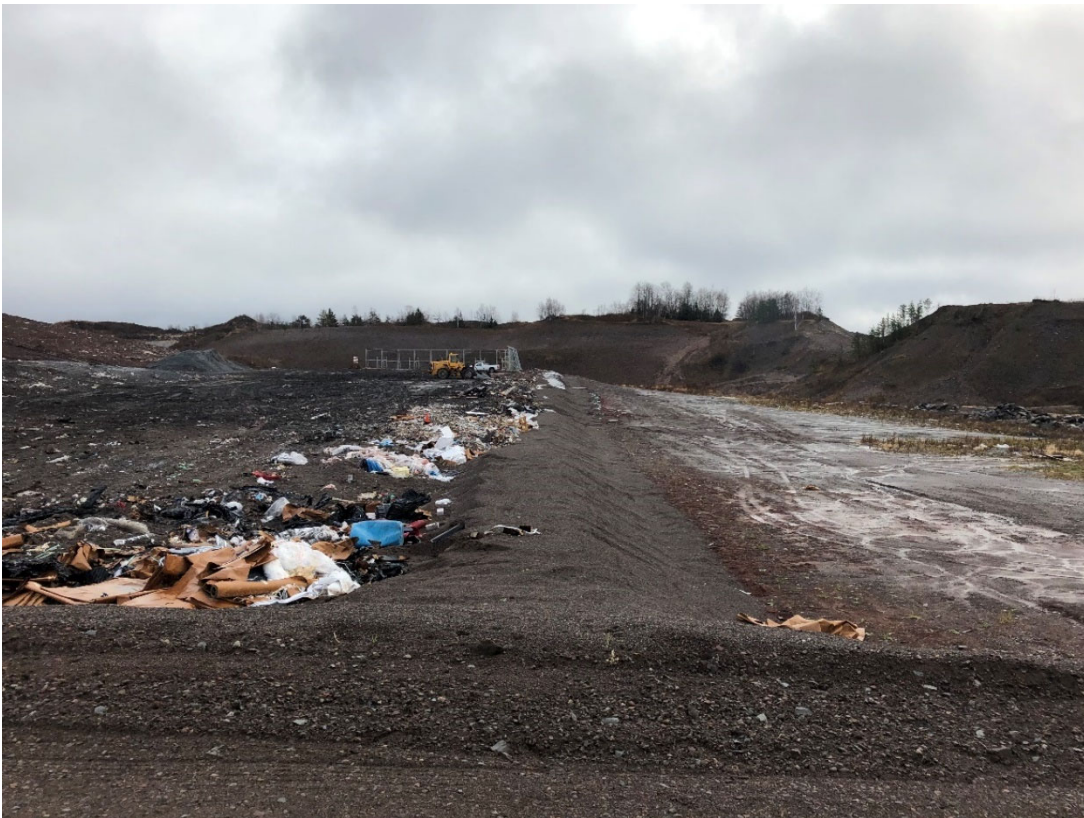
Photo 30: Location 11 – Looking East, Phase 6A/7A Southern Rain Flap

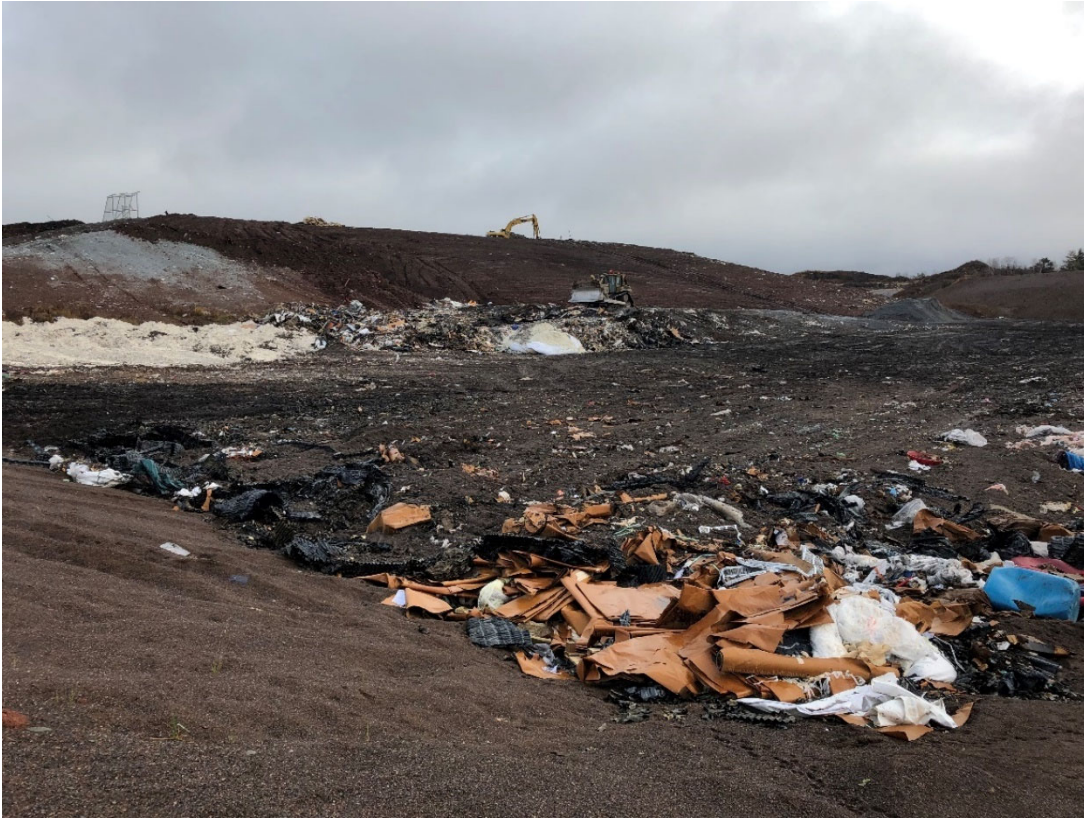
Photo 31: Location 11 – Looking Northeast, Phase 6A Active Filling Area

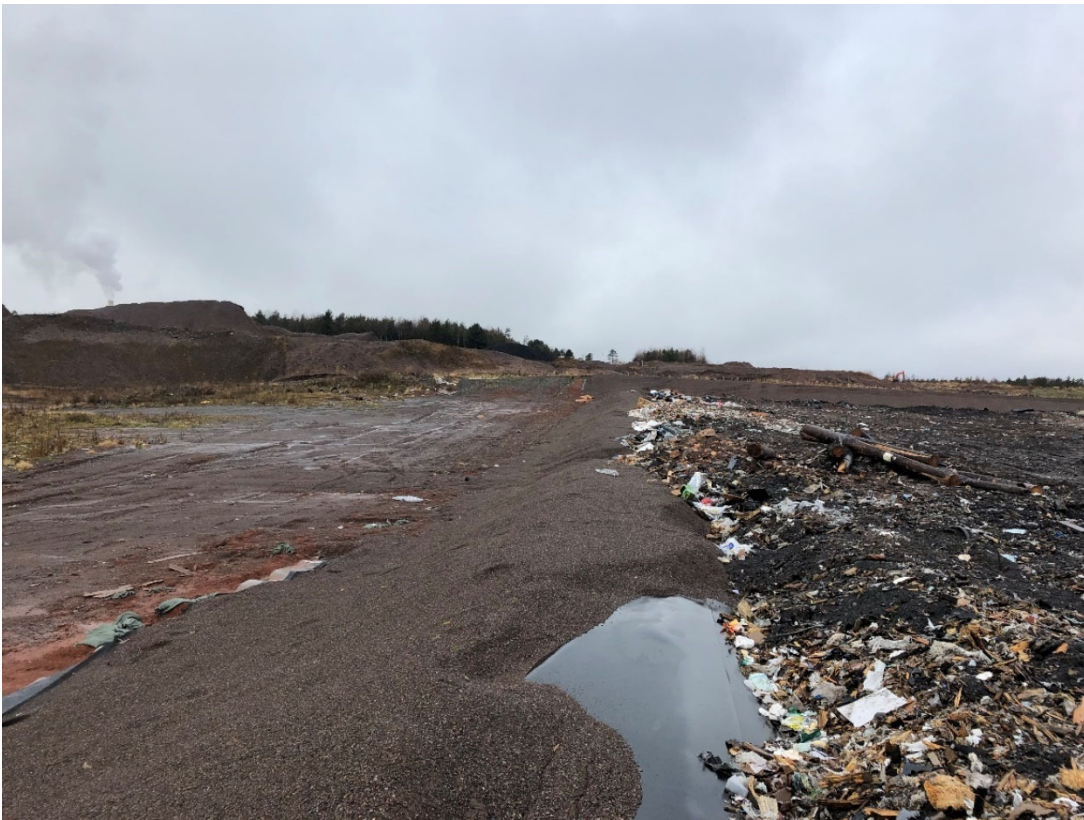
Photo 32: Location 12 – Looking West, Cell 6A Southern Rain Flap

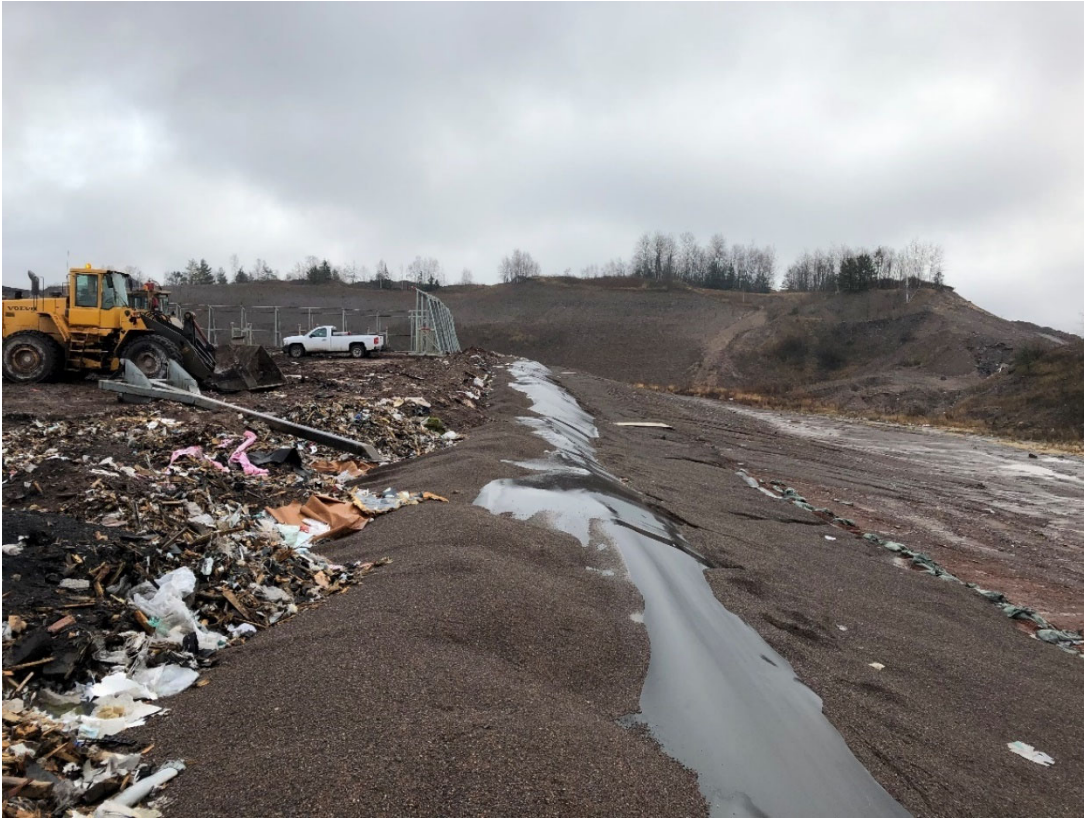
Photo 33: Location 12 – Looking East, Cell 7A Southern Rain Flap

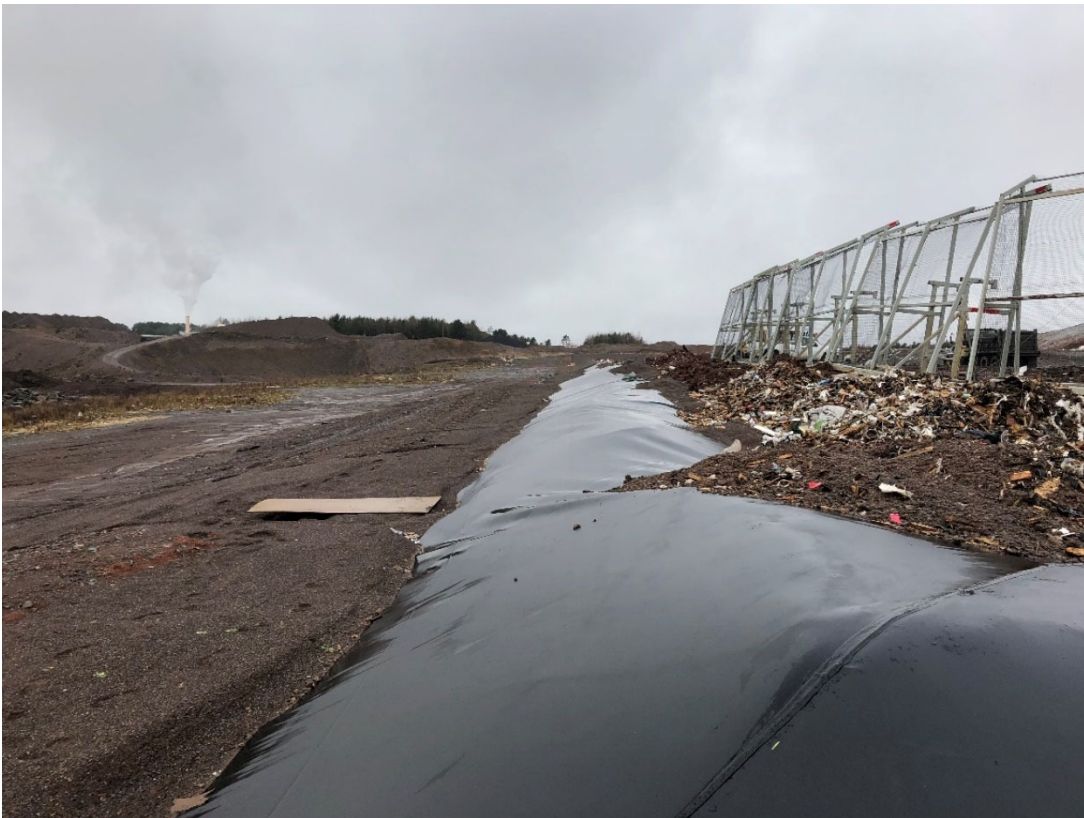
Photo 34: Location 13 – Looking West, Cell 7A Southern Rain Flap

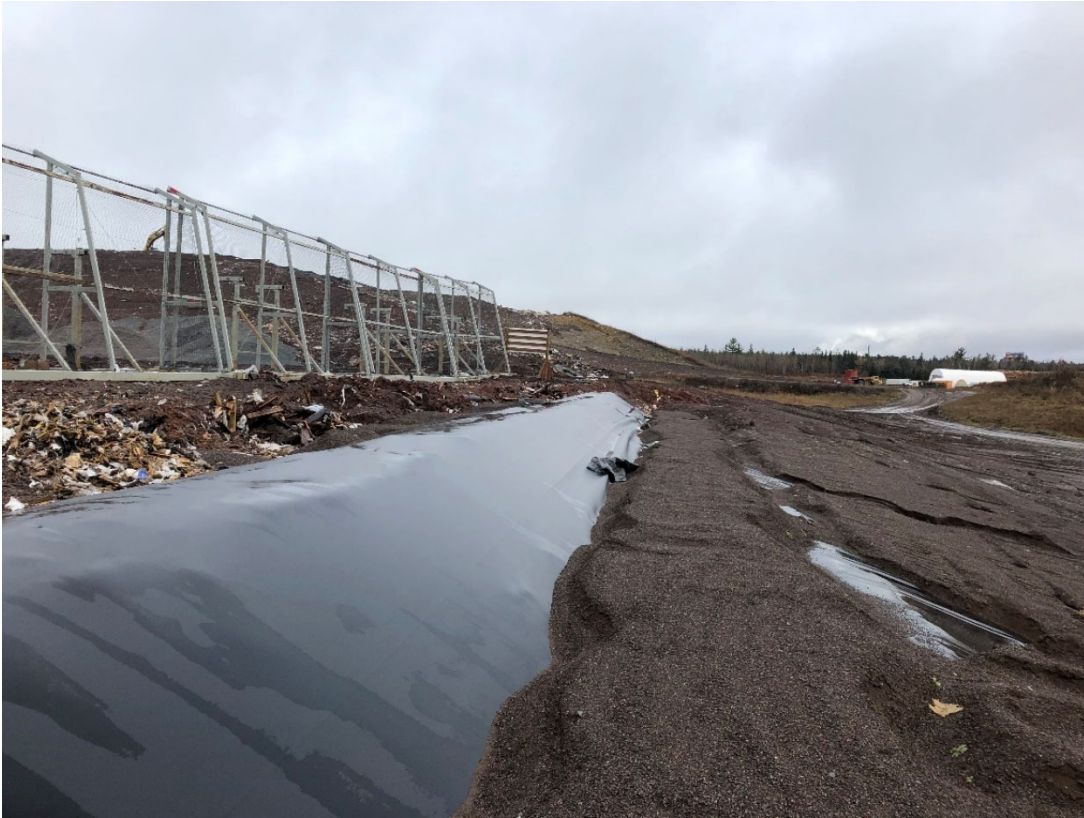
Photo 35: Location 13 – Looking North, Cell 7 Eastern Berm
