# Technical Memo

**To:** Geoff Strack, P.E., Waste Connections  
**From:** Brad Sullivan, P.E., Wenck Associates, Inc.  
**Date:** January 9, 2020  
**Subject:** SKB Environmental Cloquet Landfill  
dba Shamrock Landfill, Inc.  
2019 Annual CCR Inspection Report  
Wenck Project #B3053-0182

PROJECT TITLE  
**2019 CCR INSPECTION REPORT**

SKB ENVIRONMENTAL CLOQUET LANDFILL, INC.  
 f/n/a SHAMROCK LANDFILL, INC

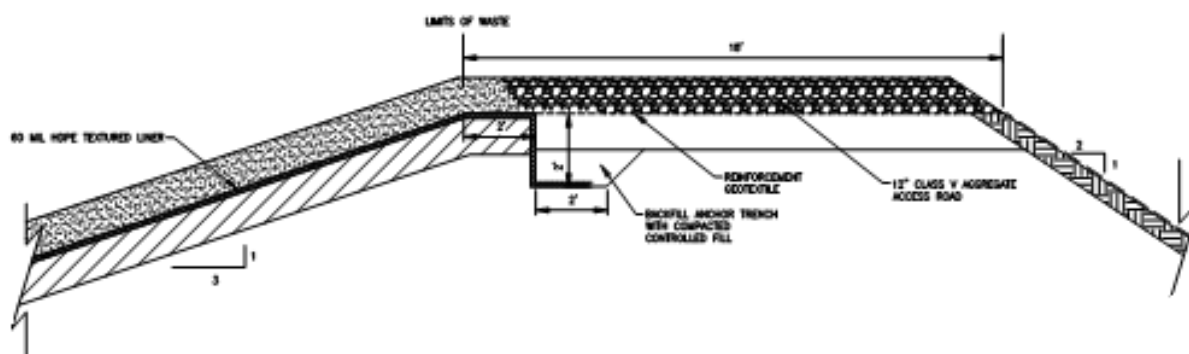
Typical Landfill Berm Detail

Most of the facility's landfill cell embankments were constructed using on-site borrow material, which consisted of silty clay and clayey sand type soils. The fill was placed and compacted to 95% of Standard Proctor Dry Density in lift thicknesses ranging from 8 inches to 12 inches. The final subgrade surface was proof rolled prior to geosynthetics installation. A typical perimeter section taken from the Phase 3 and 4 Construction Documentation Report prepared by Wenck in September 2015 is shown below.

During the inspection, no signs of landfill cell embankment distress, no signs of waste slope instability, or other CCR landfill issues were observed. The landfill embankments and interim covered slopes were generally in good condition with a well-established vegetation cover and no signs of significant erosion.

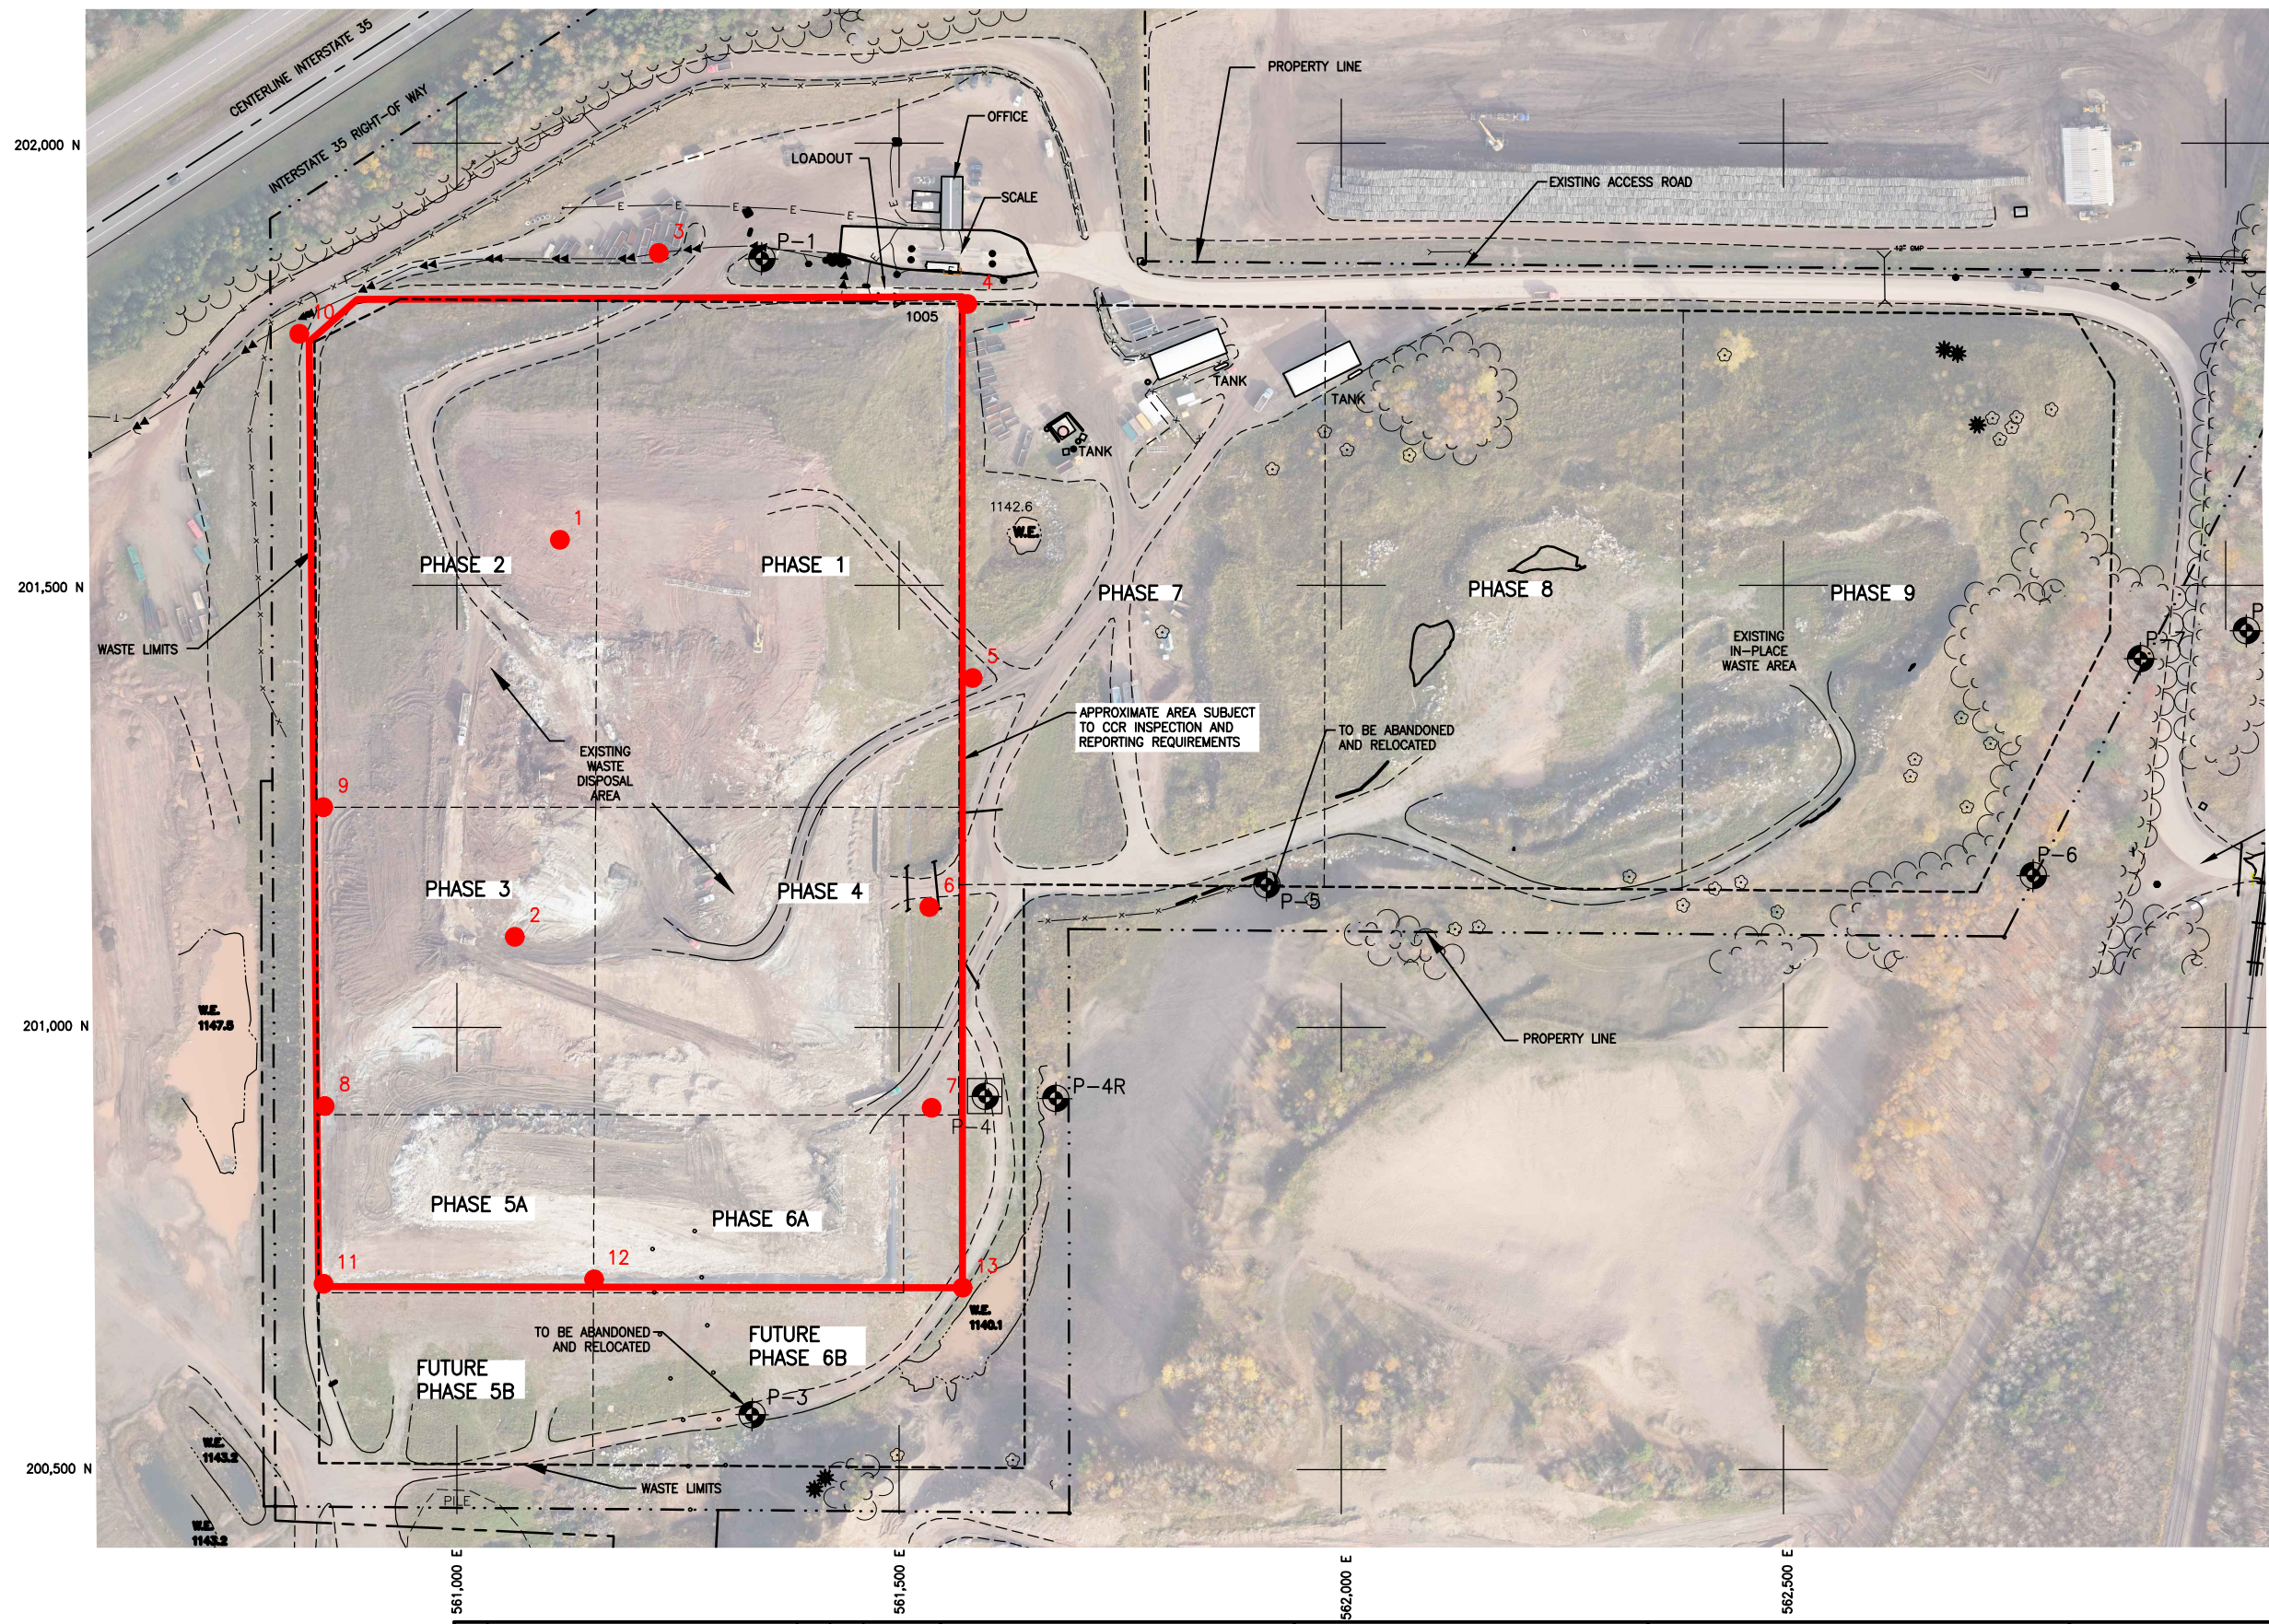
SHEET TITLE			
<b>PHOTO LOCATIONS</b>			
DWN BY	CHK'D	APP'D	DWG DATE
JVB	SH	TJS	JAN. 2020
PROJECT NO.		SCALE	
3053-0182		AS NOTED	
SHEET NO.		REV NO.	
FIGURE 1		0

Photos were taken during the inspection. Figure 1 presents the photo locations, and Attachment 1 contains a photo log and the photos taken.

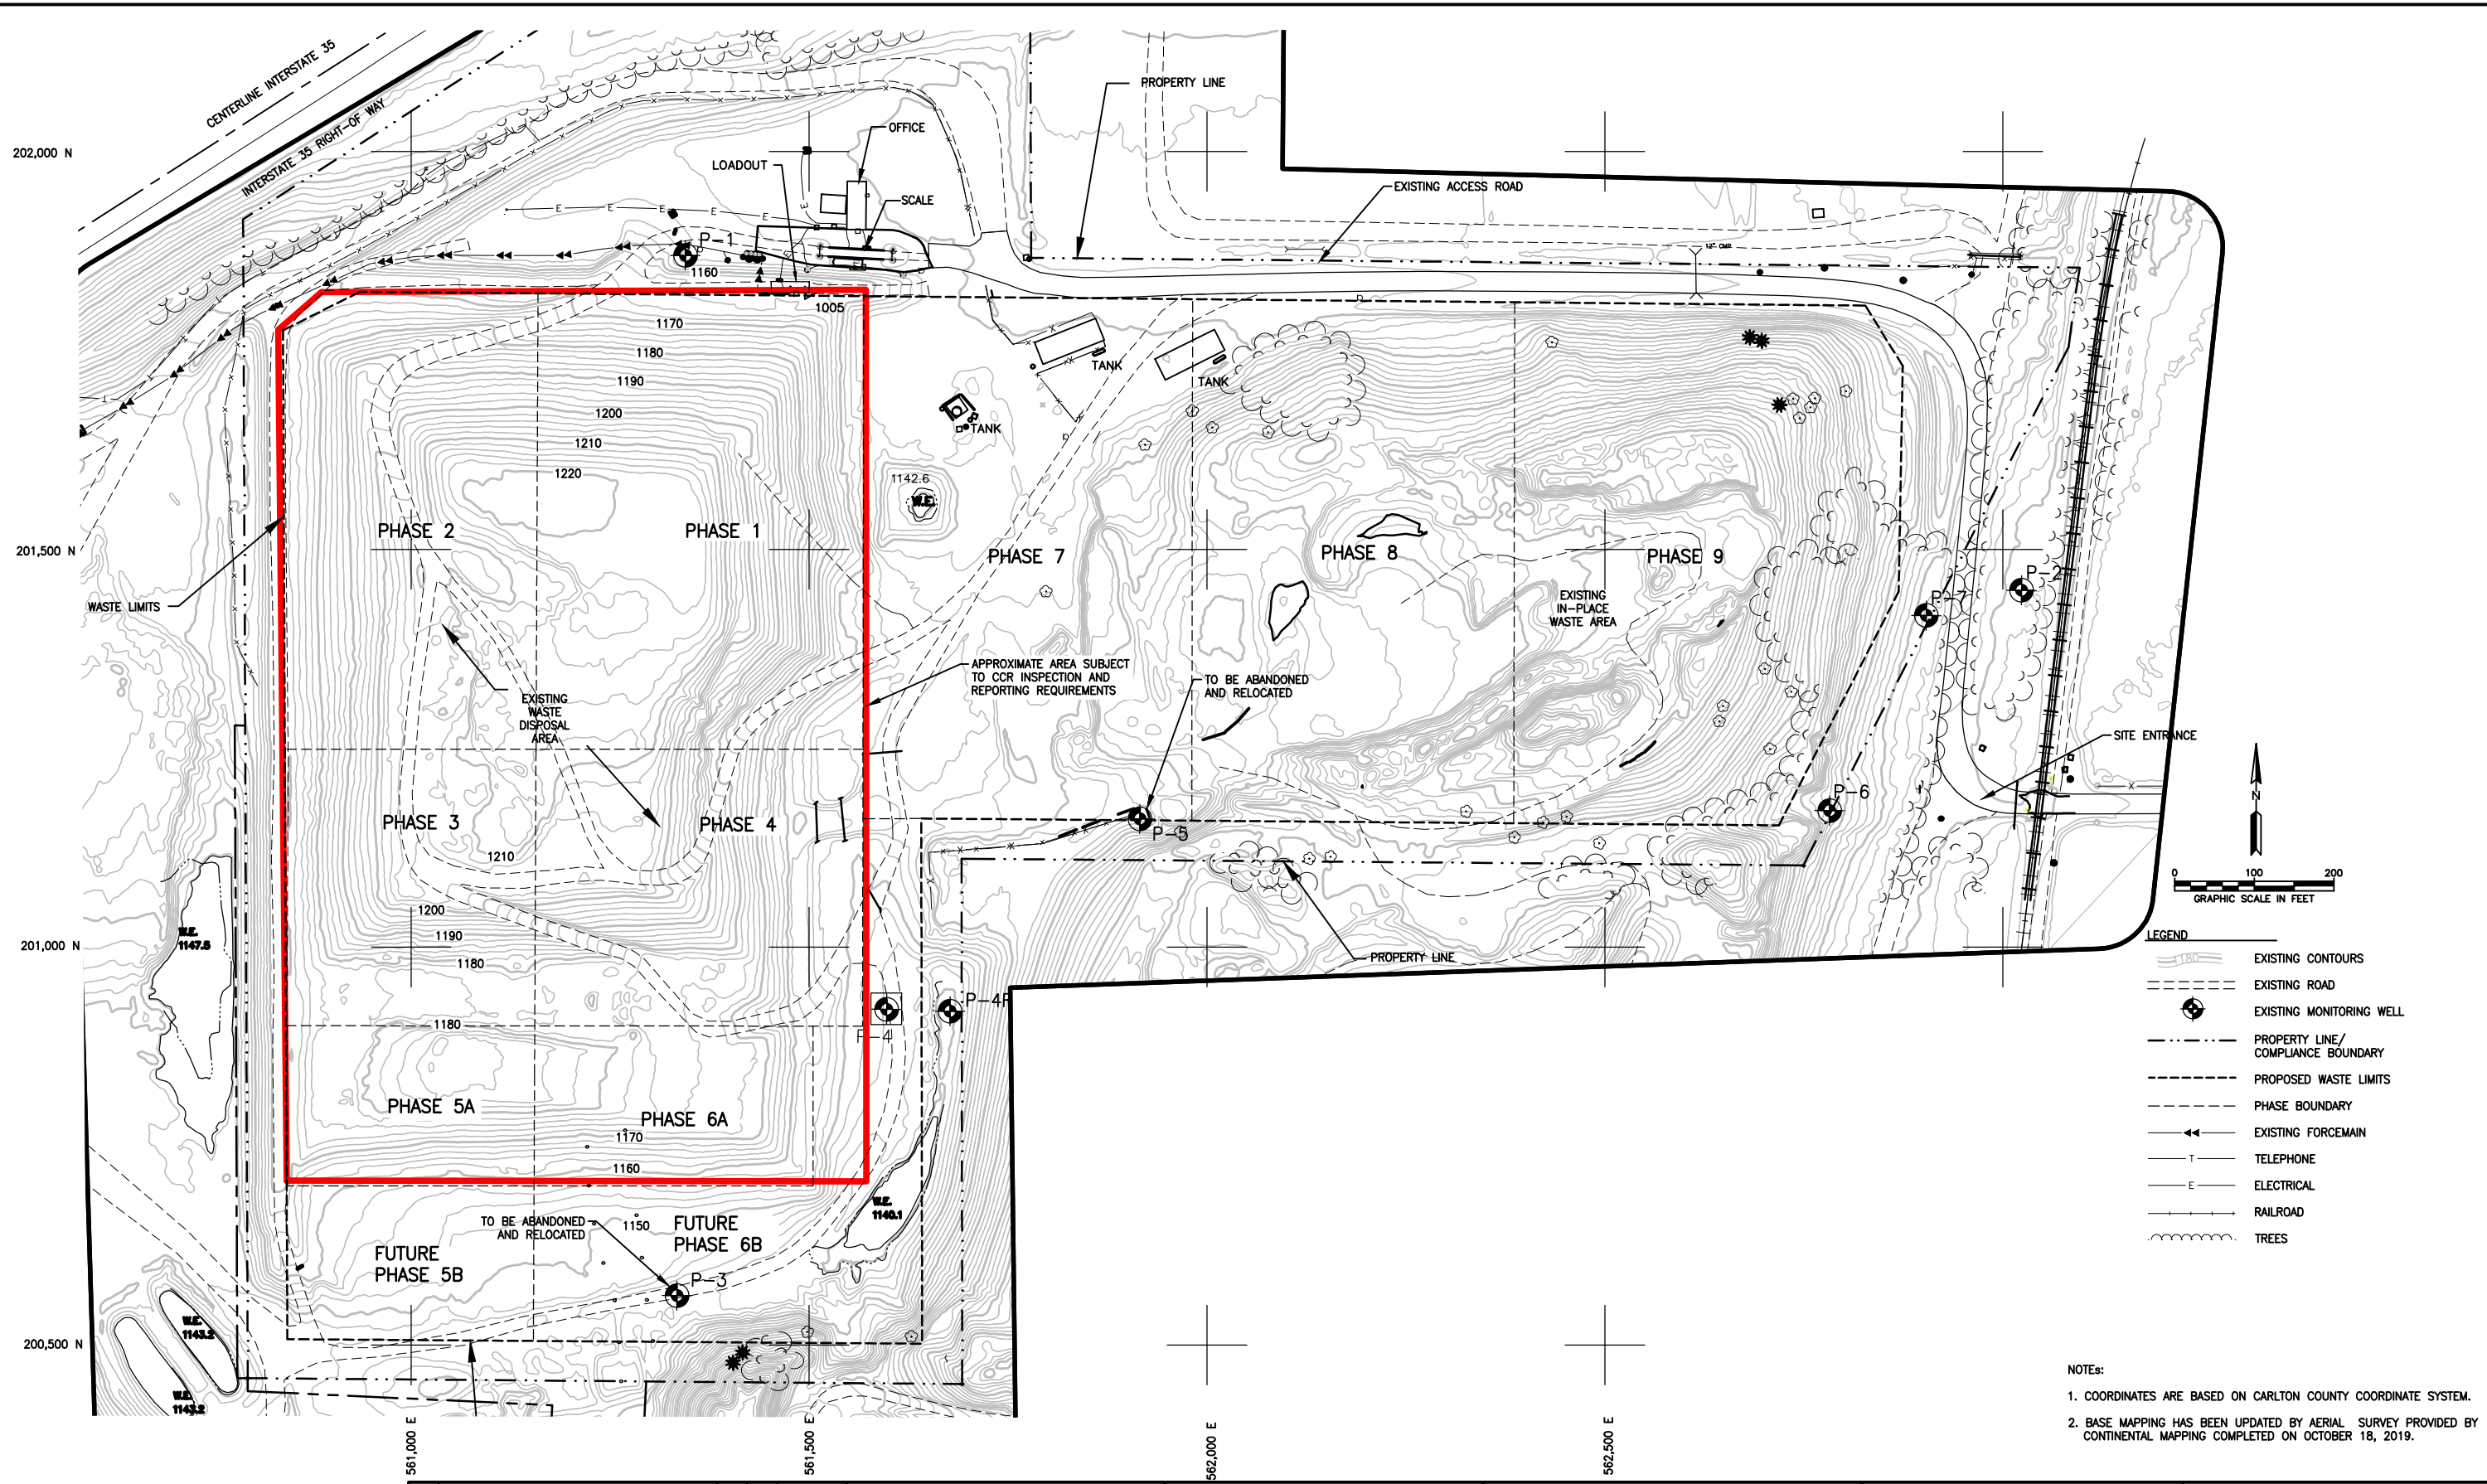
SHEET TITLE			
<b>SITE MAP</b>			
DWN BY	CHK'D	APP'D	DWG DATE
BWS	TJS	BWS	JAN. 2020
PROJECT NO.		SCALE	
3053-0182		AS NOTED	
SHEET NO.		REV NO.	
FIGURE 2		0

There were no apparent changes to the embankment geometry of Cells 1, 2, 3, or 4 when compared to the permit drawings or the past inspection reports. The annual aerial photogrammetry survey was performed on October 18, 2019, which the estimated in-place volume is based on. A comparison 2019 and 2018 aerial survey confirm that the embankment and slope topography is substantially unchanged with no significant movement. The 2019 aerial survey is included as Figure 2.

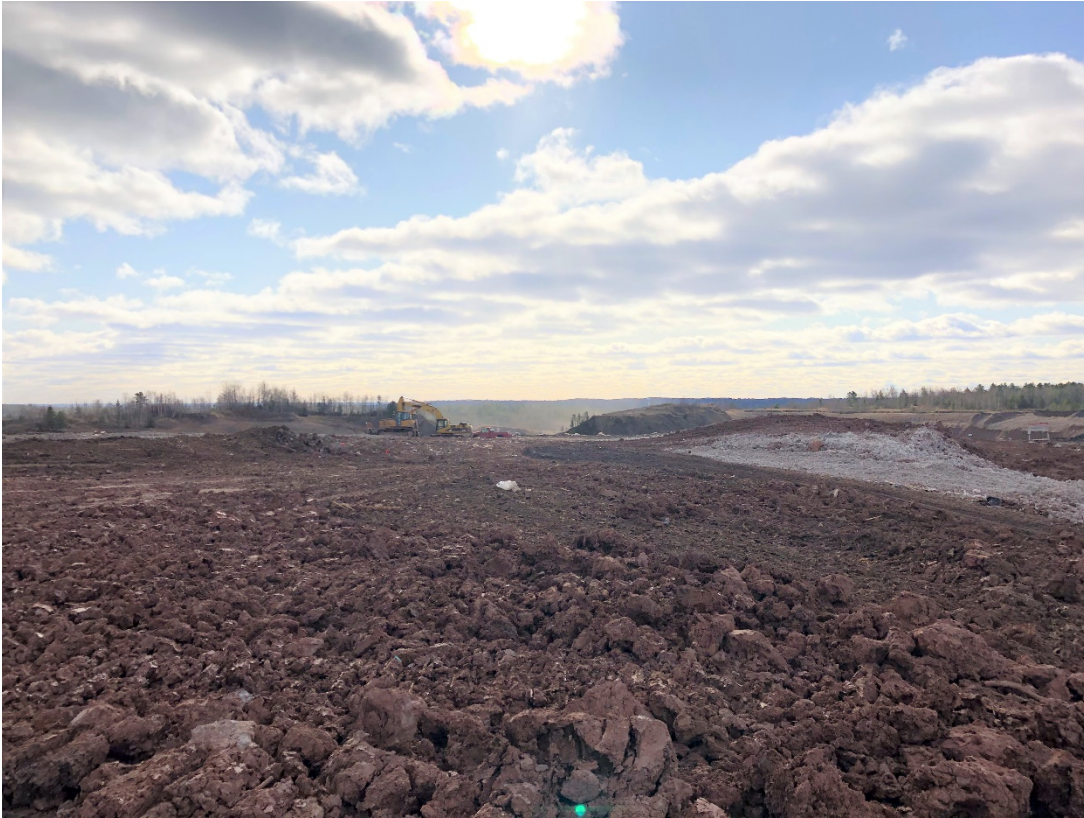
Photo 1: Location 1 – Looking South, Phase 2/3 Upper Lifts

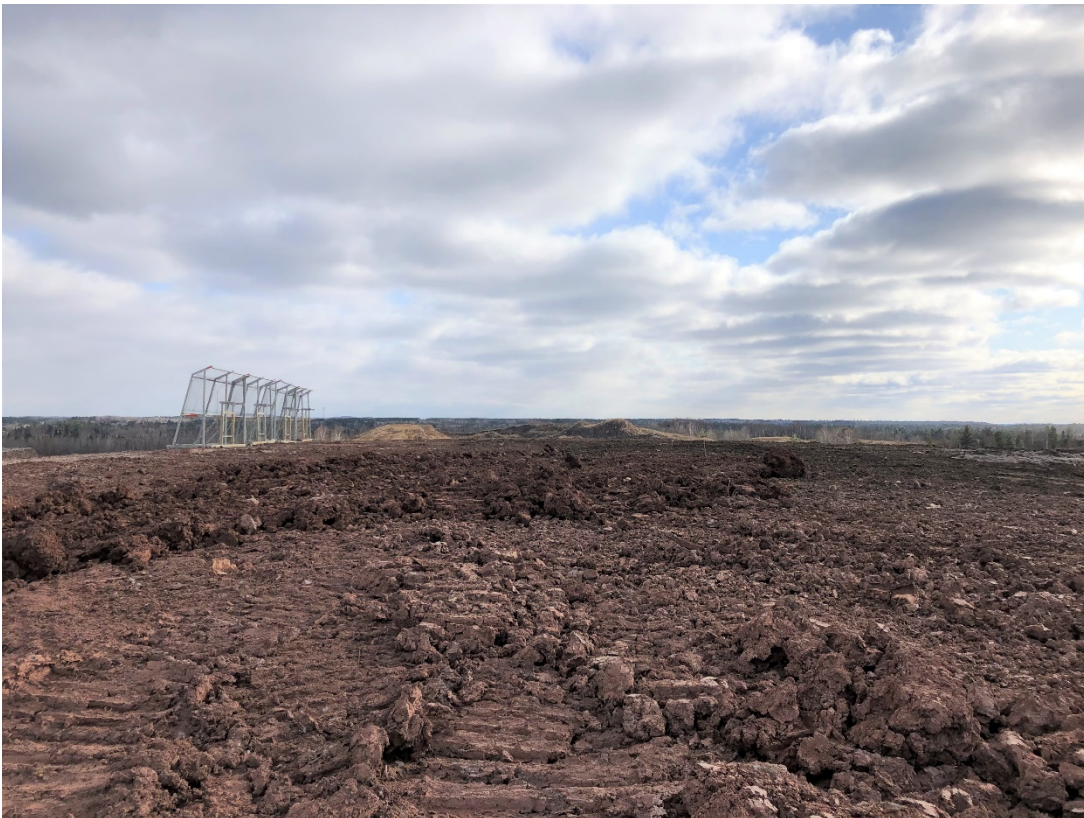
Photo 2: Location 1 – Looking Northeast, Phase 2/1 Upper Lifts

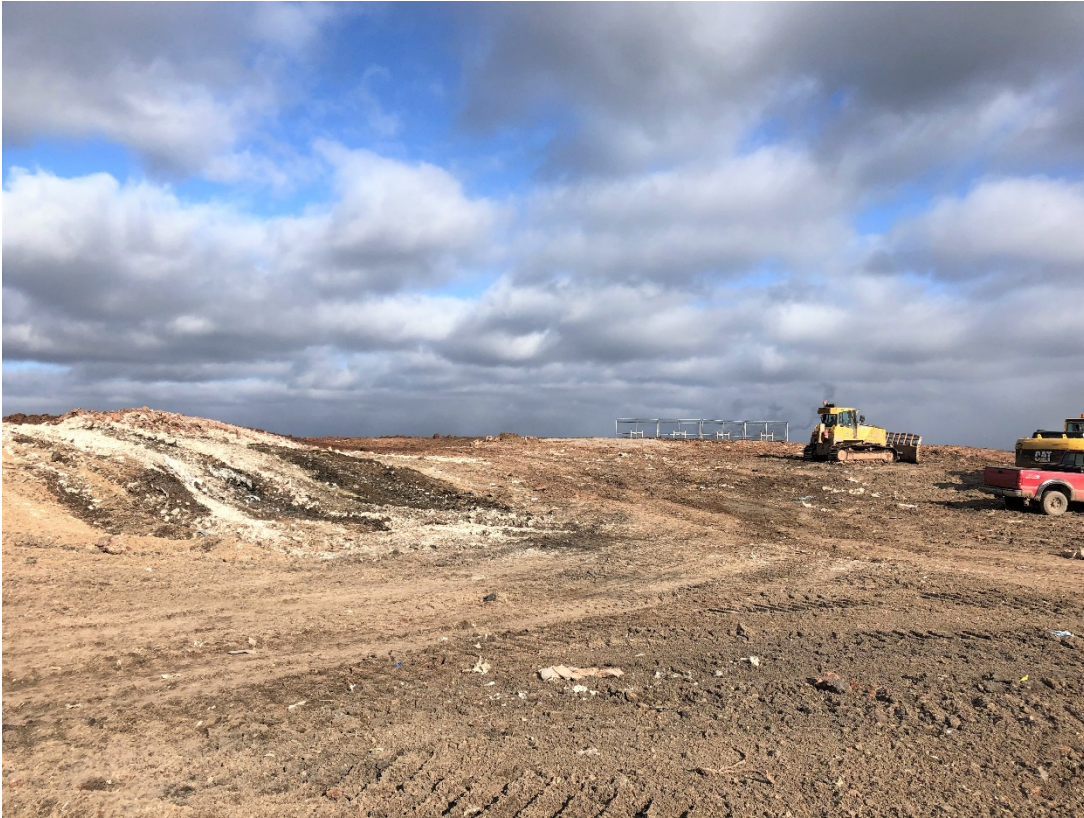
Photo 3: Location 2 – Looking North, Phase 3/4 Upper Lifts

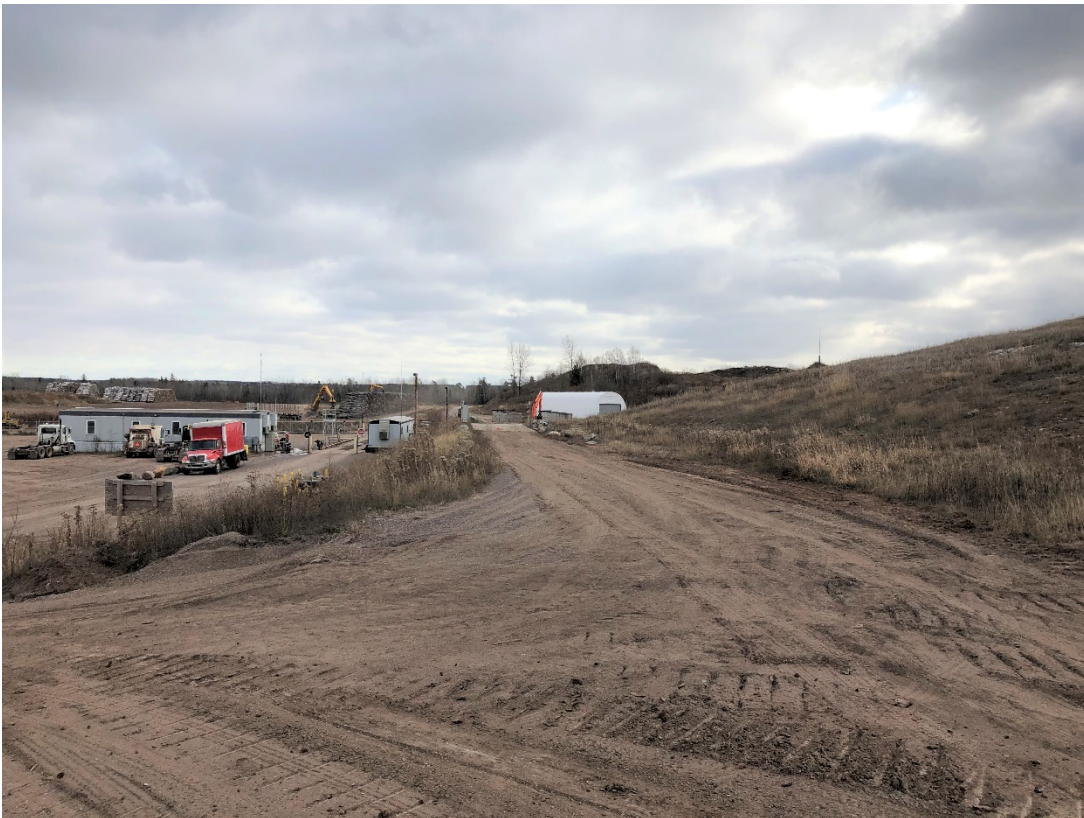
Photo 4: Location 3 – Looking East, Phase 1 Northern Waste Slope

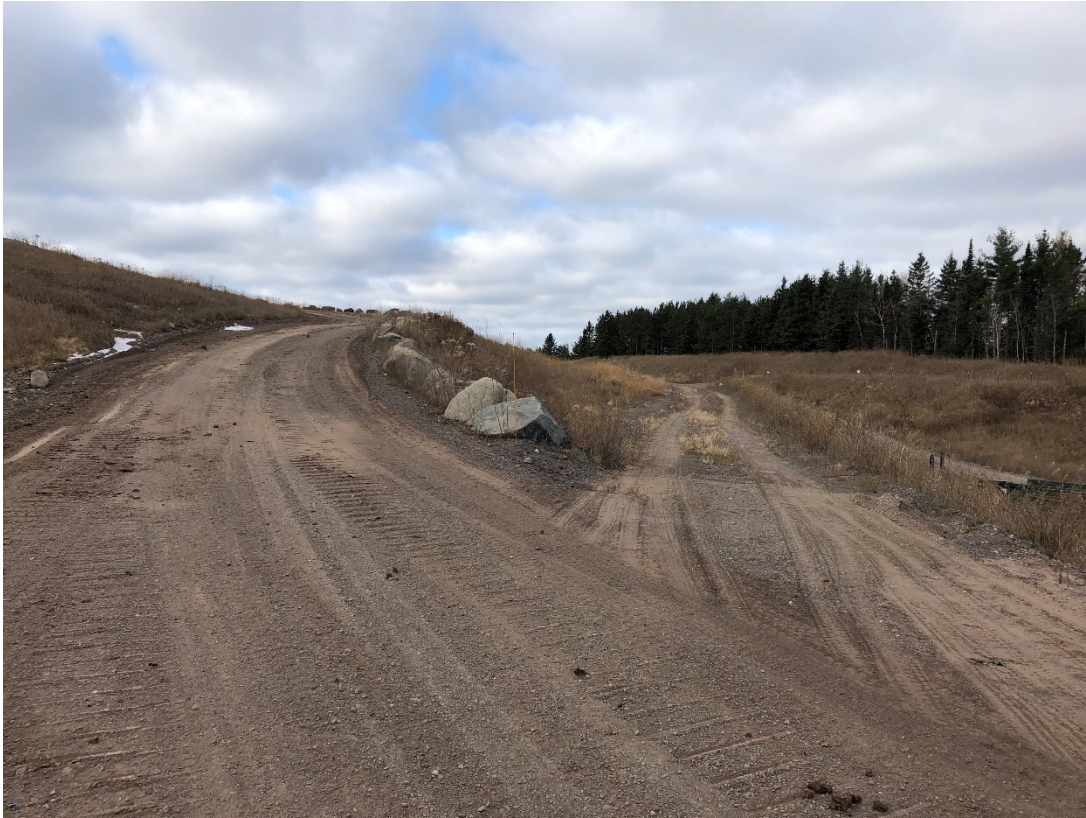
Photo 5: Location 3 – Looking West, Phase 2 Northern Waste Slope & Berm

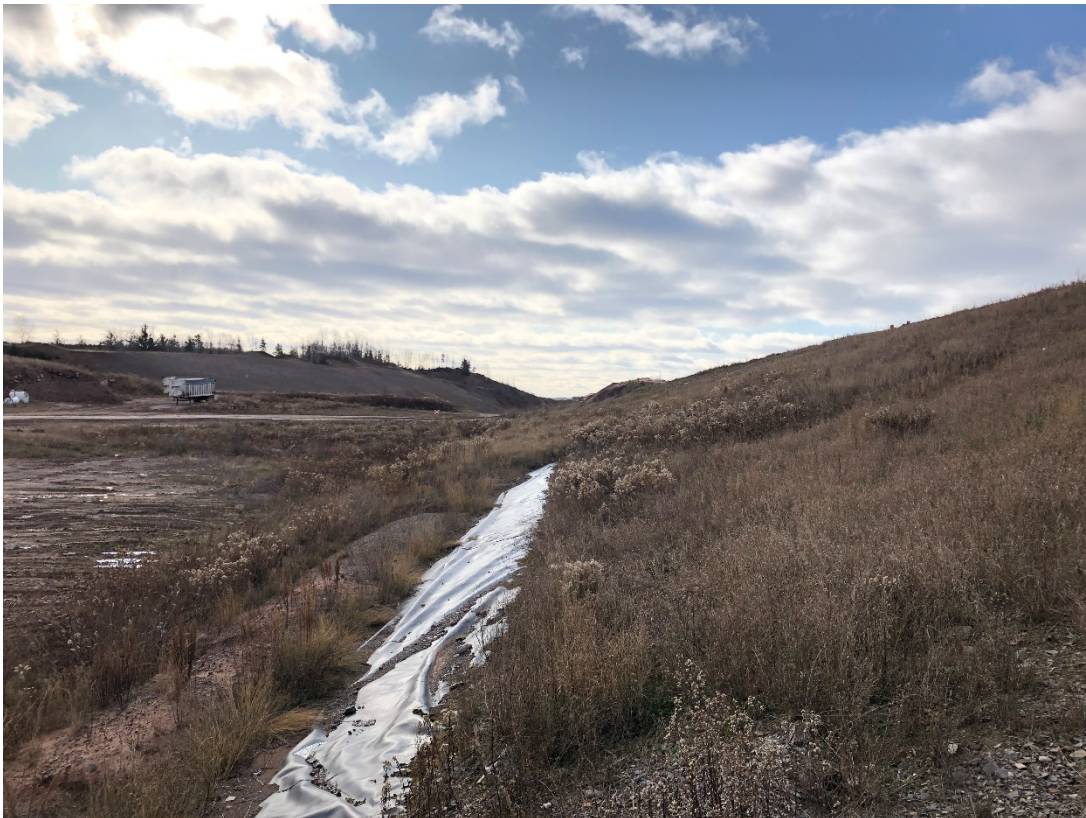
Photo 6: Location 4 – Looking South, Phase 1 Eastern Berm

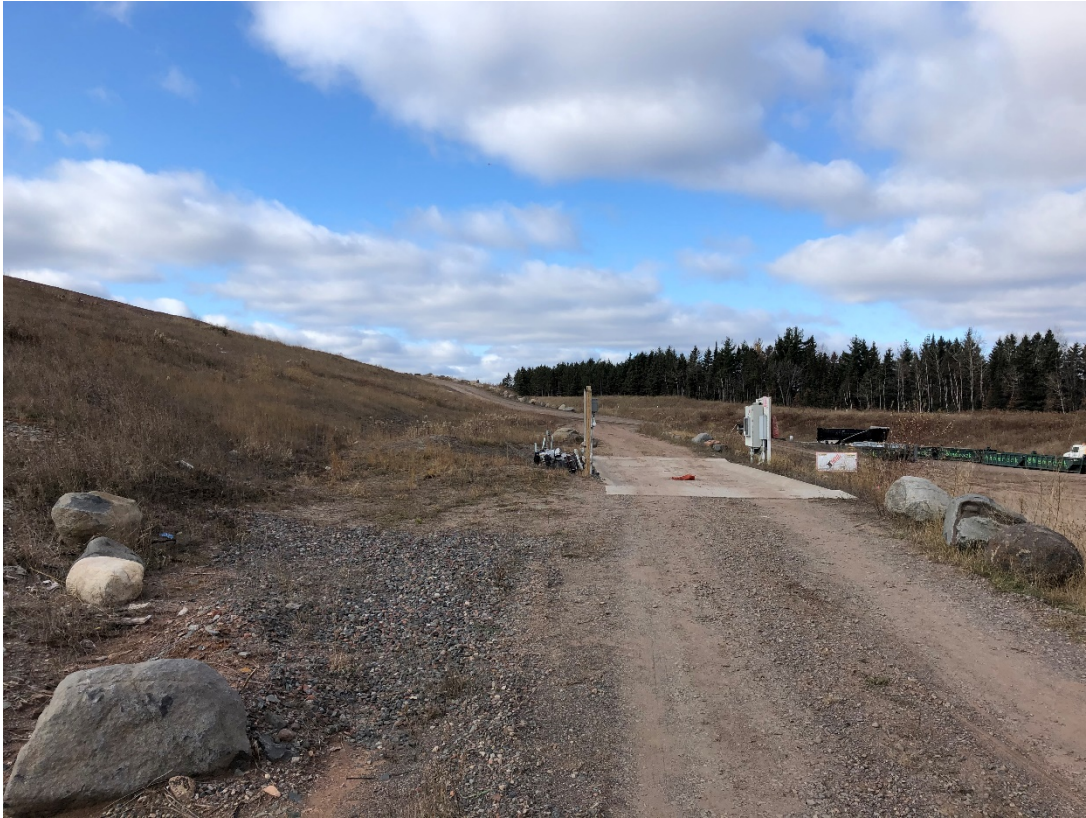
Photo 7: Location 4 – Looking West, Phase 1 Northern Berm

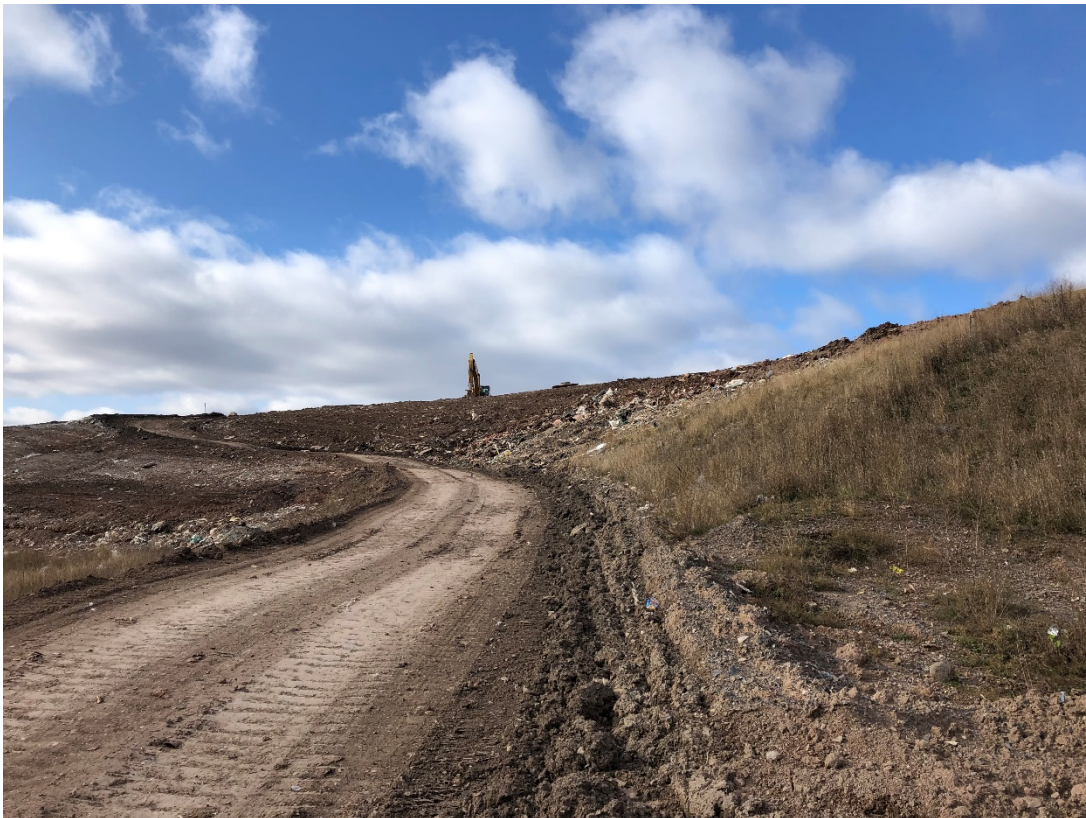
Photo 8: Location 5 – Looking Southwest, Phase 1 Southern Access Road

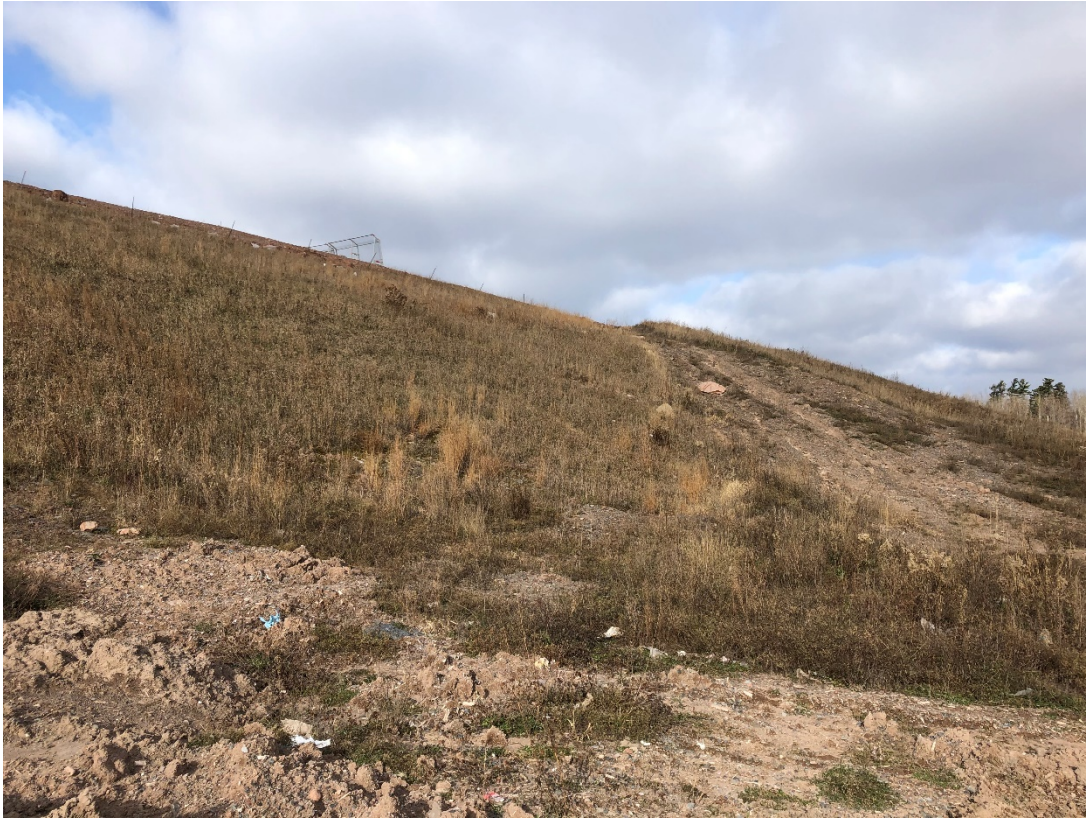
Photo 9: Location 5 – Looking North, Phase 1 Northern Access Road

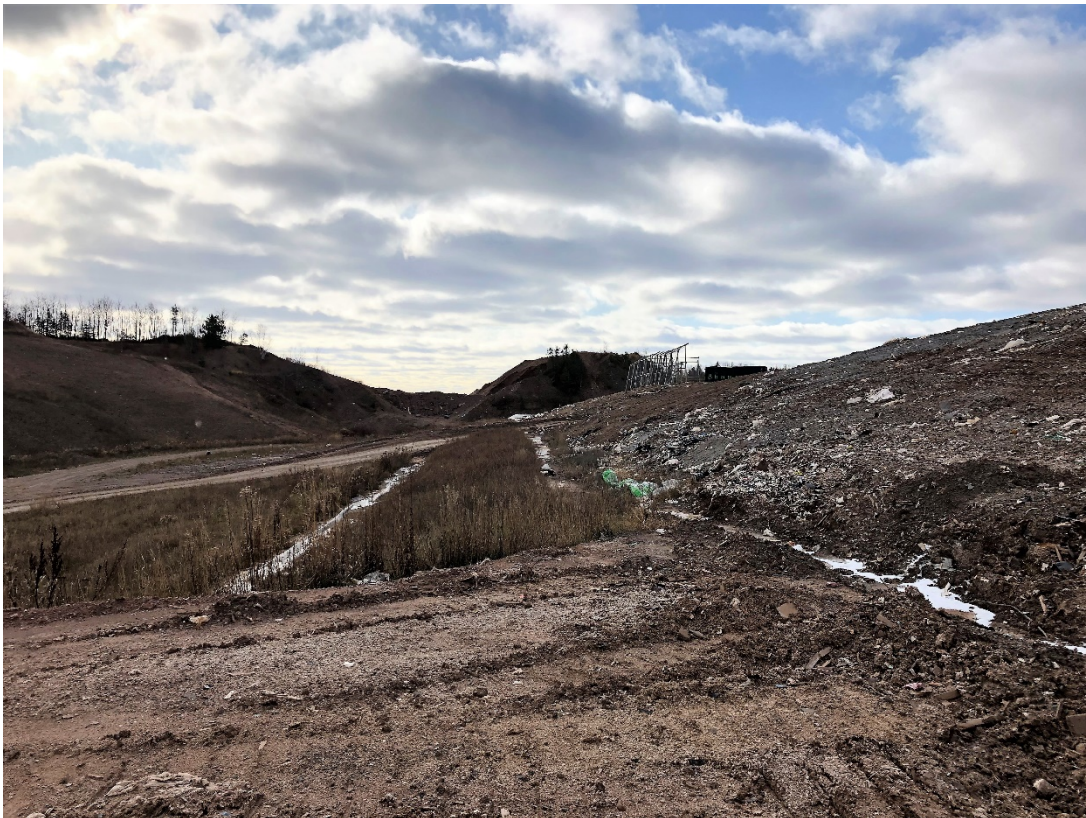
Photo 10: Location 6 – Looking South, Phase 4 Eastern Berm and Waste Slope

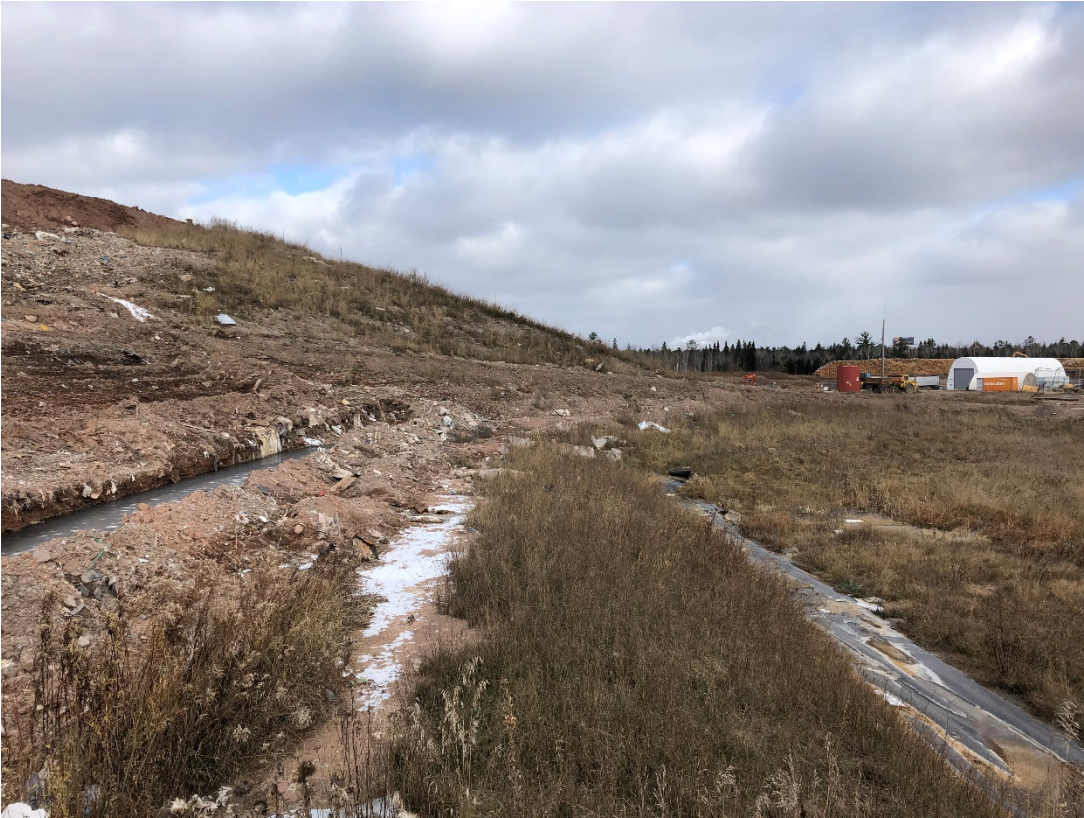
Photo 11: Location 6 – Looking North, Phase 4 Eastern Berm & Phase 1 Southeast Corner

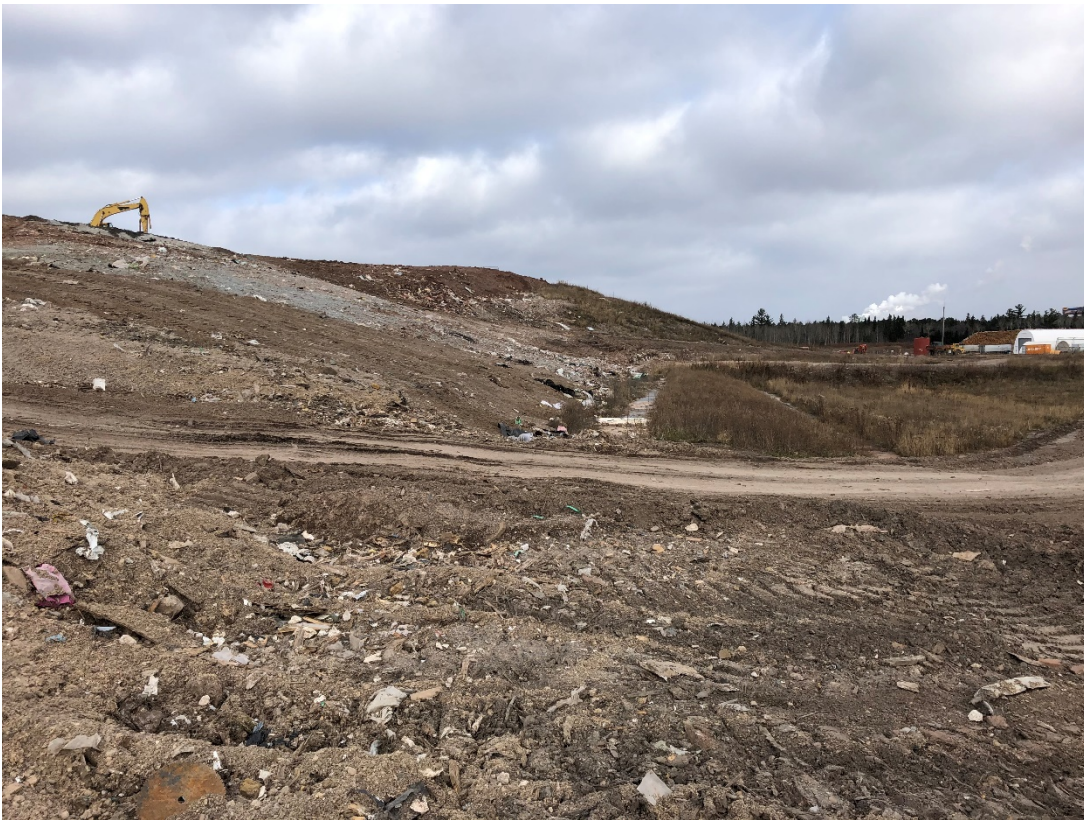
Photo 12: Location 7 – Looking North, Phase 4 Eastern LF Berm and Waste Slope

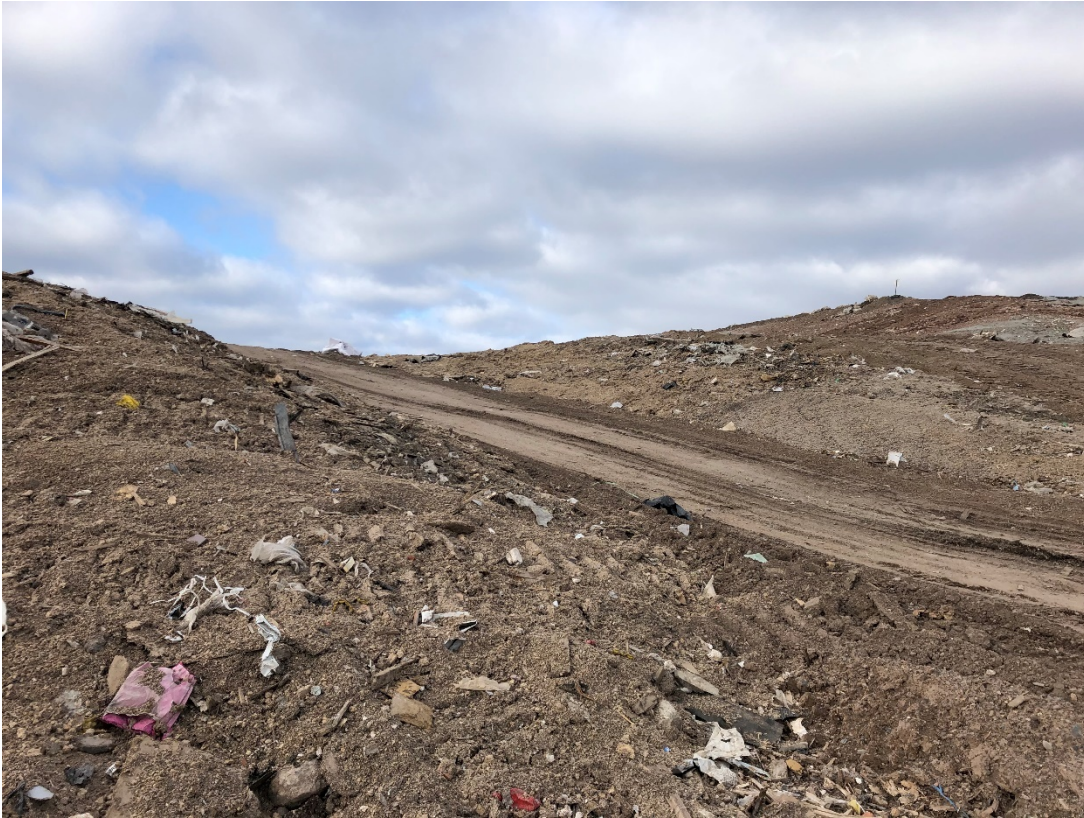
Photo 13: Location 7 – Looking West, Phase 4 Eastern LF Berm and Waste Slope

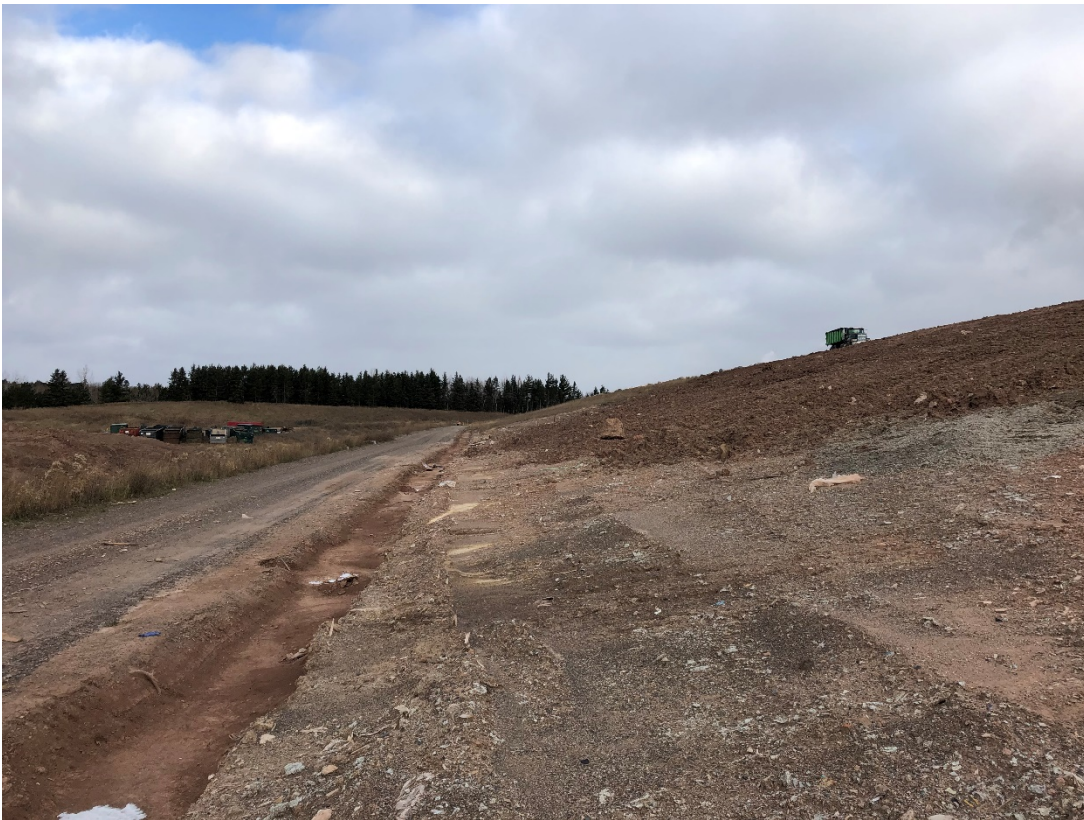
Photo 14: Location 8 – Looking North, Phase 3 Western Waste Slope

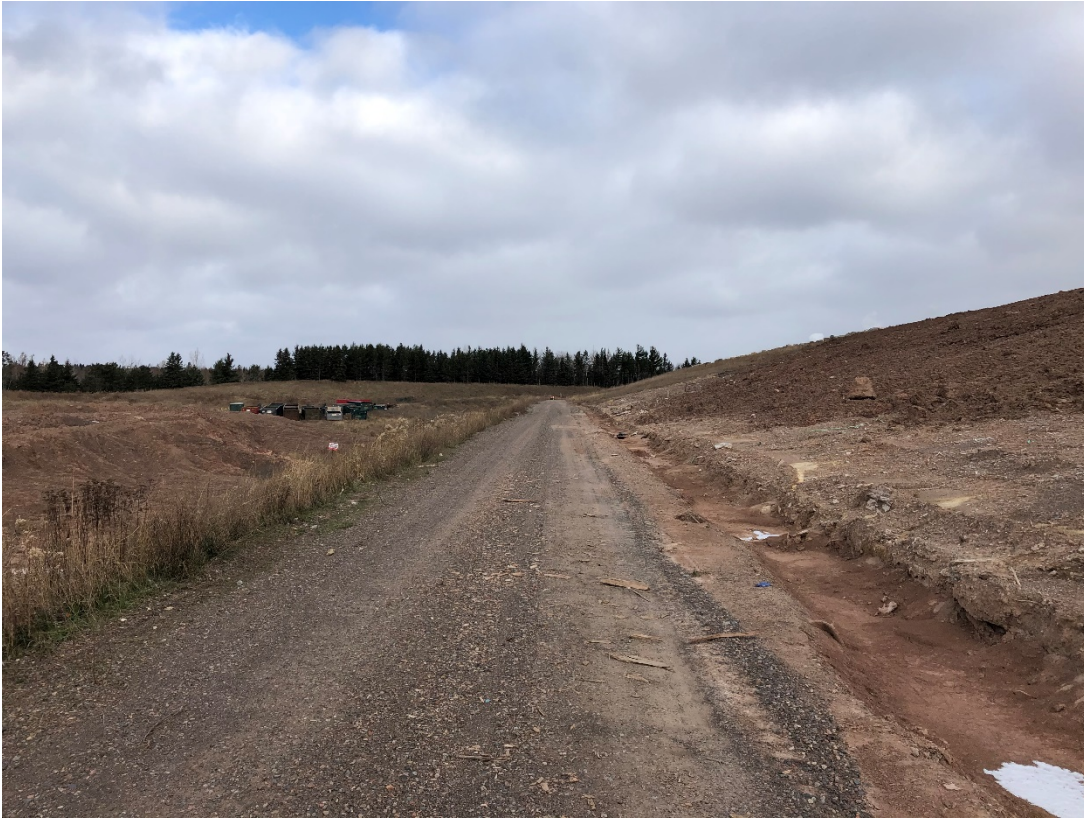
Photo 15: Location 8 – Looking North, Phase 3 LF Western Road

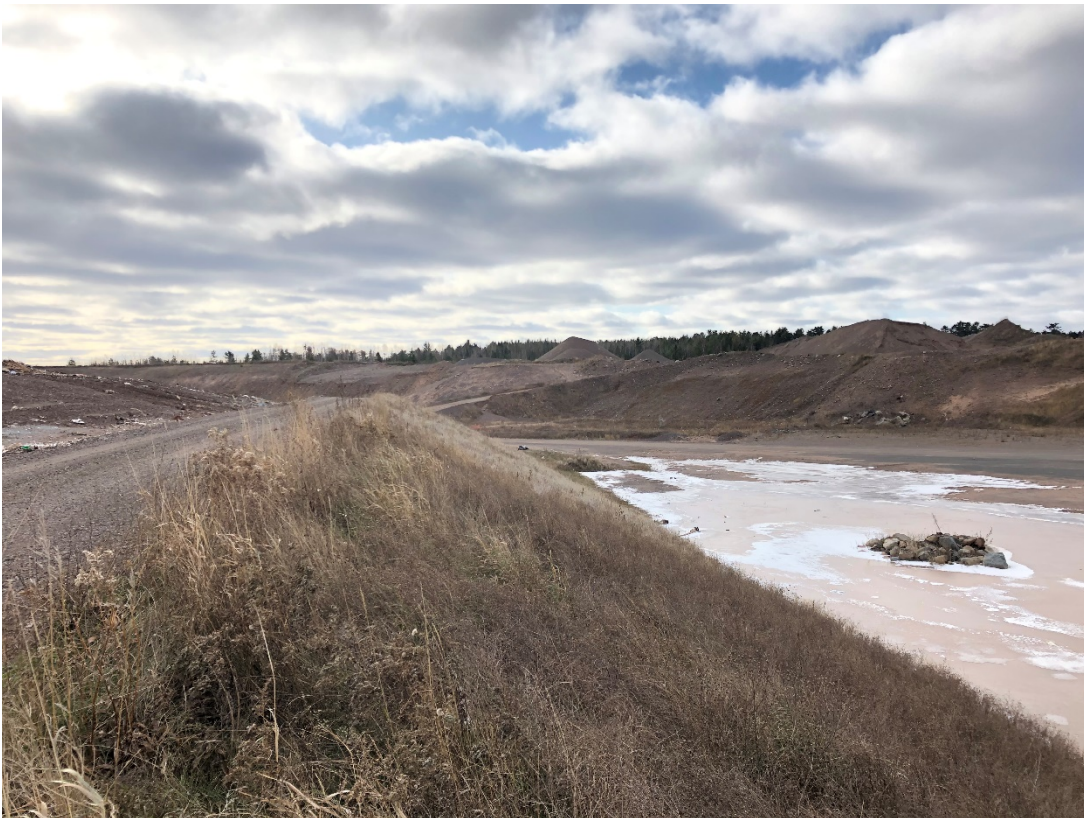
Photo 16: Location 8 – Looking South, Phase 6 Western LF Berm
