# Technical Memo

**To:** Geoff Strack, P.E., Waste Connections  
**From:** Brad Sullivan, P.E., Wenck Associates, Inc.  
**Date:** January 9, 2020  
**Subject:** SKB Environmental Cloquet Landfill  
dba Shamrock Landfill, Inc.  
2019 Annual CCR Inspection Report  
Wenck Project #B3053-0182

PROJECT TITLE  
**2019 CCR INSPECTION REPORT**

SKB ENVIRONMENTAL CLOQUET LANDFILL, INC.  
 f/n/a SHAMROCK LANDFILL, INC

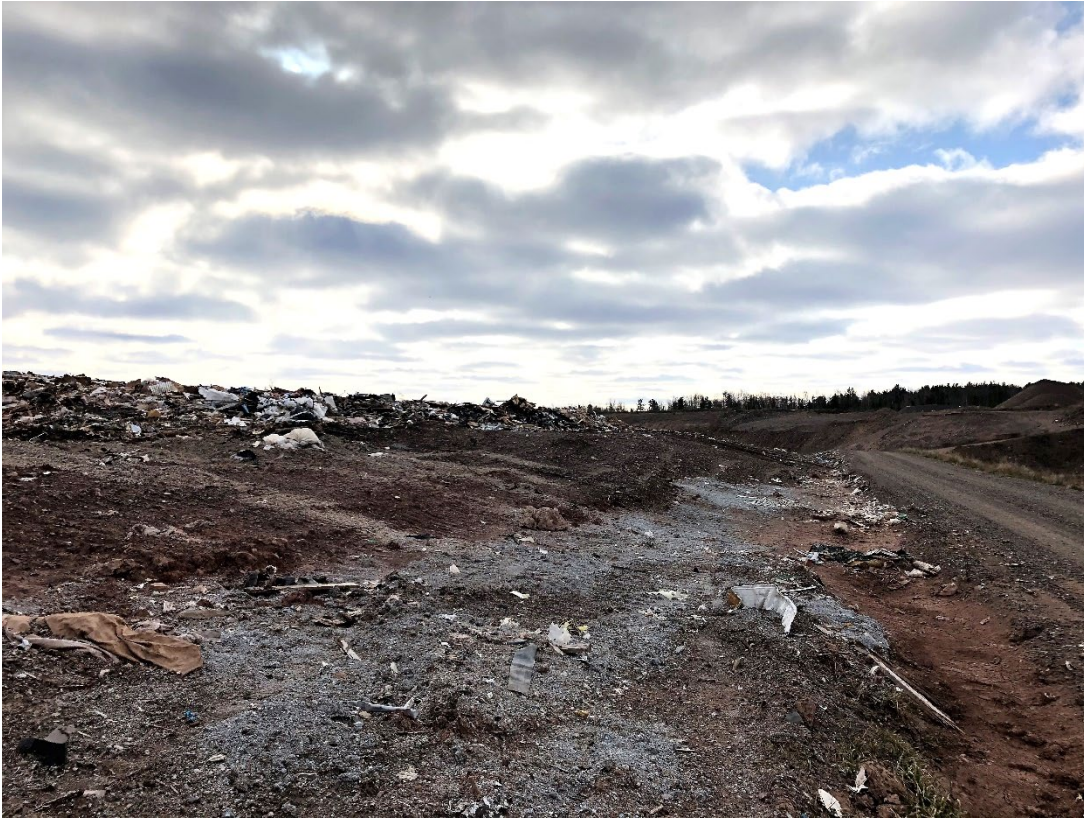
Photo 17: Location 8 – Looking South, Phase 6 Interior

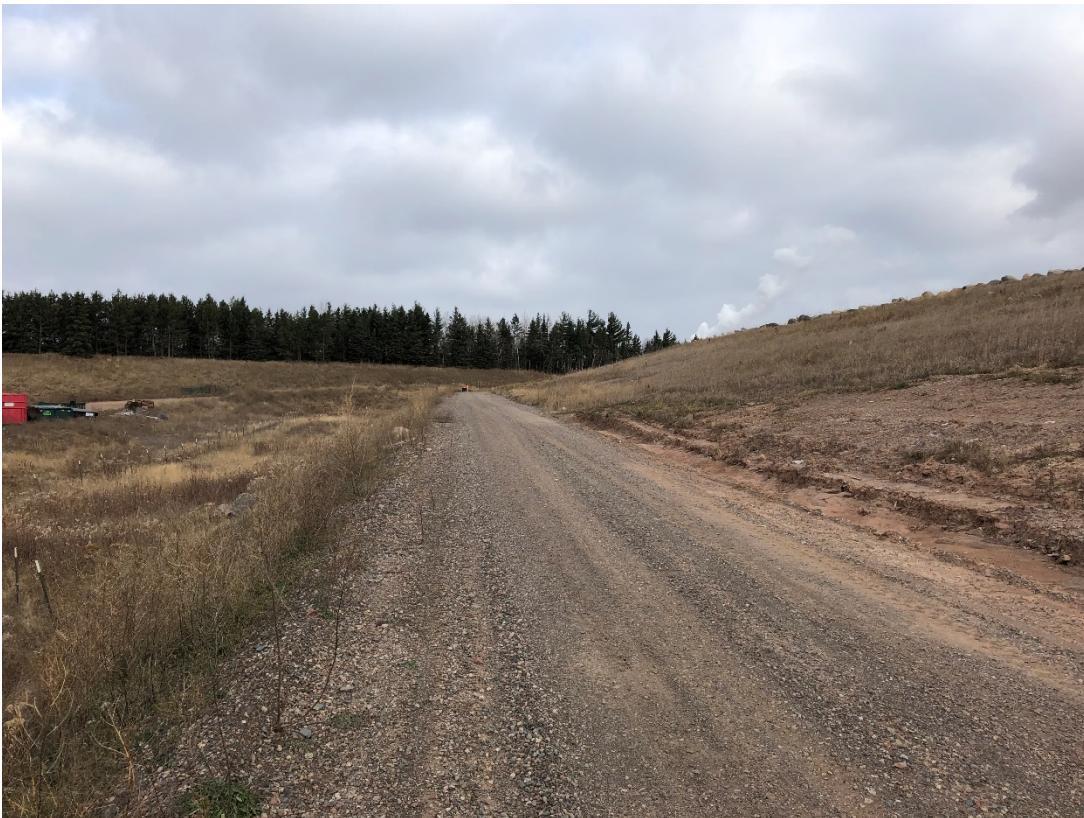
Photo 18: Location 9 – Looking North, Phase 2 Perimeter Road

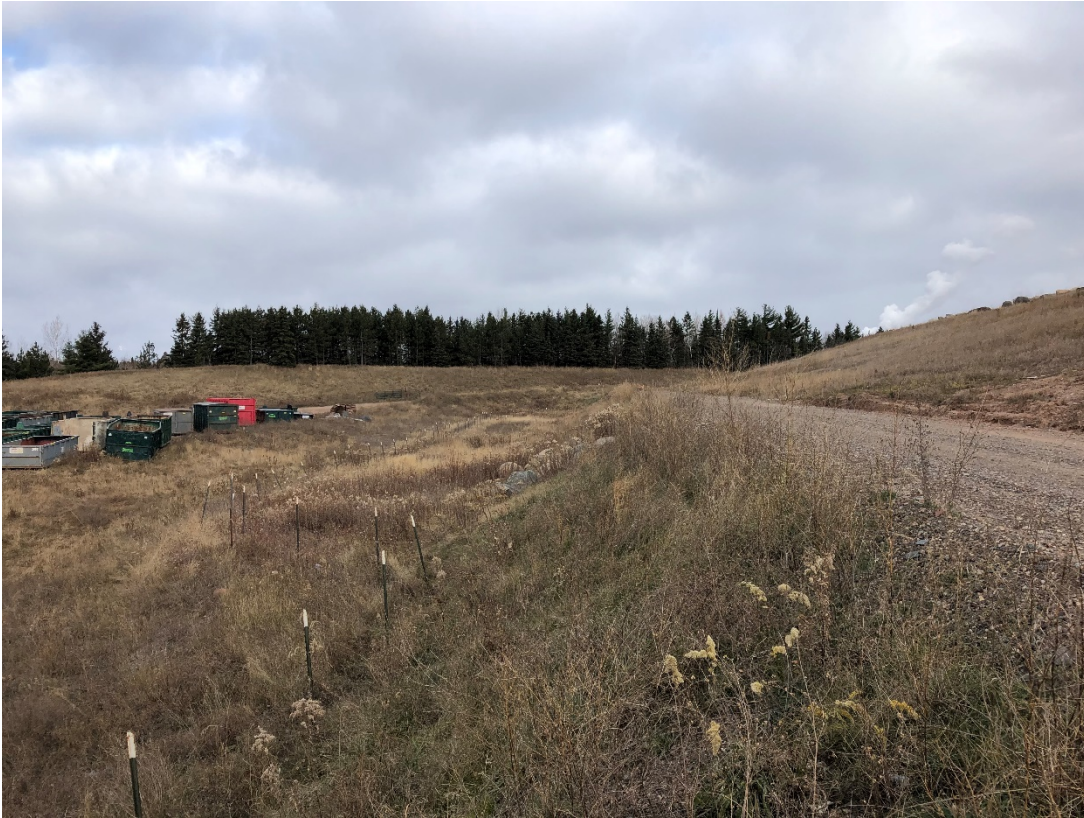
Photo 19: Location 9 – Looking North, Phase 2 Western Berm

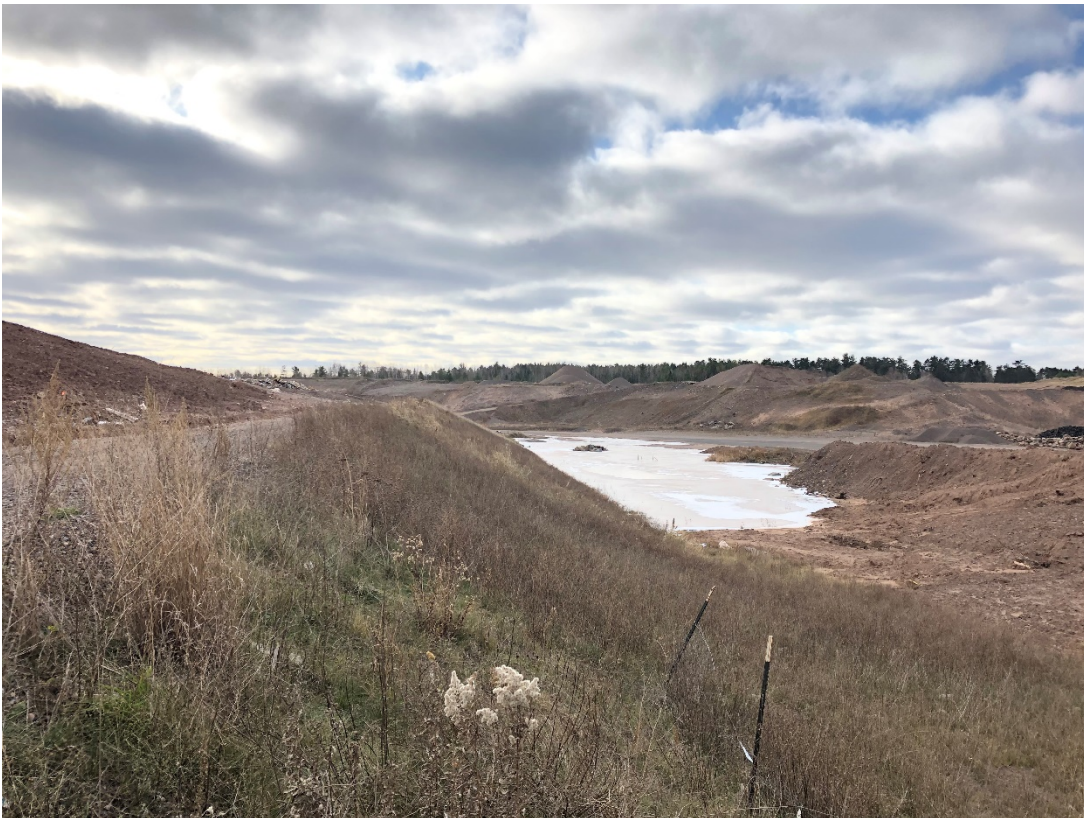
Photo 20: Location 9 – Looking South, Phase 3 Western Berm

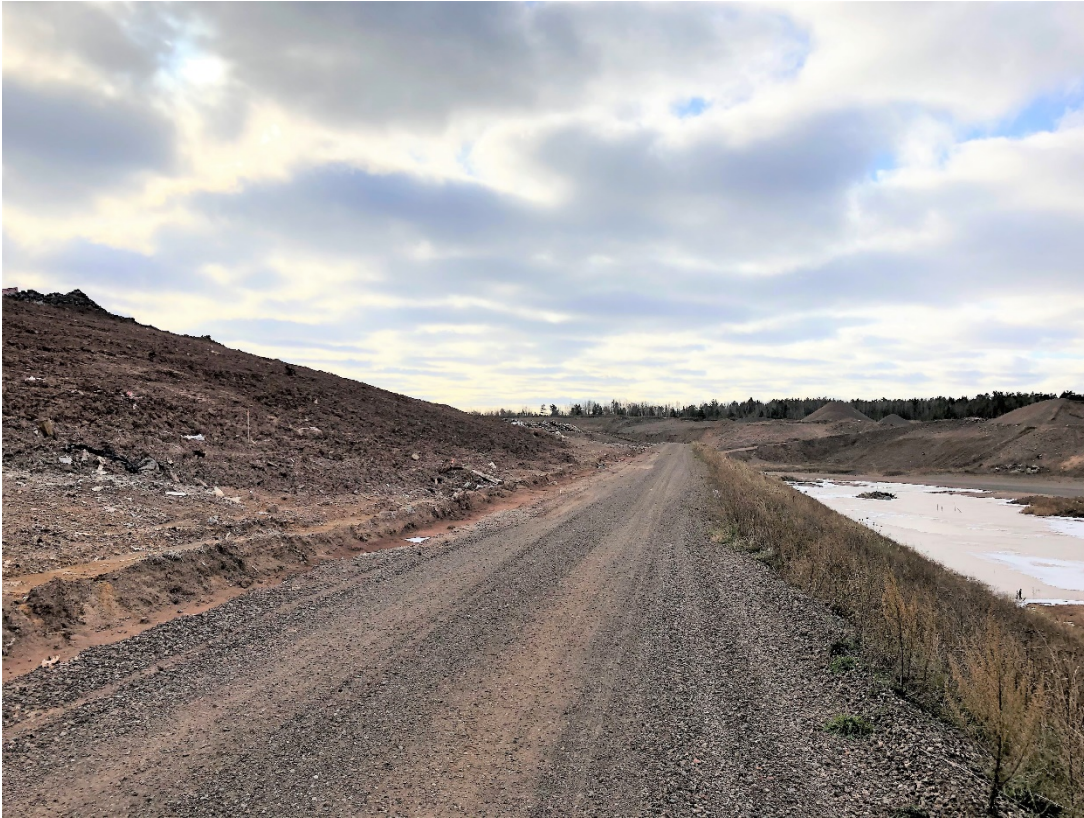
Photo 21: Location 9 – Looking South, Phase 3 Perimeter Road

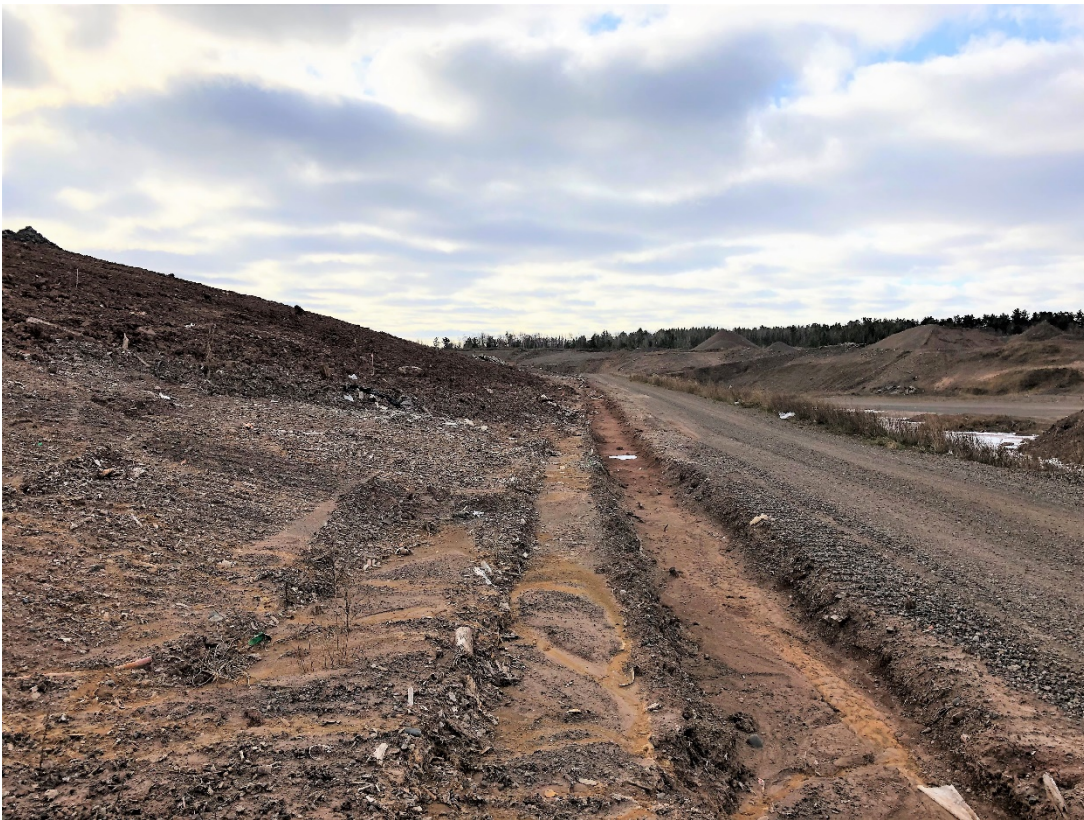
Photo 22: Location 9 – Looking South, Phase 3 Waste Slope

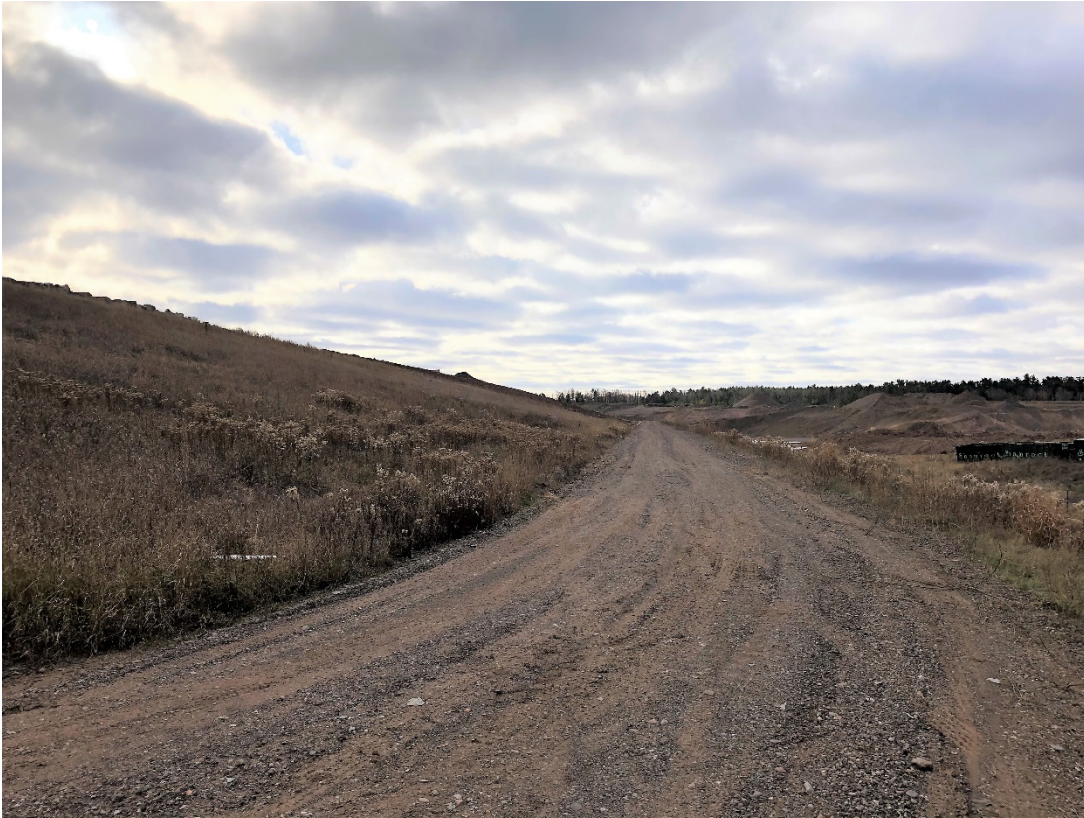
Photo 23: Location 10 – Looking South, Phase 2 Perimeter Road

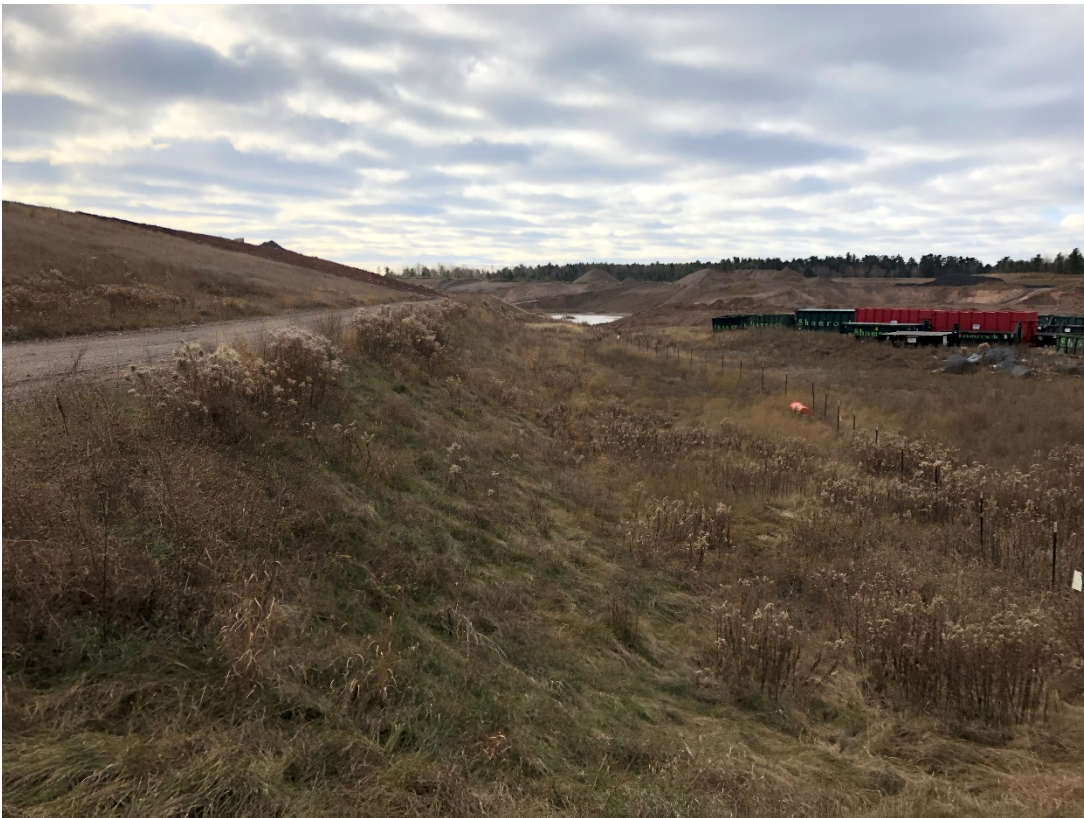
Photo 24: Location 10 – Looking South, Phase 2 Western Berm

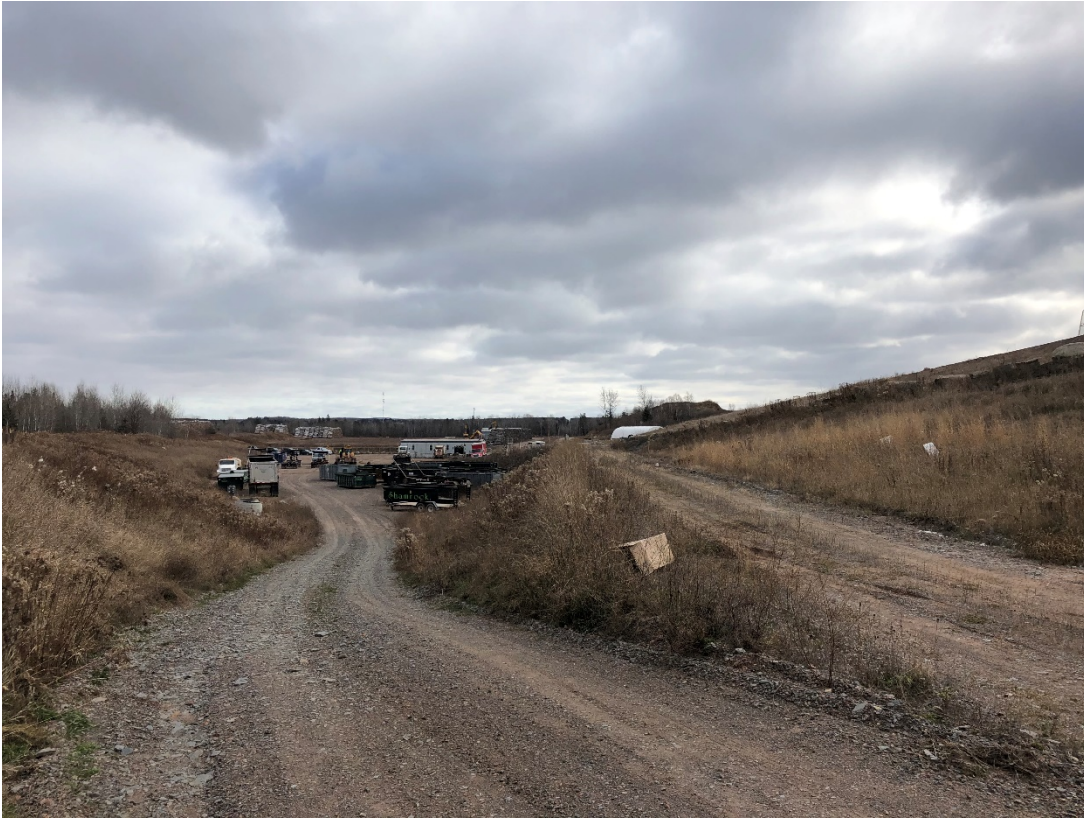
Photo 25: Location 10 – Looking East, Phase 2 Road & Berm

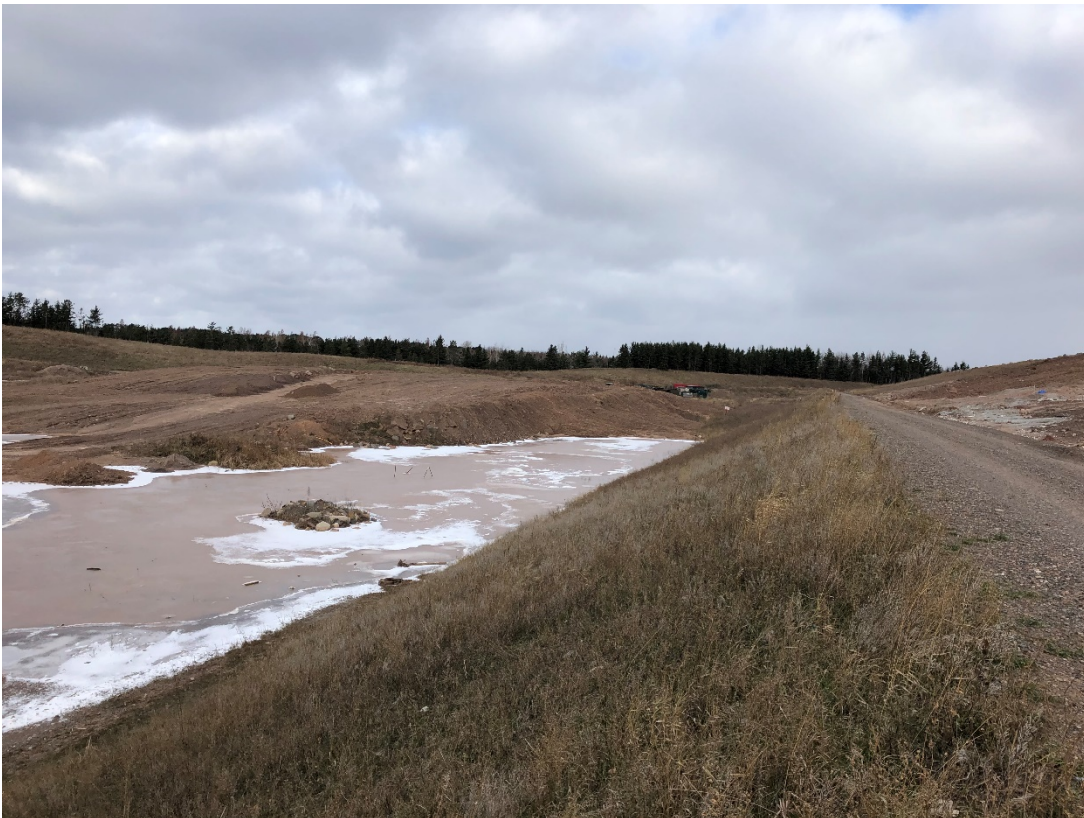
Photo 26: Location 11 – Looking North, Phase 6 Western LF Berm

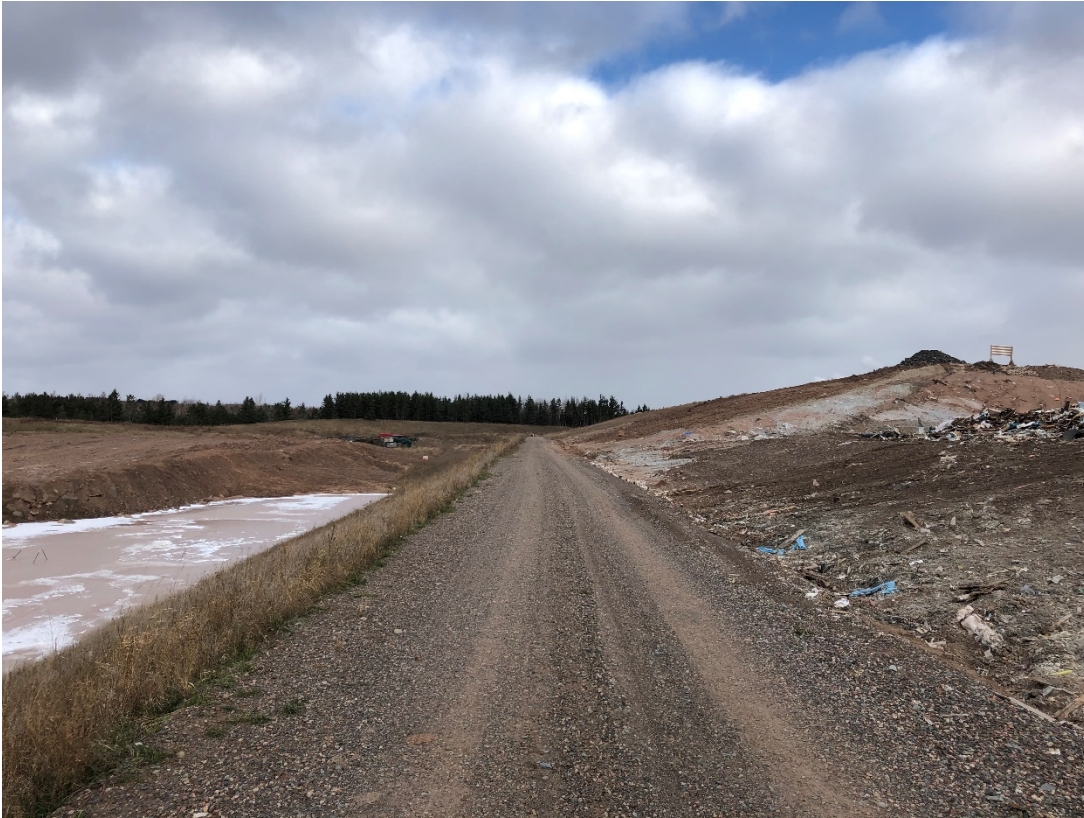
Photo 29: Location 11 – Looking North, Phase 6 Interior (Future Waste Slope)7

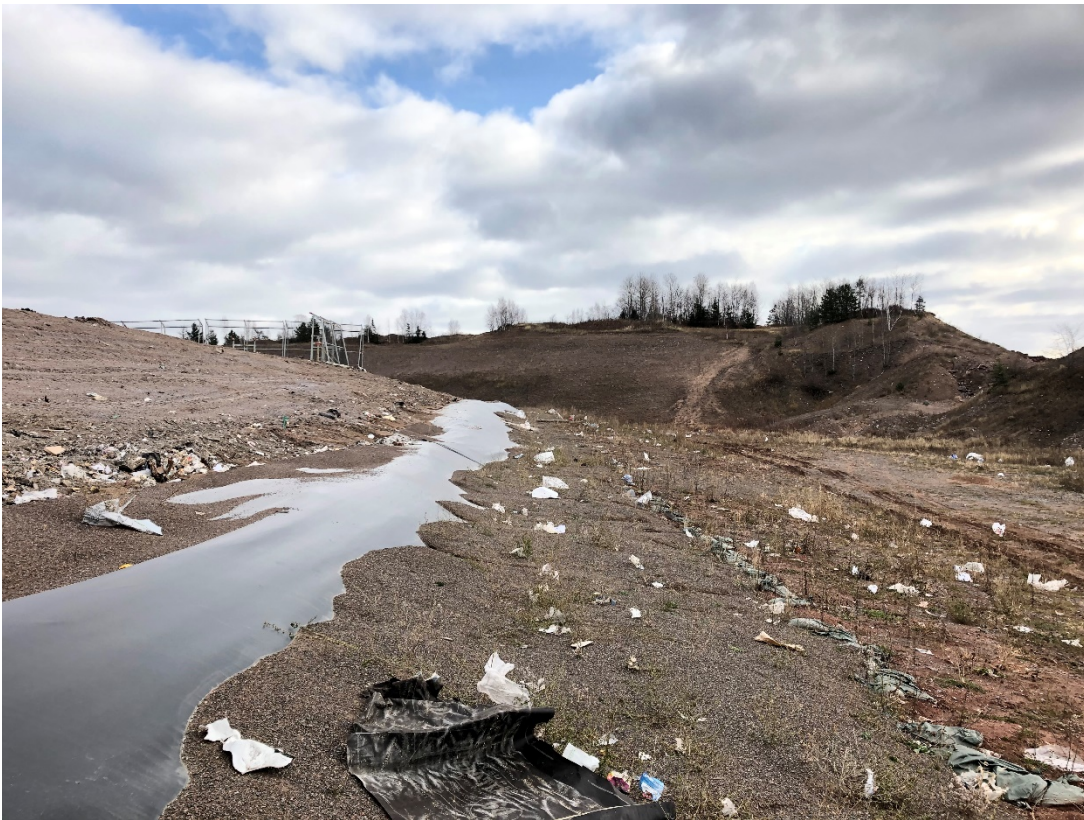
Photo 28: Location 11 – Looking East, Phase 6A/7A Southern Rain Flap

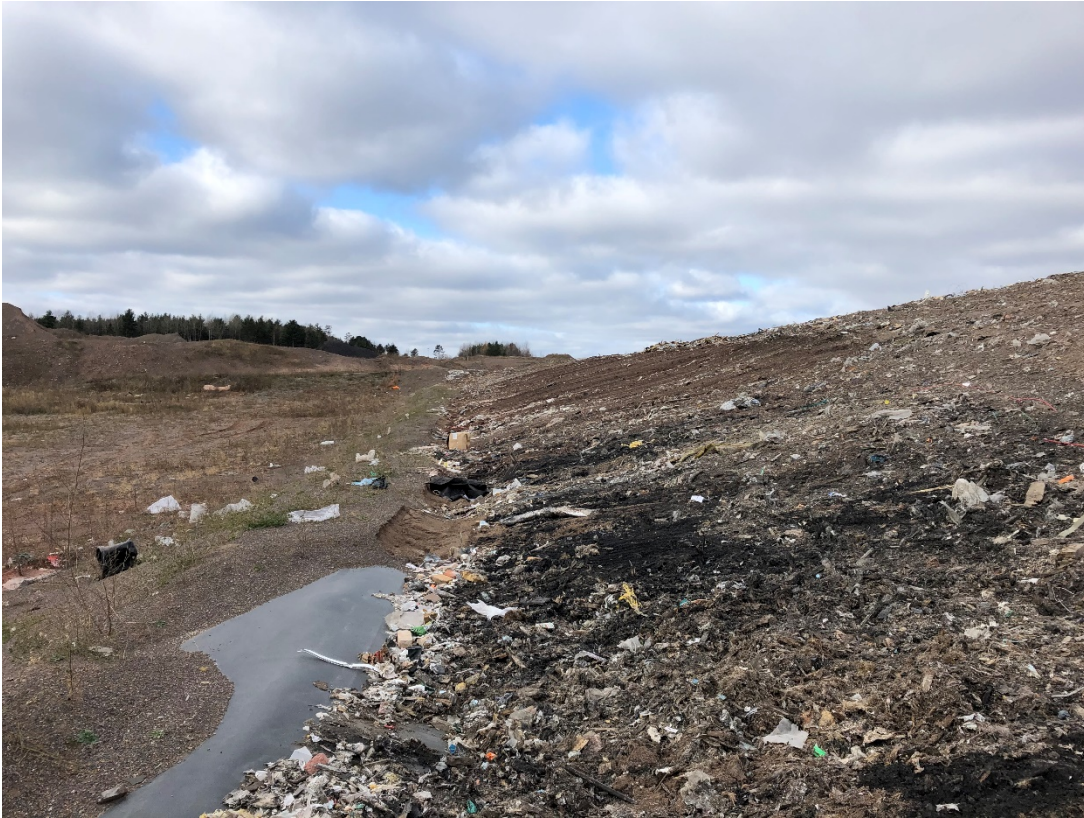
Photo 29: Location 12 – Looking West, Cell 6A Southern Rain Flap

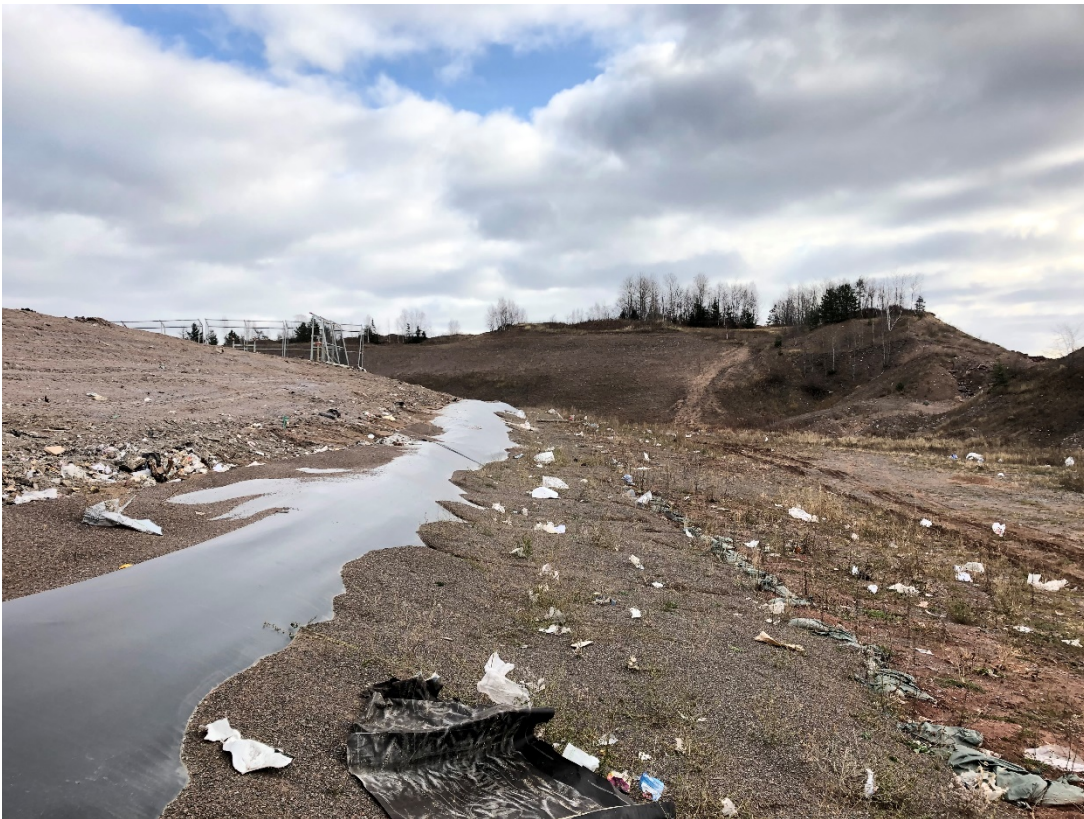
Photo 30: Location 12 – Looking East, Cell 7A Southern Rain Flap

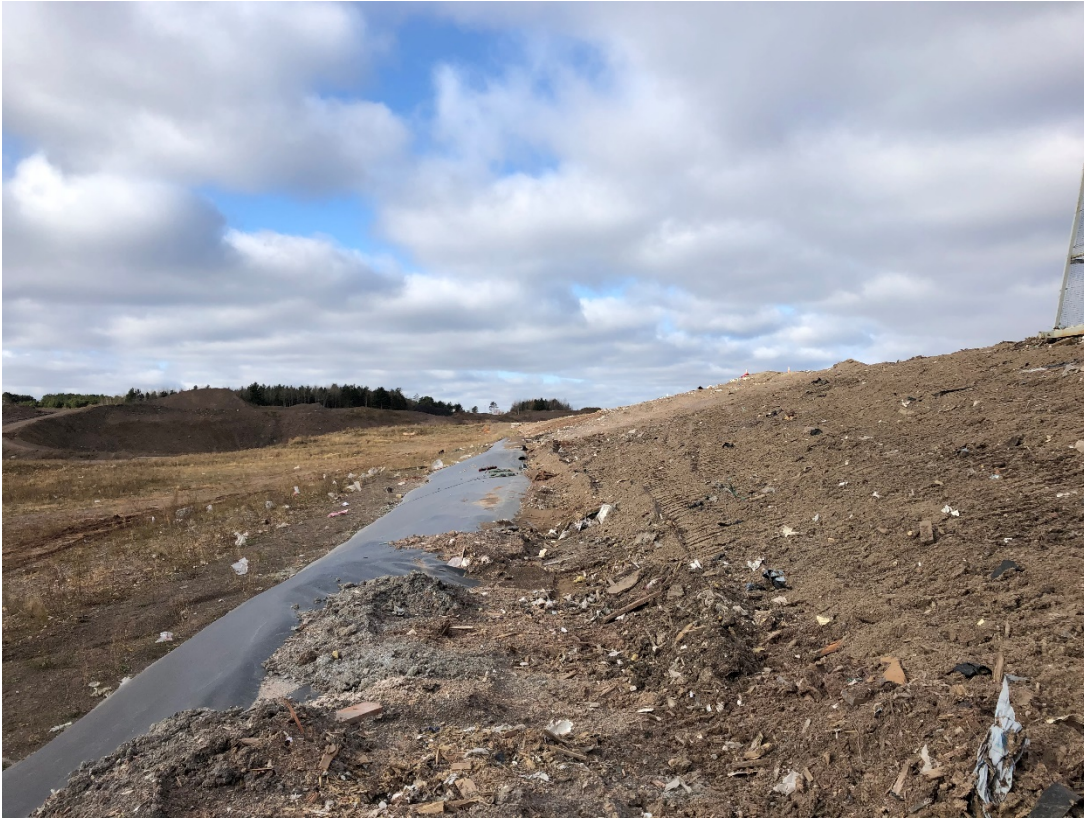
Photo 31: Location 13 – Looking West, Cell 7A Southern Rain Flap

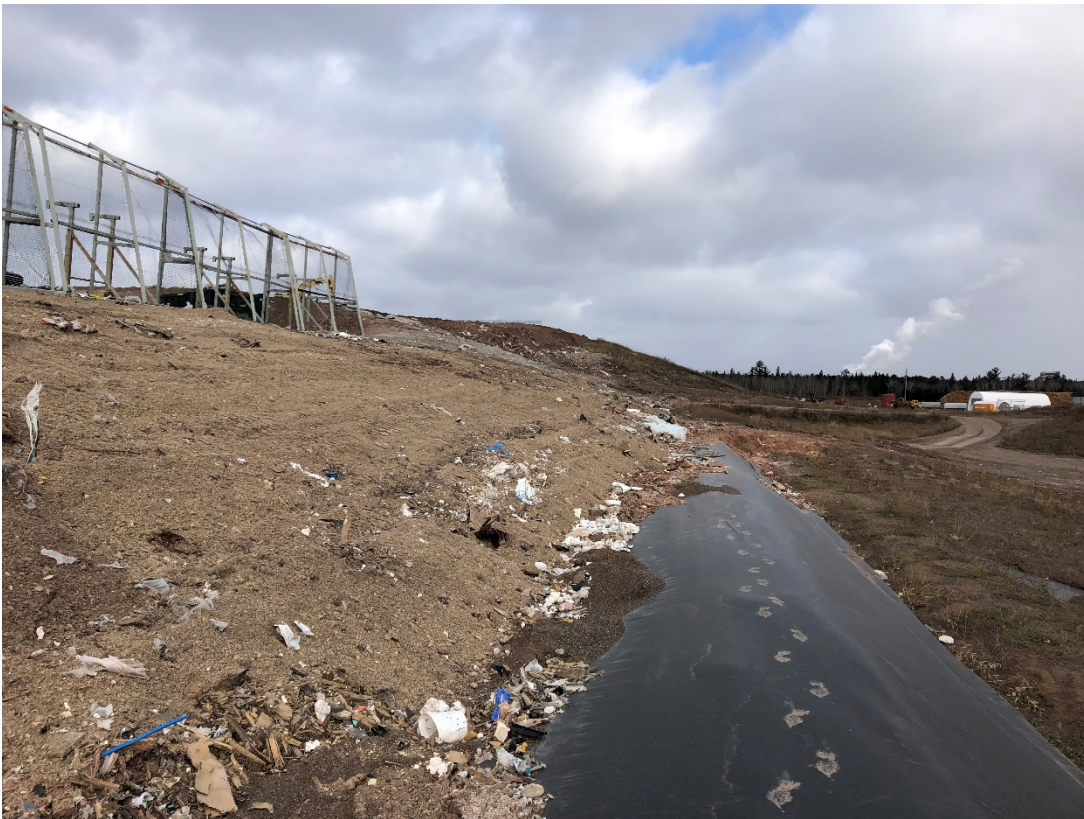
Photo 32: Location 13 – Looking North, Cell 7 Eastern Berm
