To:	Geoff Strack, PE, Waste Connections	From:	Bradley W Sullivan, PE, Stantec Consulting Services, Inc.
File:	Project #B3053-0519	Date:	January 9, 2021

Reference: SKB Environmental Cloquet Landfill, dba Shamrock Landfill, Inc. 2020 Annual CCR Inspection Report

CCR Landfill Inspection Report

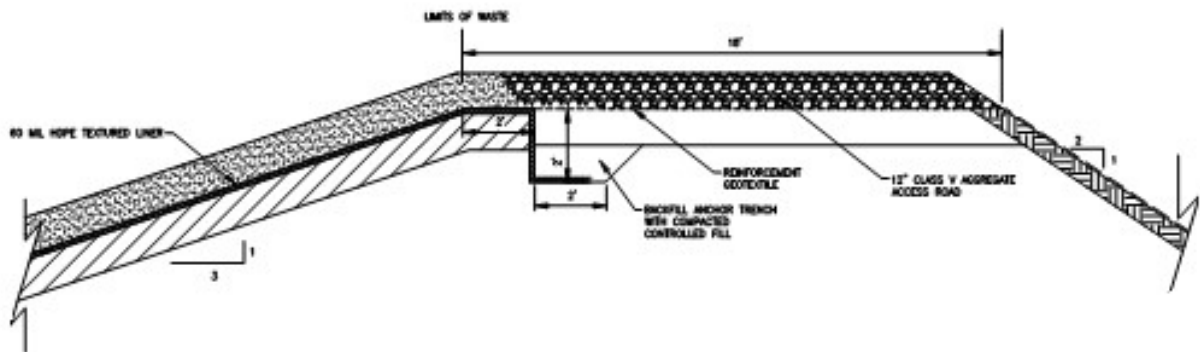
Typical Landfill Berm Detail

Most of the facility's landfill cell embankments were constructed using on-site borrow material, which consisted of silty clay and clayey sand type soils. The fill was placed and compacted to 95% of Standard Proctor Dry Density in lift thicknesses ranging from 8 inches to 12 inches. The final subgrade surface was proof rolled prior to geosynthetics installation. A typical perimeter section taken from the Phase 3 and 4 Construction Documentation Report prepared by Wenck in September 2015 is shown below.

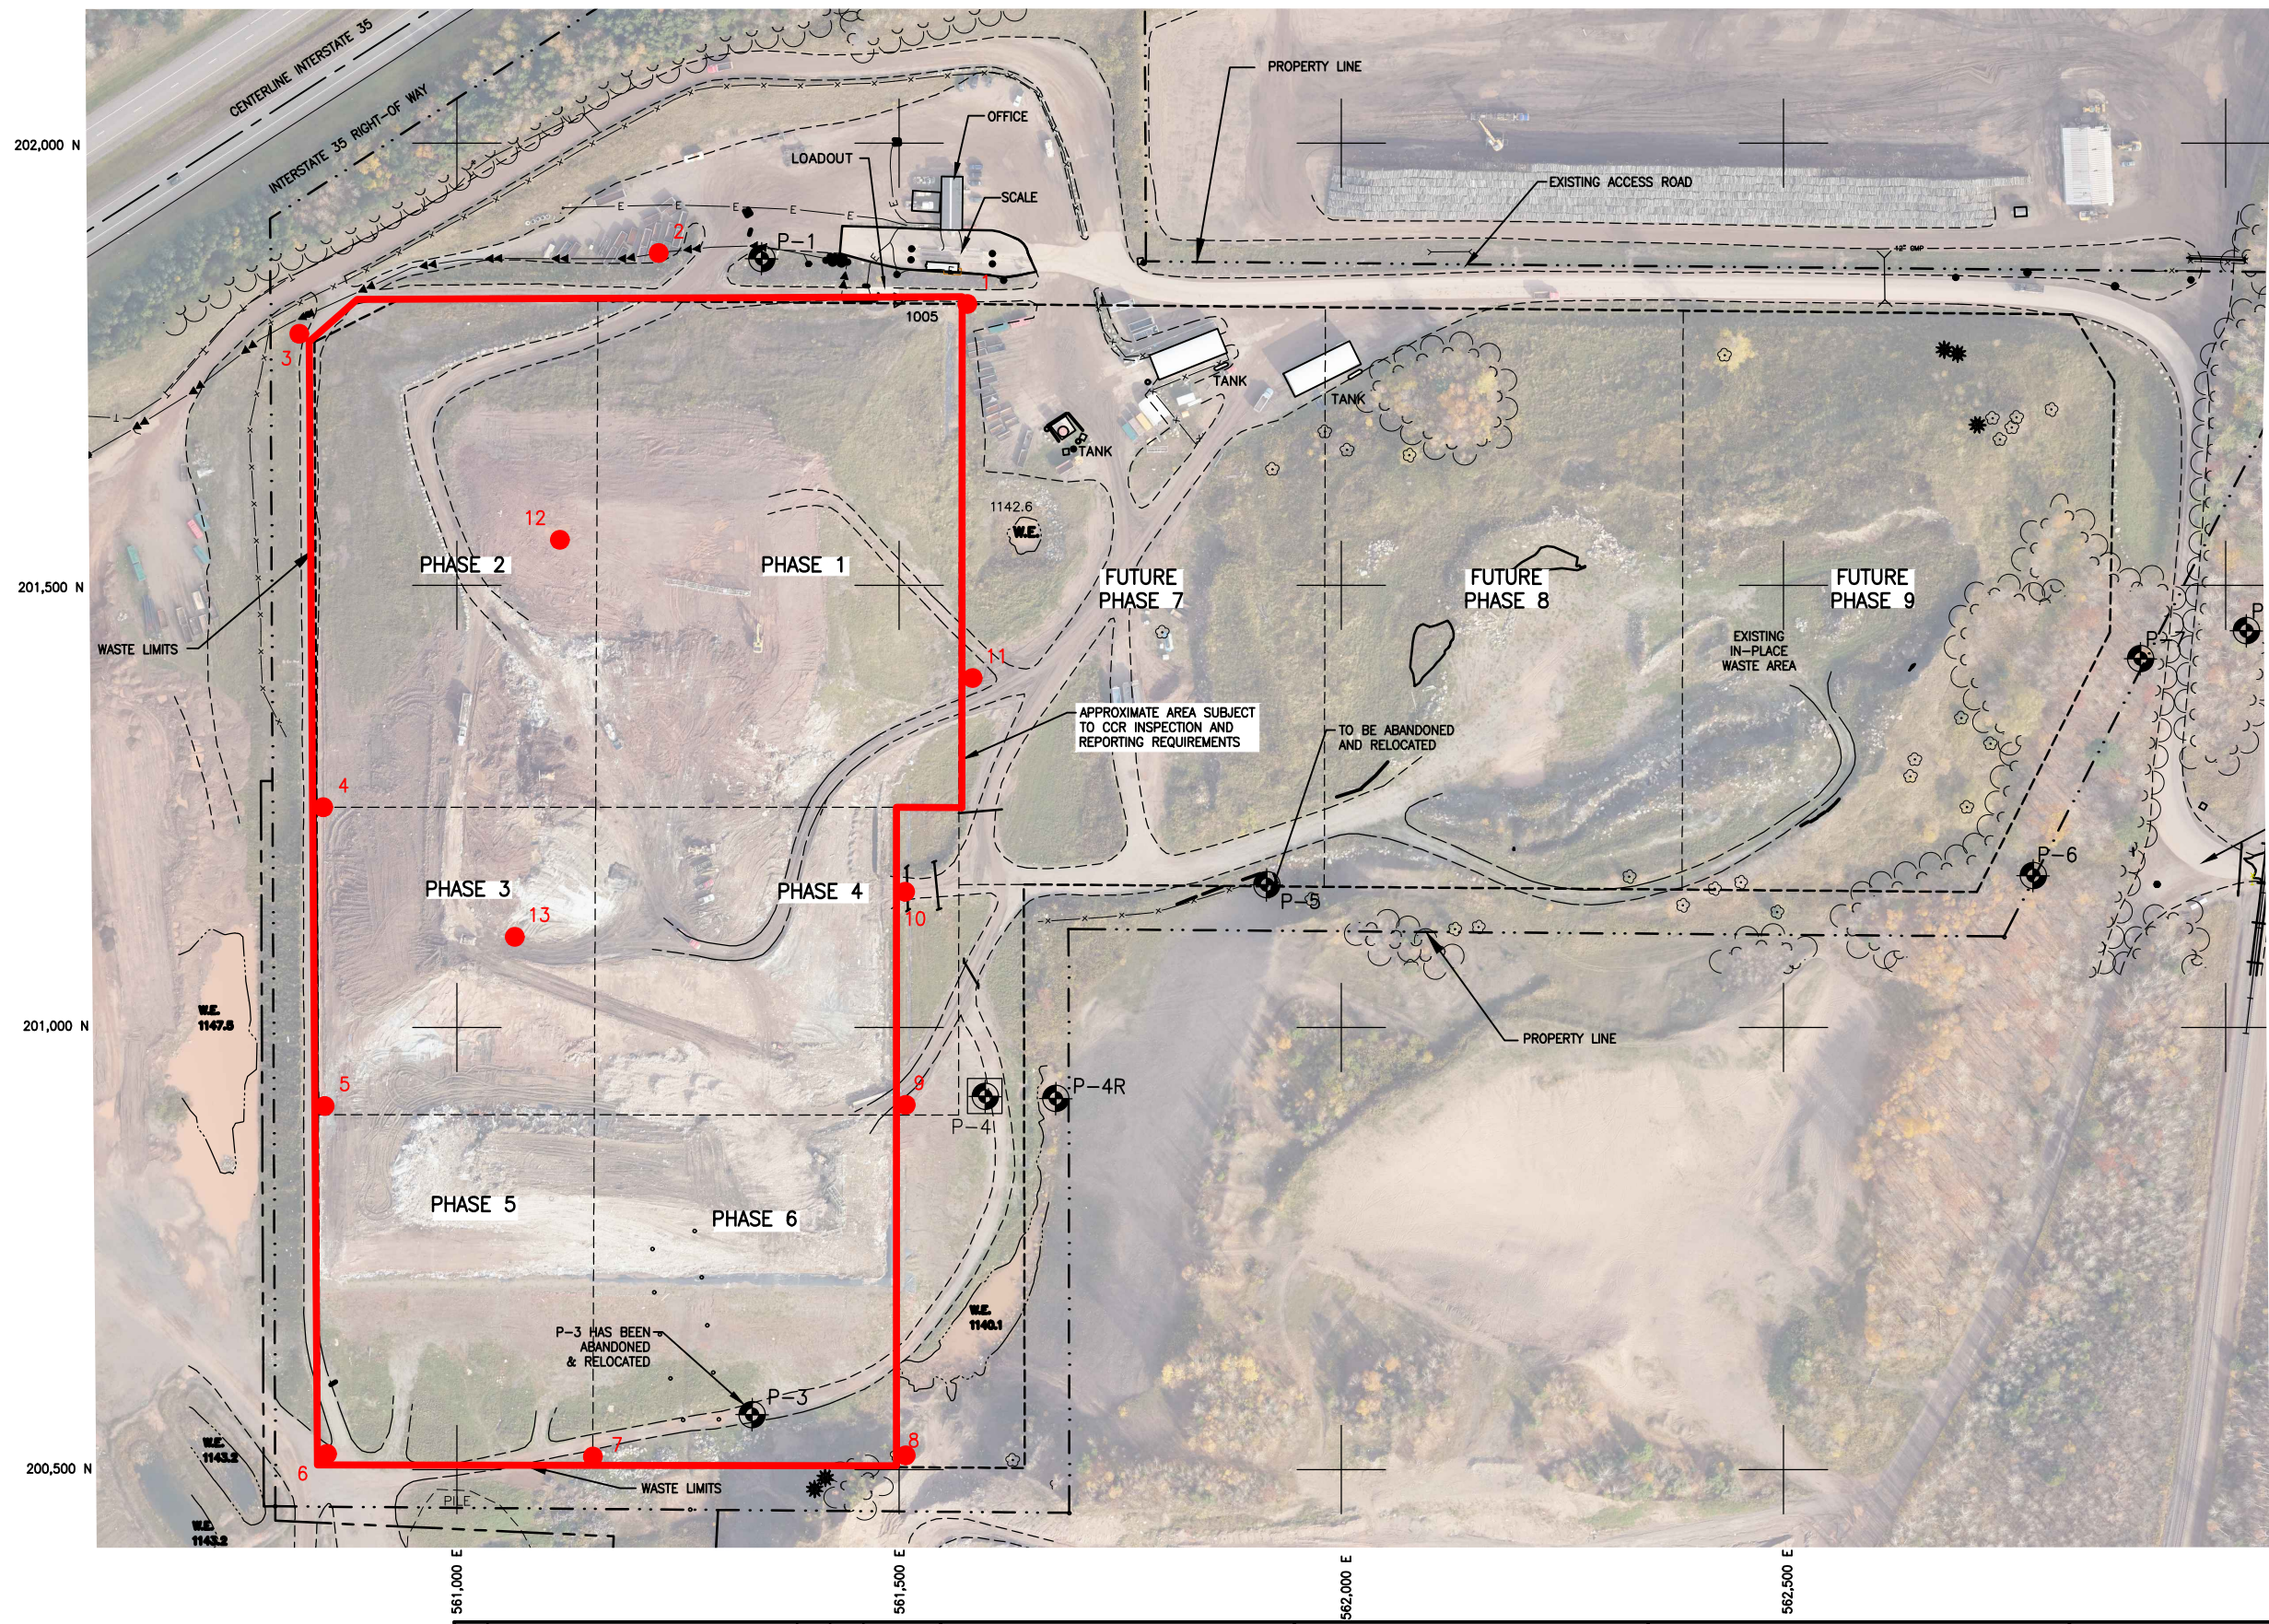
SHEET TITLE
PHOTO LOCATIONS

Photos were taken during the inspection. Figure 1 presents the photo locations, and Attachment 1 contains a photo log and the photos taken.

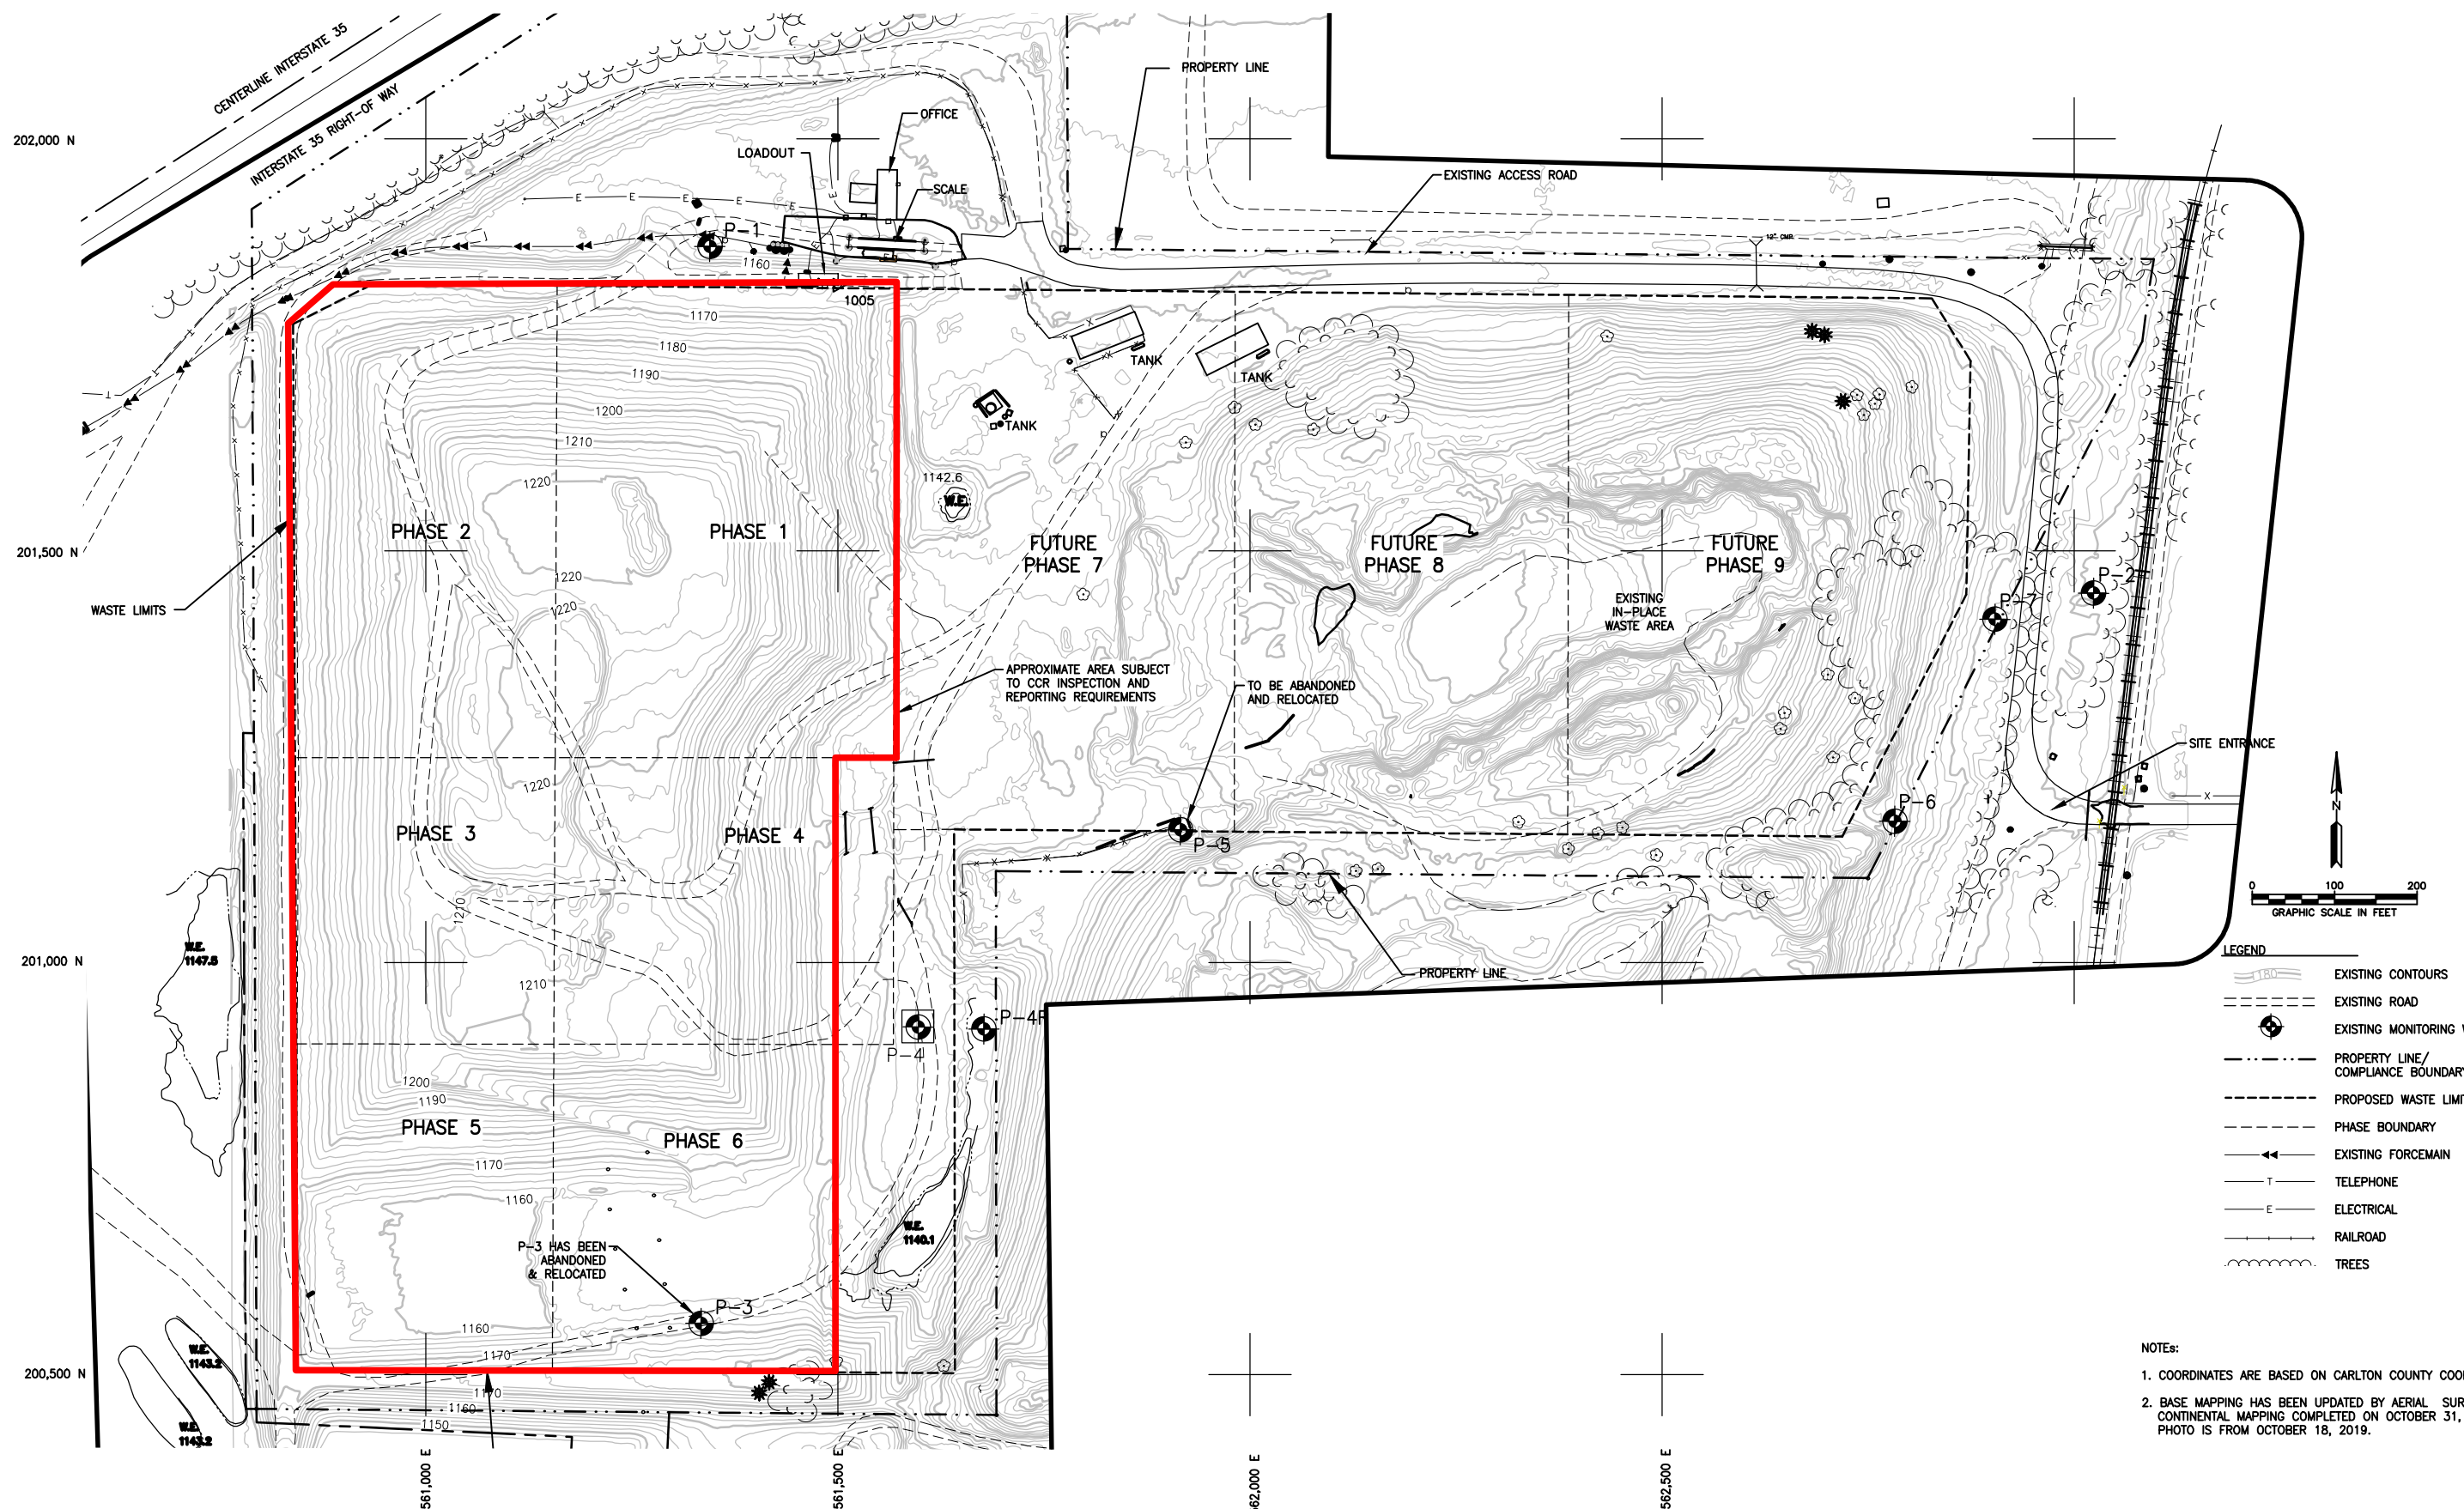
SHEET TITLE			
SITE MAP			
DWN BY	CHK'D	APP'D	DWG DATE
JJT	SH	TJS	JAN. 2021
SCALE		AS NOTED	
PROJECT NO.	SHEET NO.	REV NO.	
3053-20-519	FIGURE 2	0

Other than the construction of the remaining areas of Cell 5 and 6, there were no apparent changes to the embankment geometry of Cells 1 through 6 when compared to the permit drawings or the past inspection reports. The annual aerial photogrammetry survey was performed on October 31, 2020, which the estimated in-place volume is based on. A comparison 2020 and 2019 aerial survey confirm that the embankment and slope topography is substantially unchanged with no significant movement. The 2020 aerial survey is included as Figure 2.

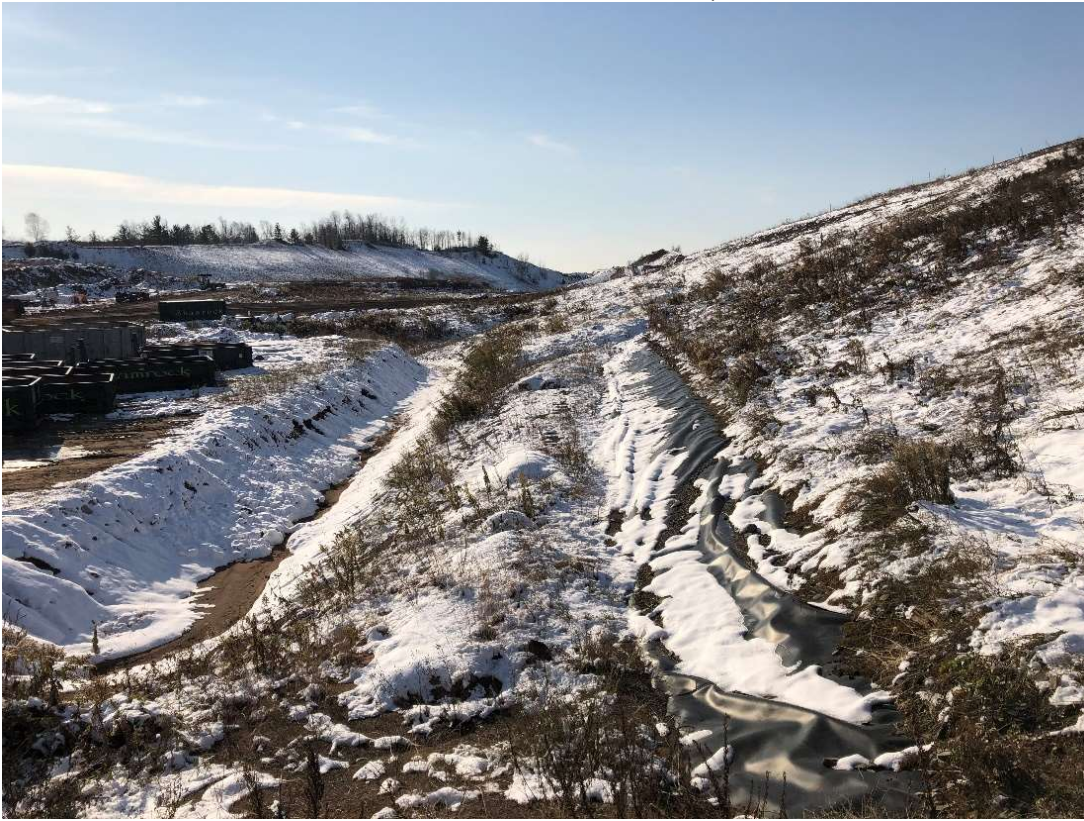
Location 1 – Looking South, Phase 1 Eastern Berm

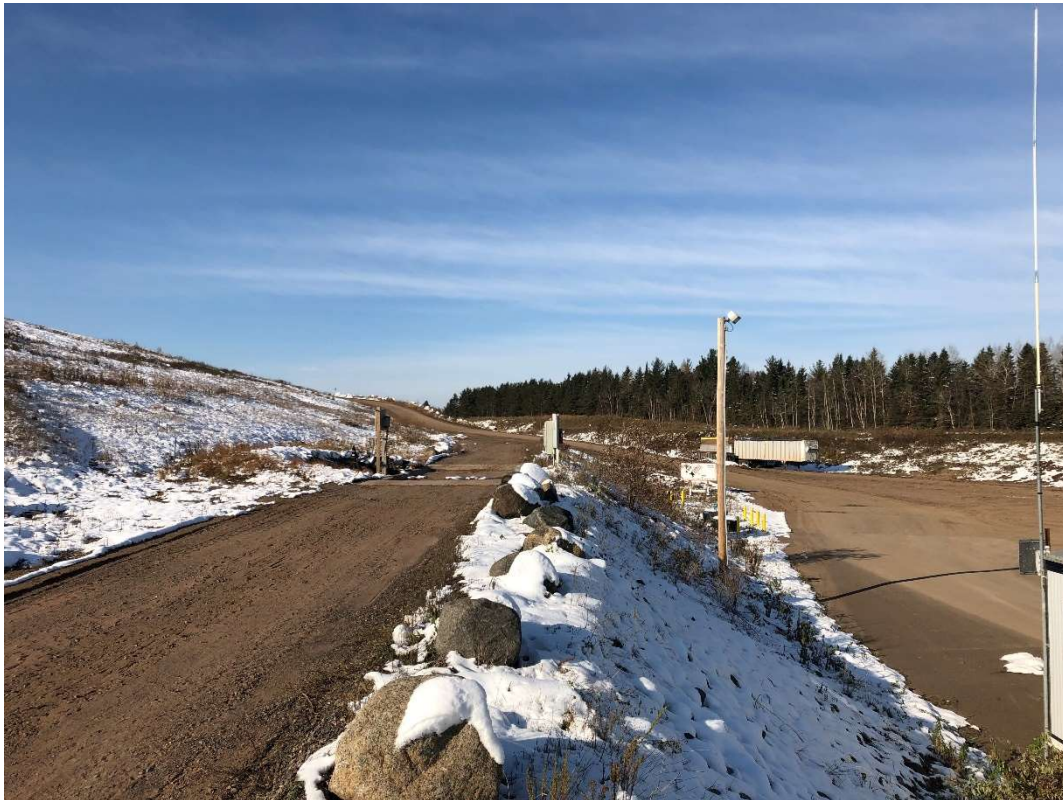
Location 1 – Looking West, Phase 1 Northern Berm

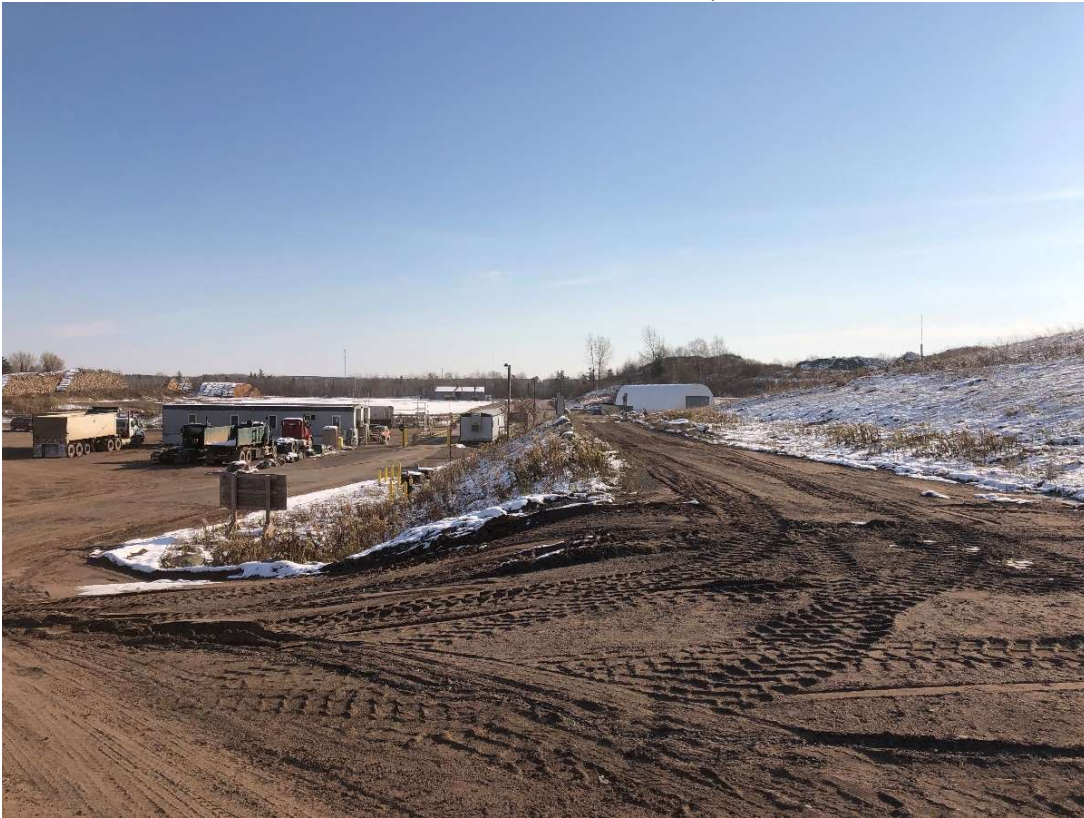
Location 2 – Looking East, Phase 1 Northern Waste Slope

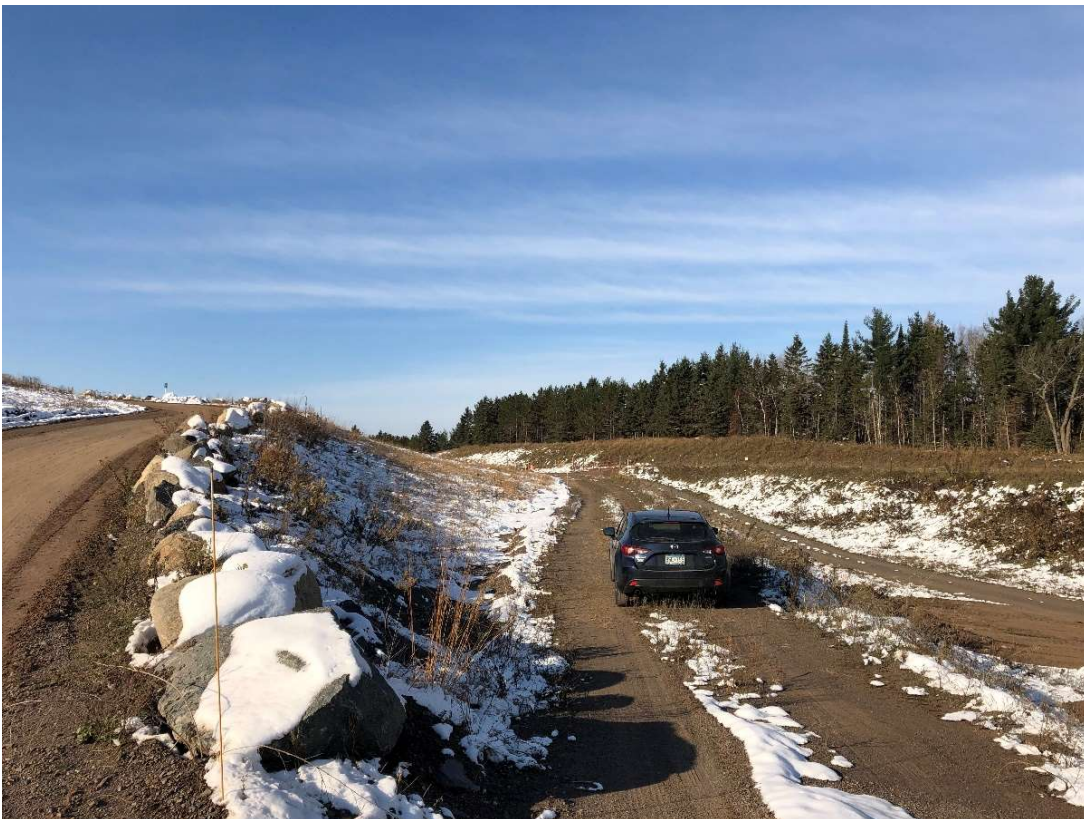
Location 2 – Looking West, Phase 2 Northern Waste Slope & Berm

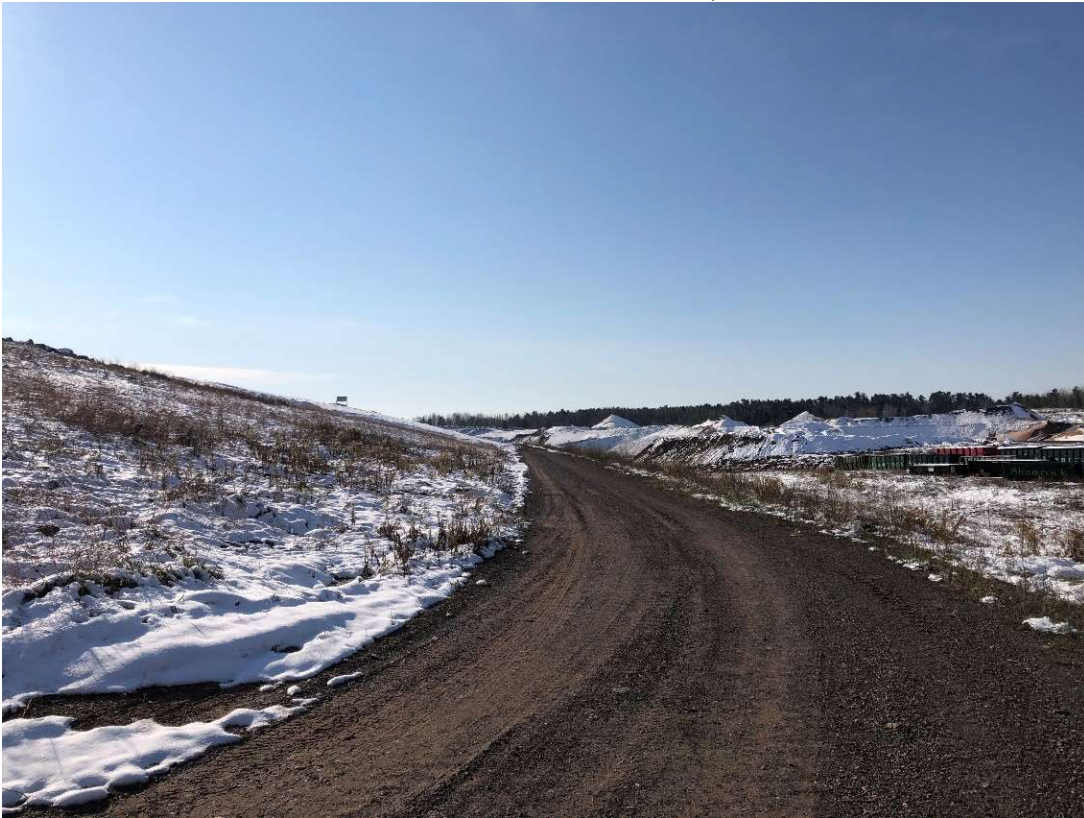
Location 3 – Looking South, Phase 2 Perimeter Road

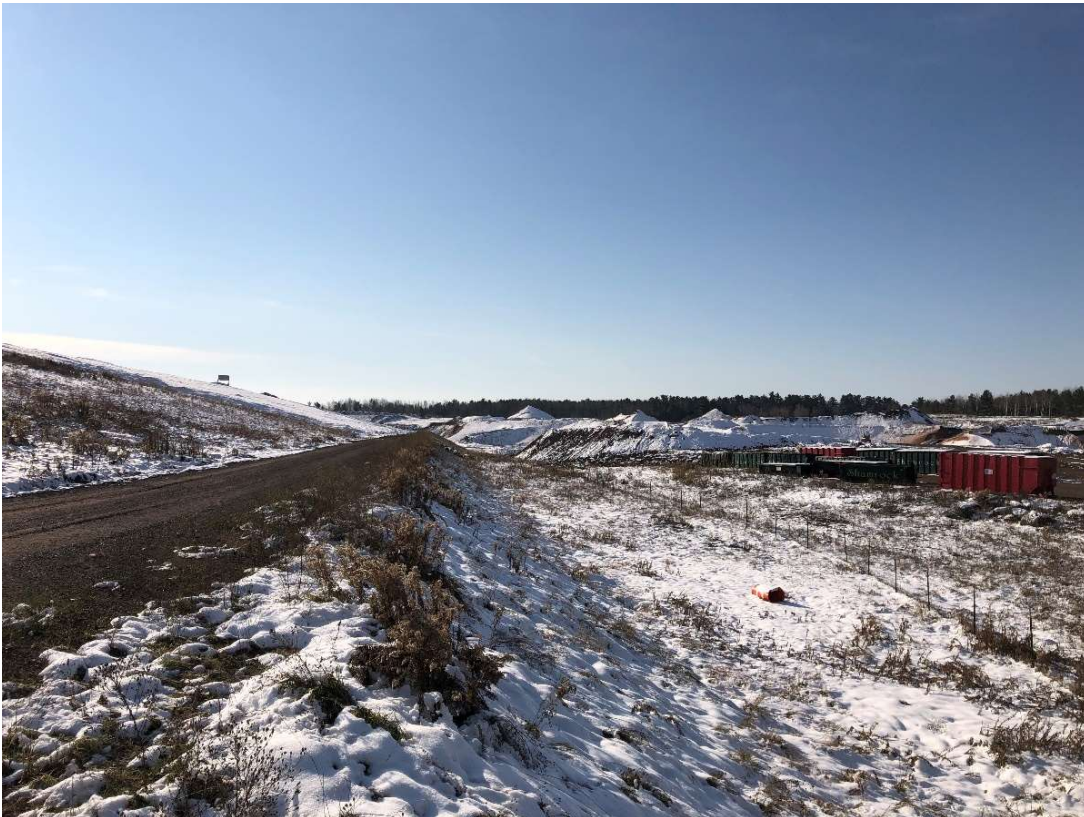
Location 3 – Looking South, Phase 2 Western Berm

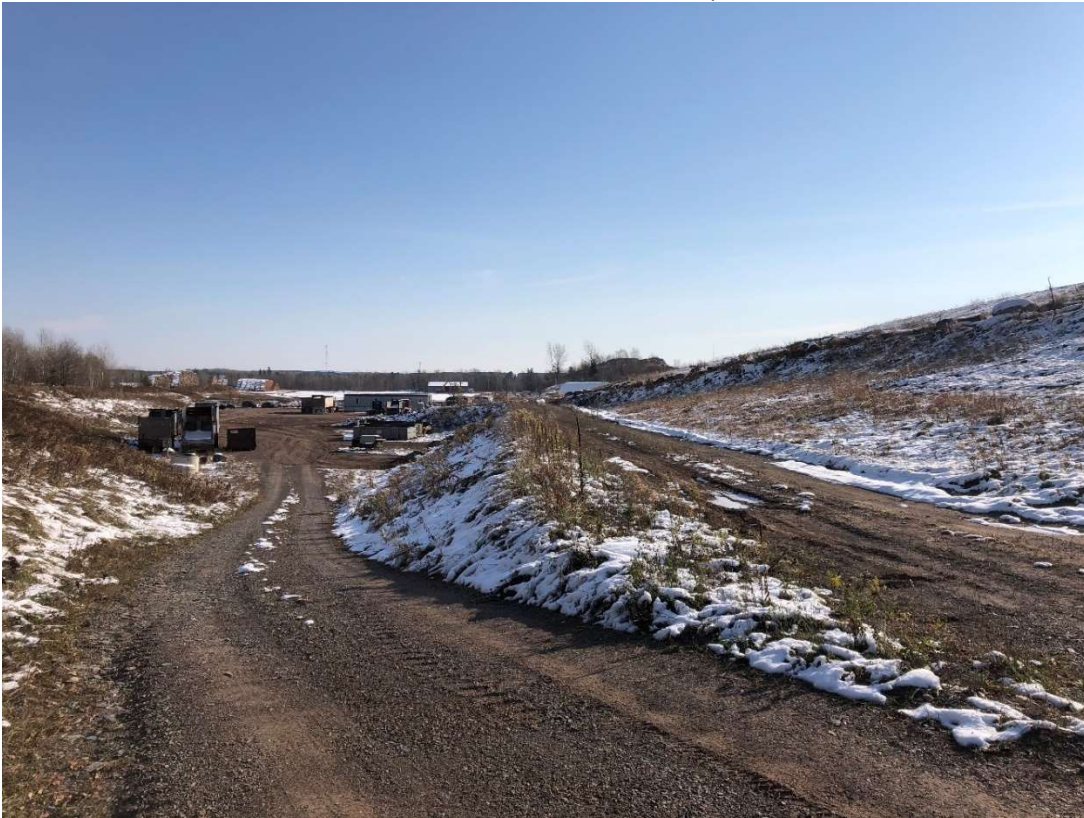
Location 3 – Looking East, Phase 2 Road & Berm

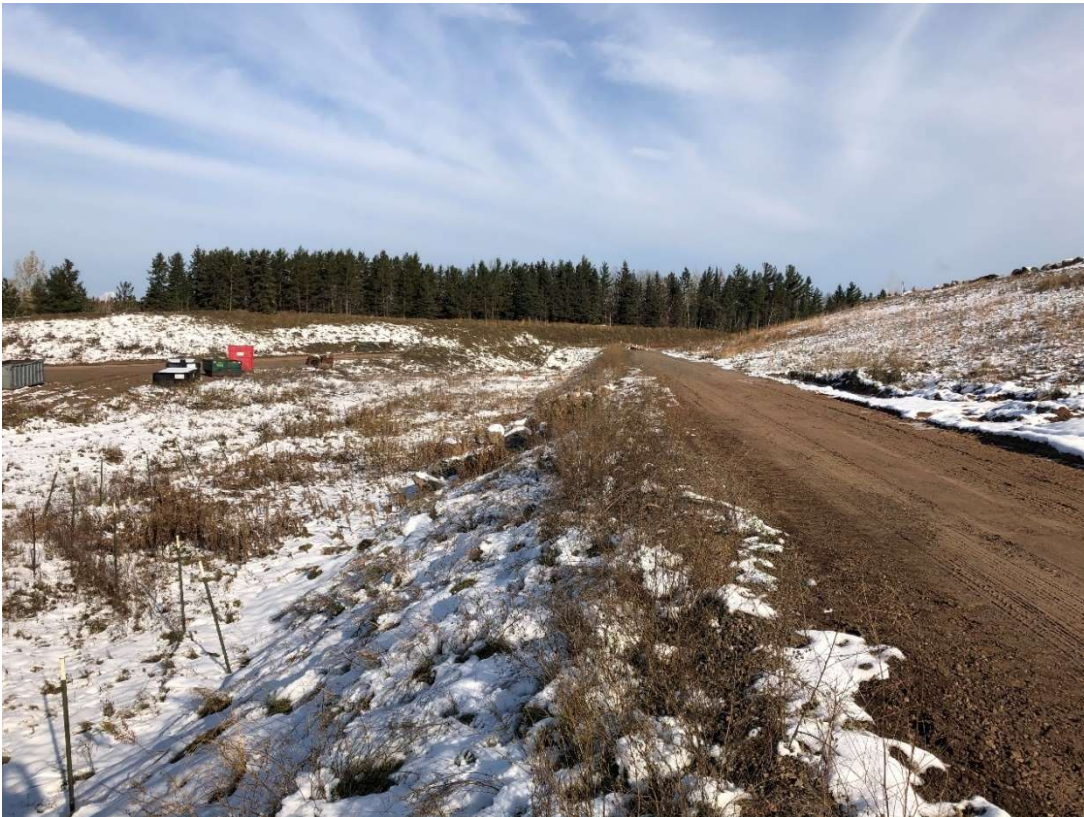
Location 4 – Looking North, Phase 2 Western Berm

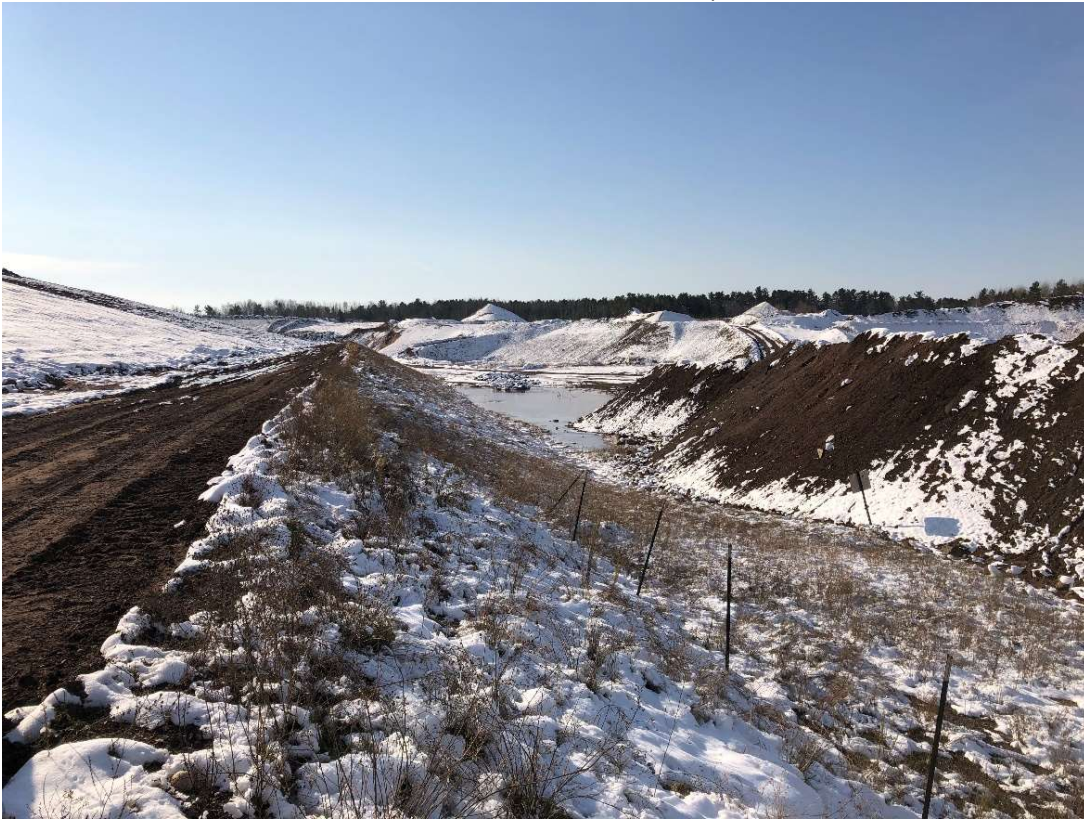
Location 4 – Looking South, Phase 3 Western Berm

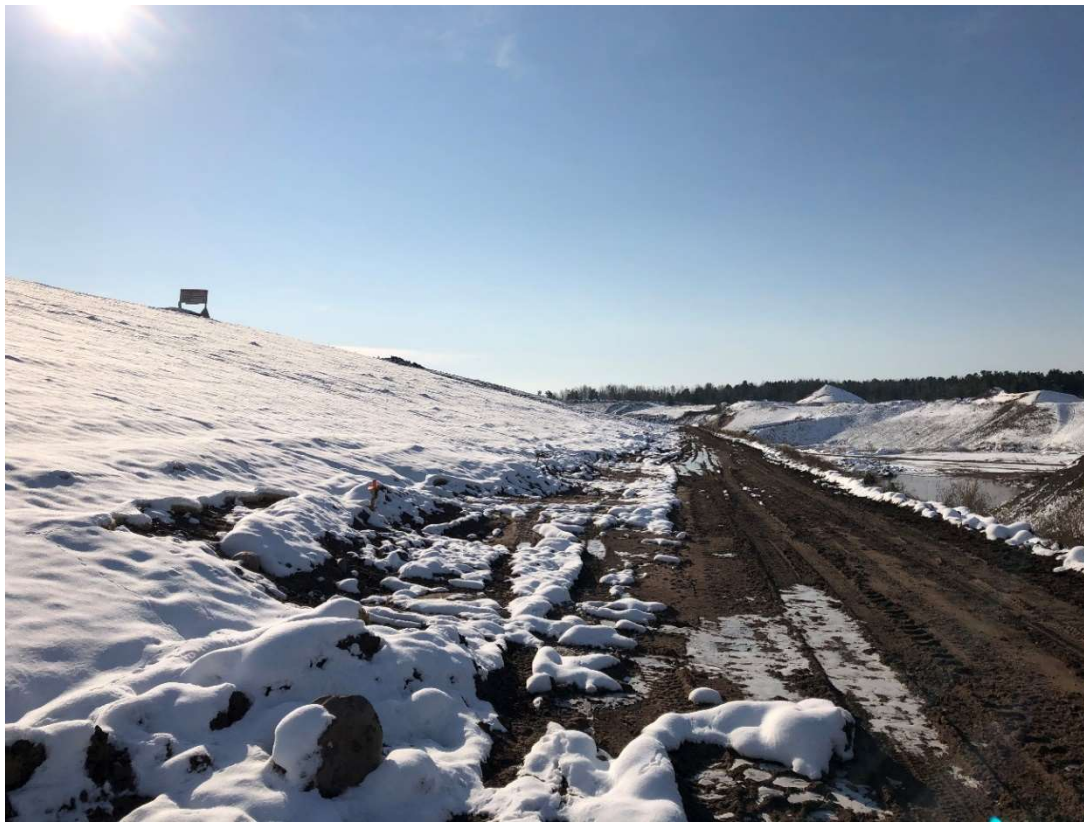
Location 4 – Looking South, Phase 3 Waste Slope

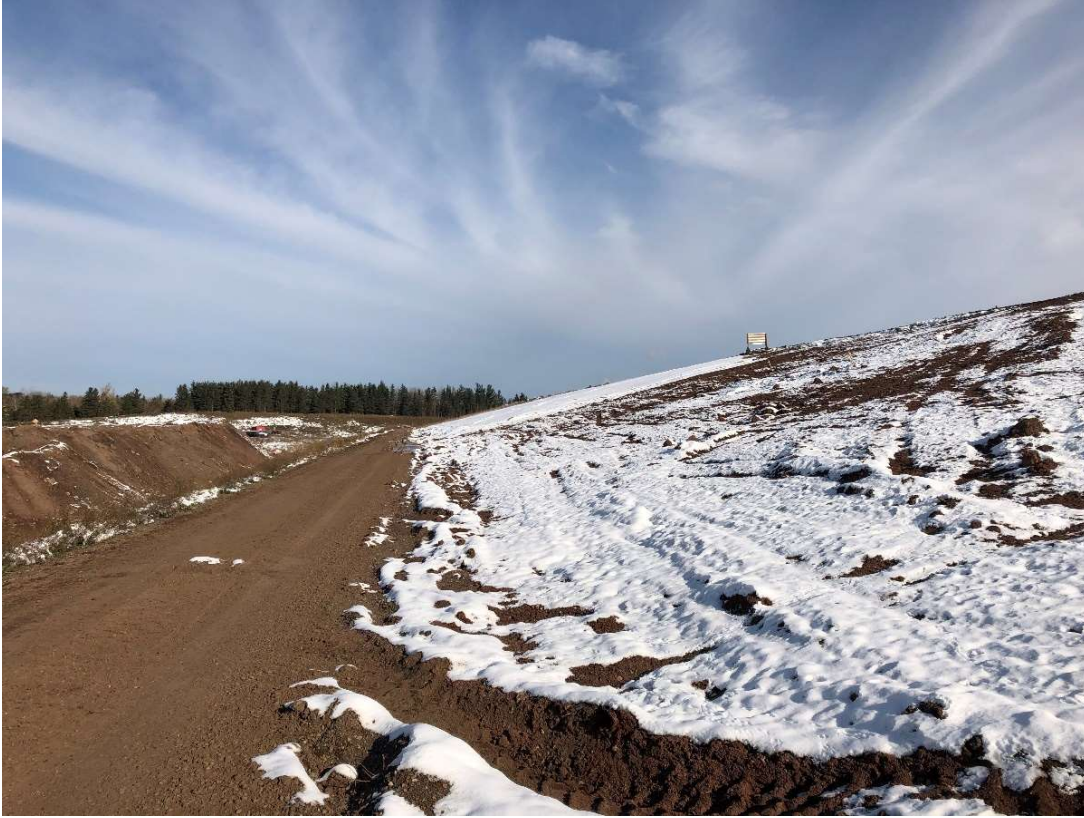
Location 5 – Looking North, Phase 3 Western Waste Slope

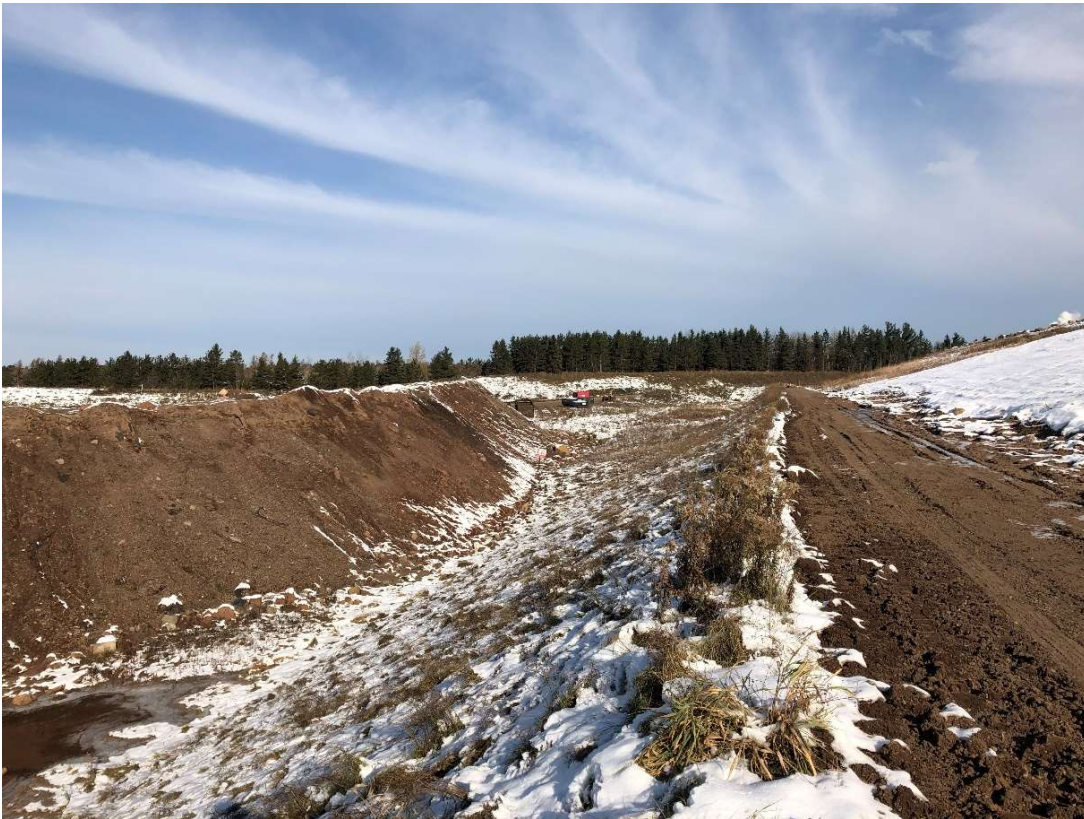
Location 5 – Looking North, Phase 3 LF Western Road

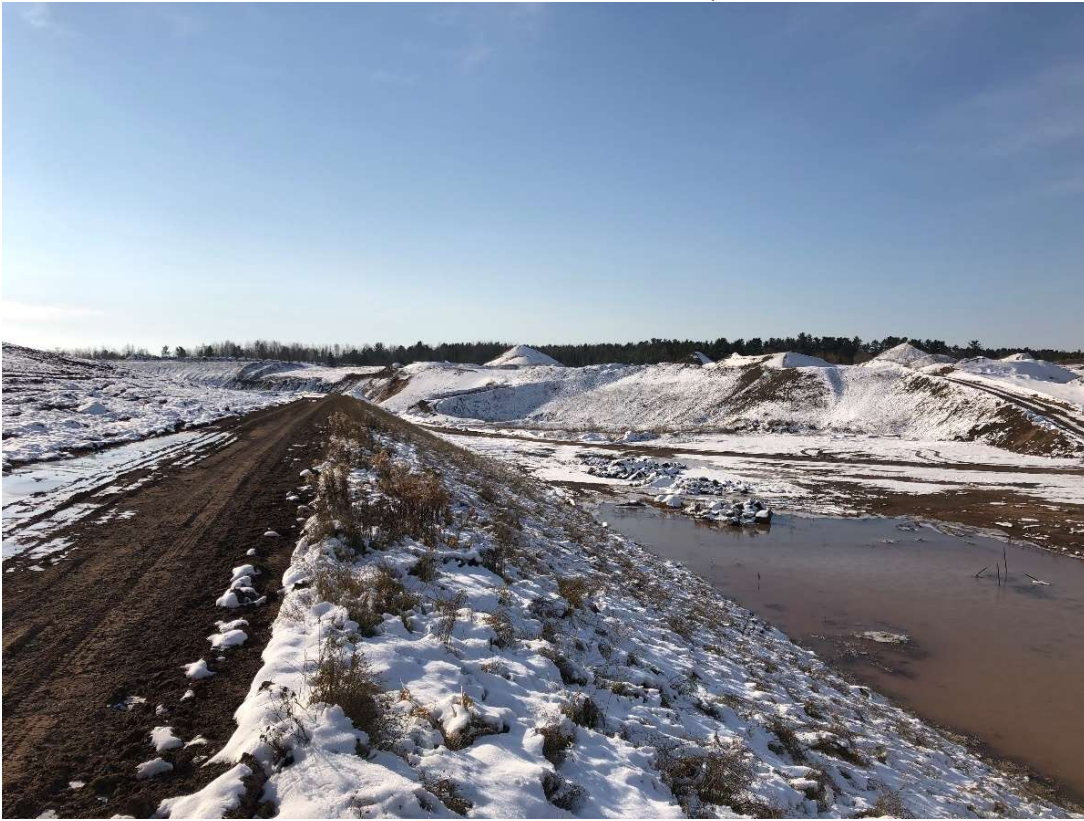
Location 5 – Looking South, Phase 6 Western LF Berm

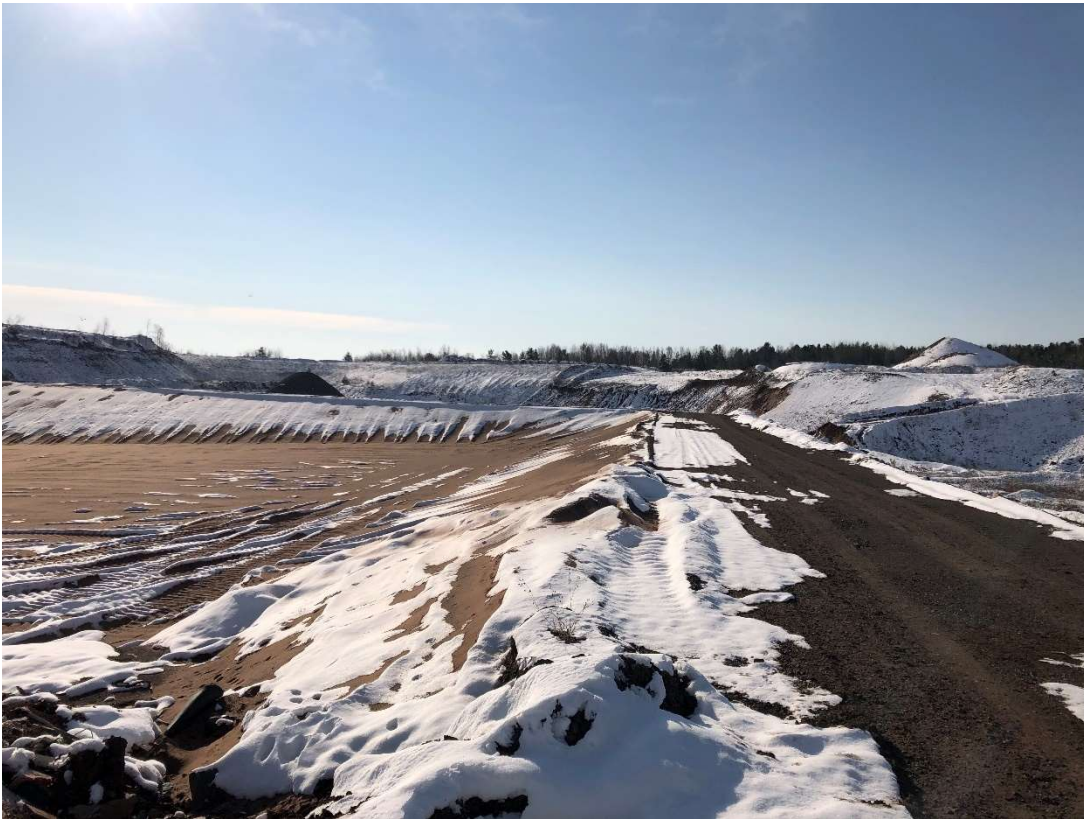
Location 5 – Looking South, Phase 5 Interior

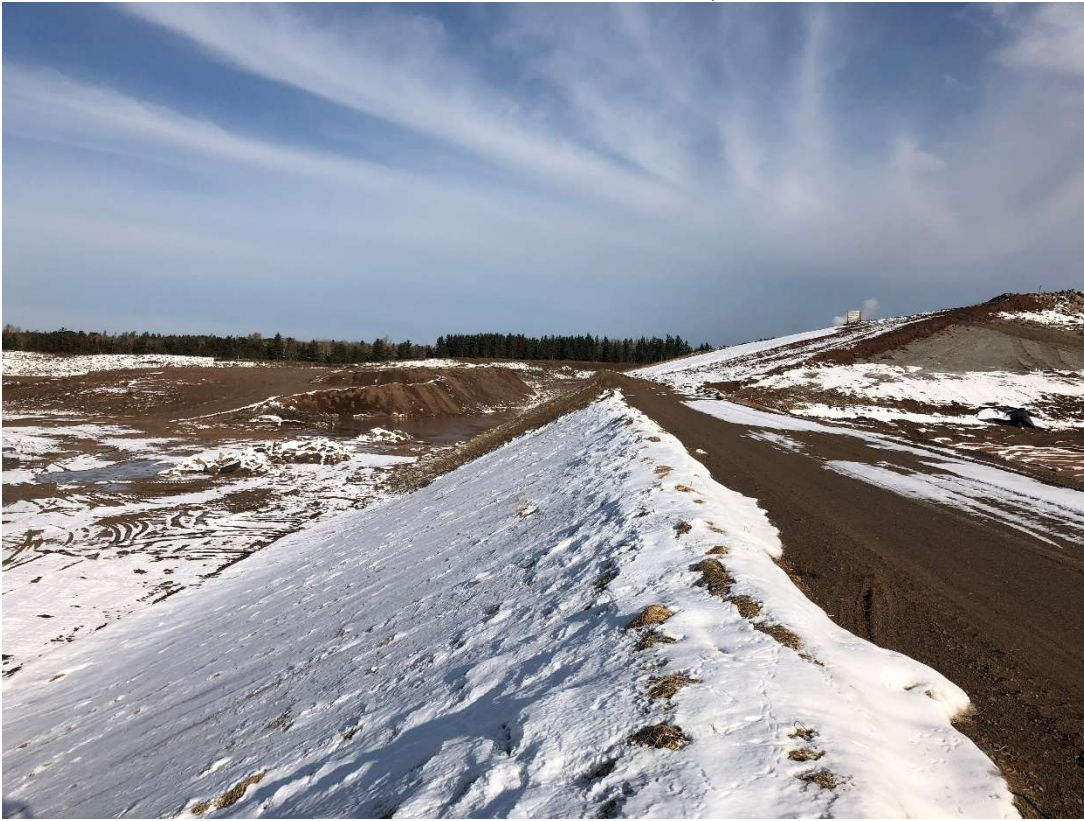
Location 6 – Looking North, Phase 6 Western LF Berm

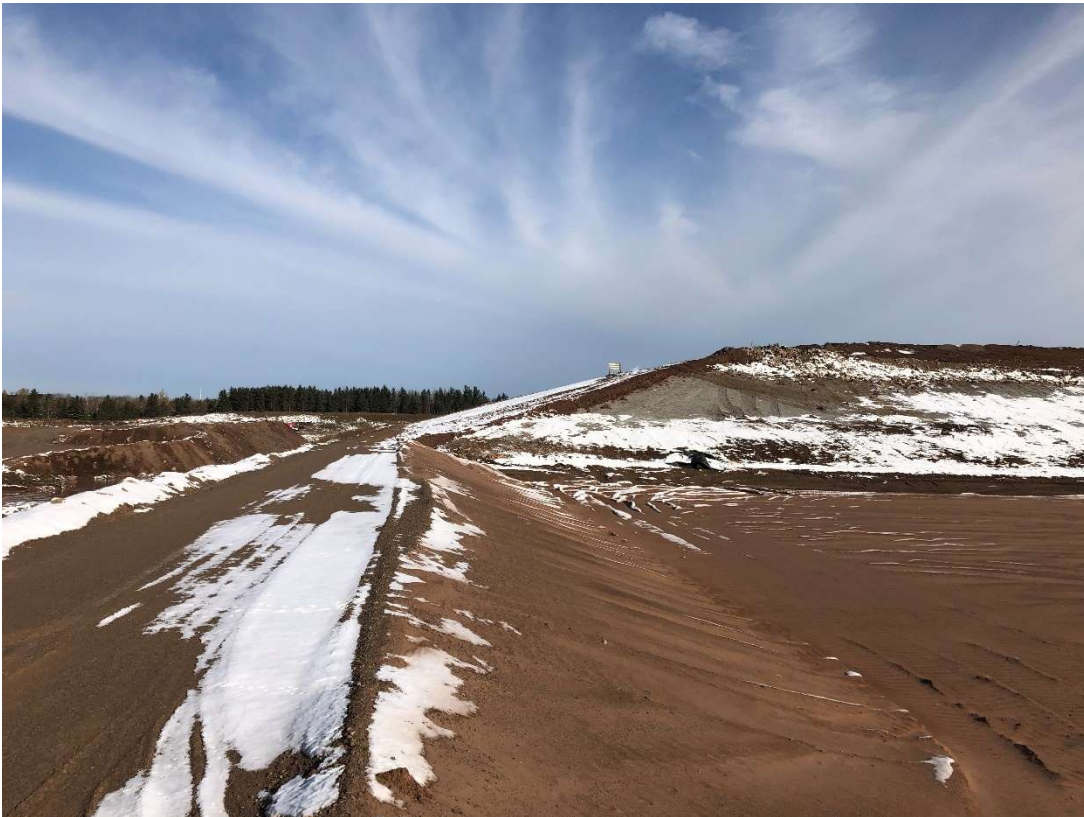
Location 6 – Looking North, Phase 6 Interior (Future Waste Slope)
