To:	Geoff Strack, PE, Waste Connections	From:	Bradley W Sullivan, PE, Stantec Consulting Services, Inc.
File:	Project #B3053-0519	Date:	January 9, 2021

Reference: SKB Environmental Cloquet Landfill, dba Shamrock Landfill, Inc. 2020 Annual CCR Inspection Report

CCR Landfill Inspection Report

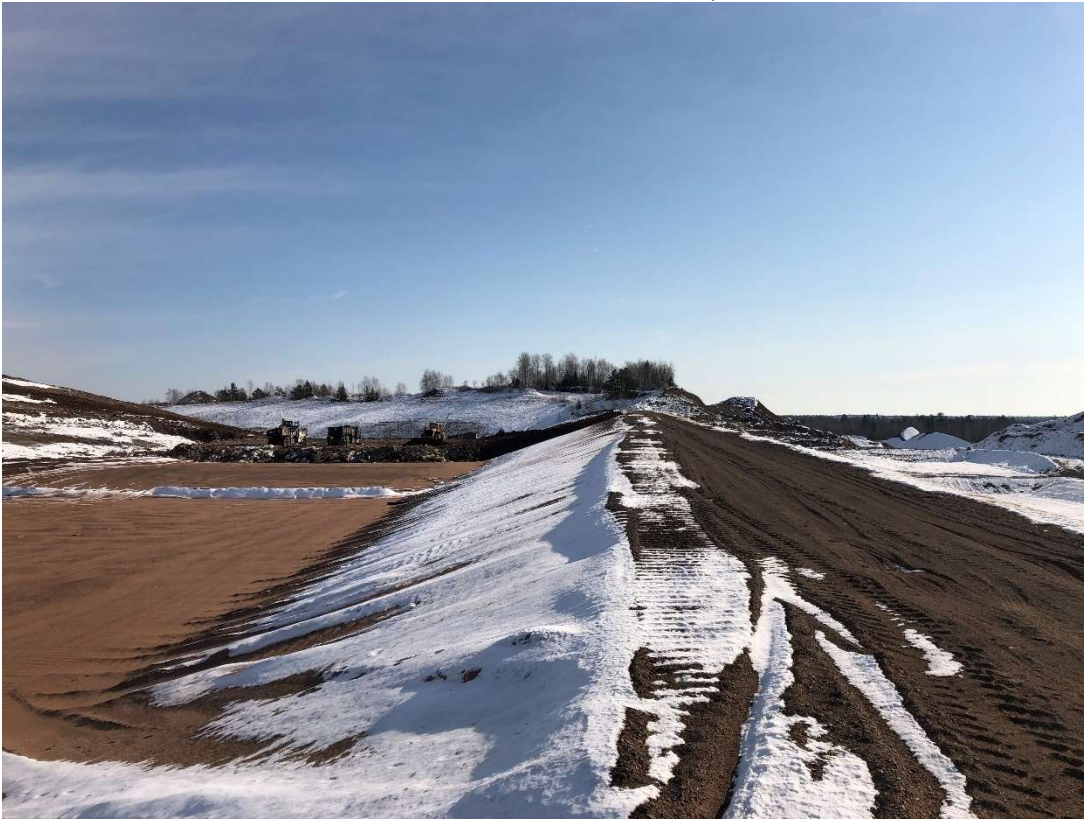
Location 6 – Looking East, Phase 5/6 Southern Anchor Trench

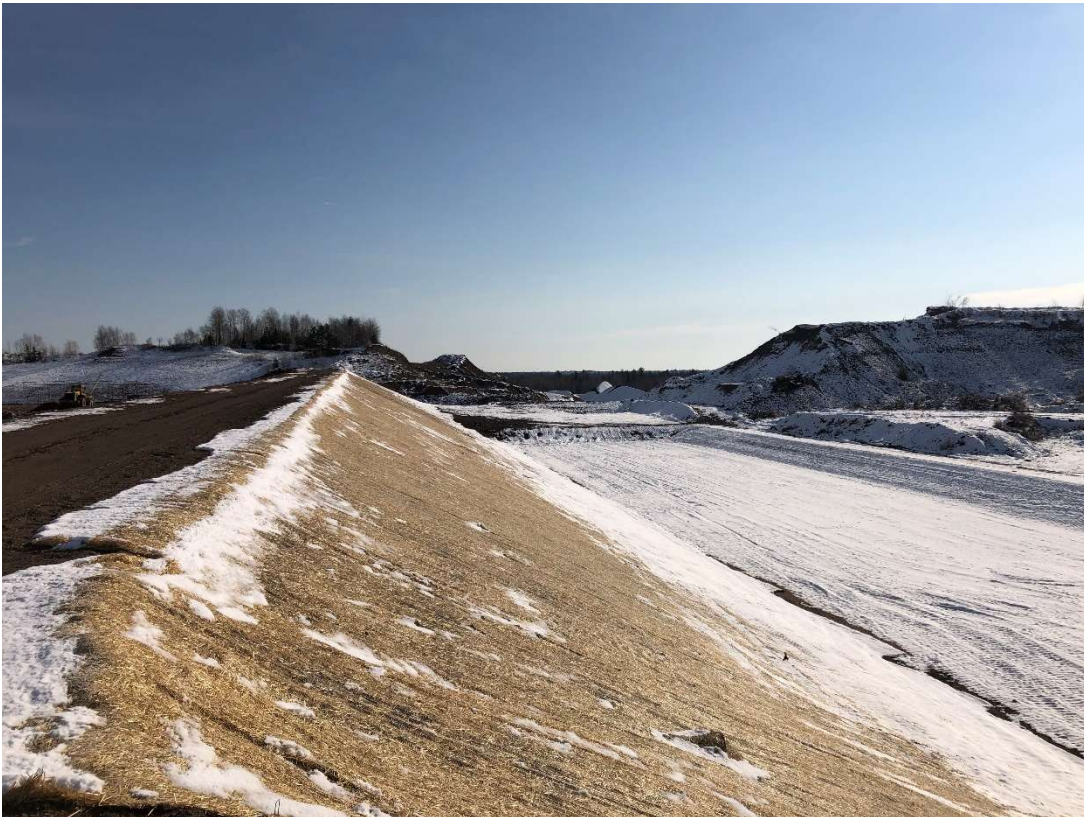
Location 6 – Looking East, Phase 5/6 Southern Berm

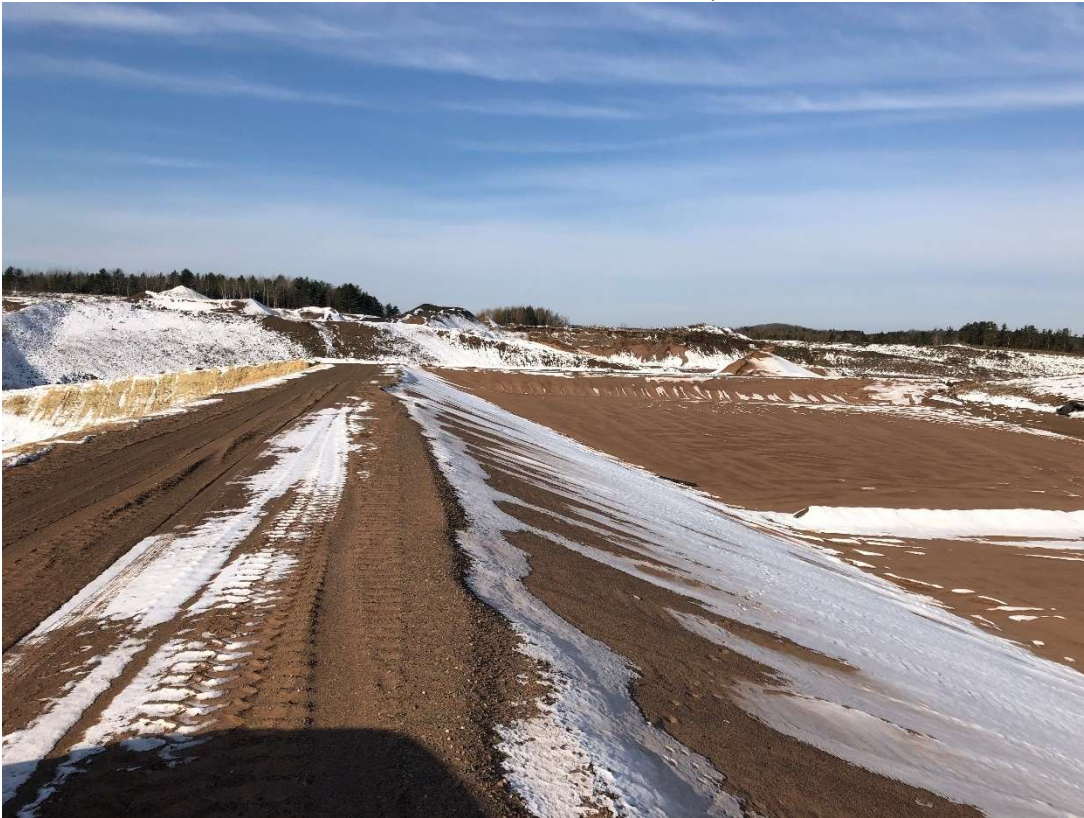
Location 7 – Looking West, Cell 5 Southern Anchor Trench

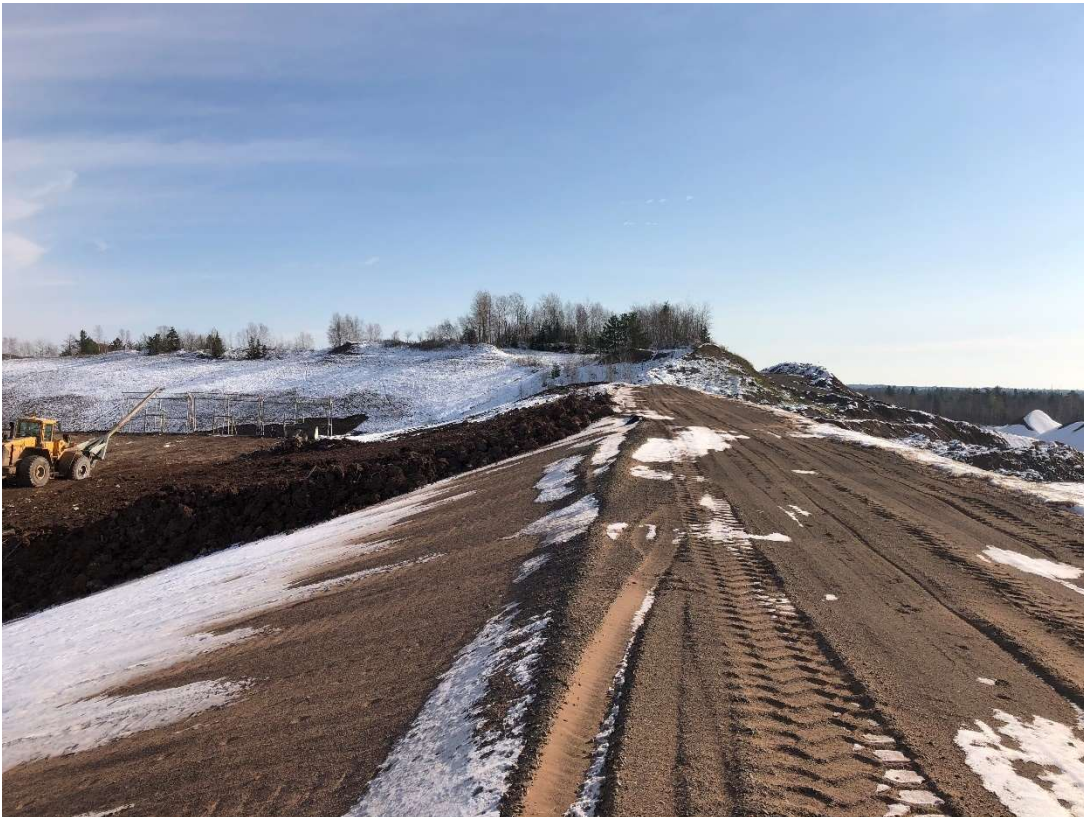
Location 7 – Looking East, Cell 6 Southern Anchor Trench

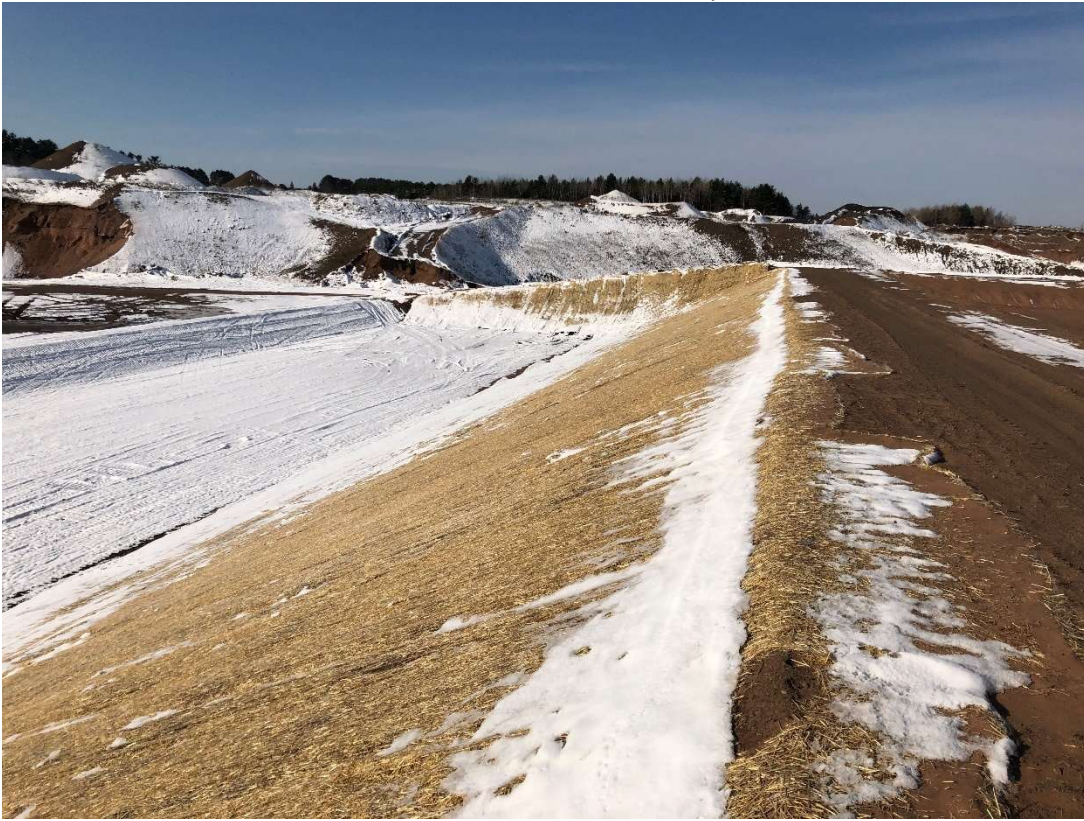
Location 7 – Looking West, Cell 5 Southern Berm

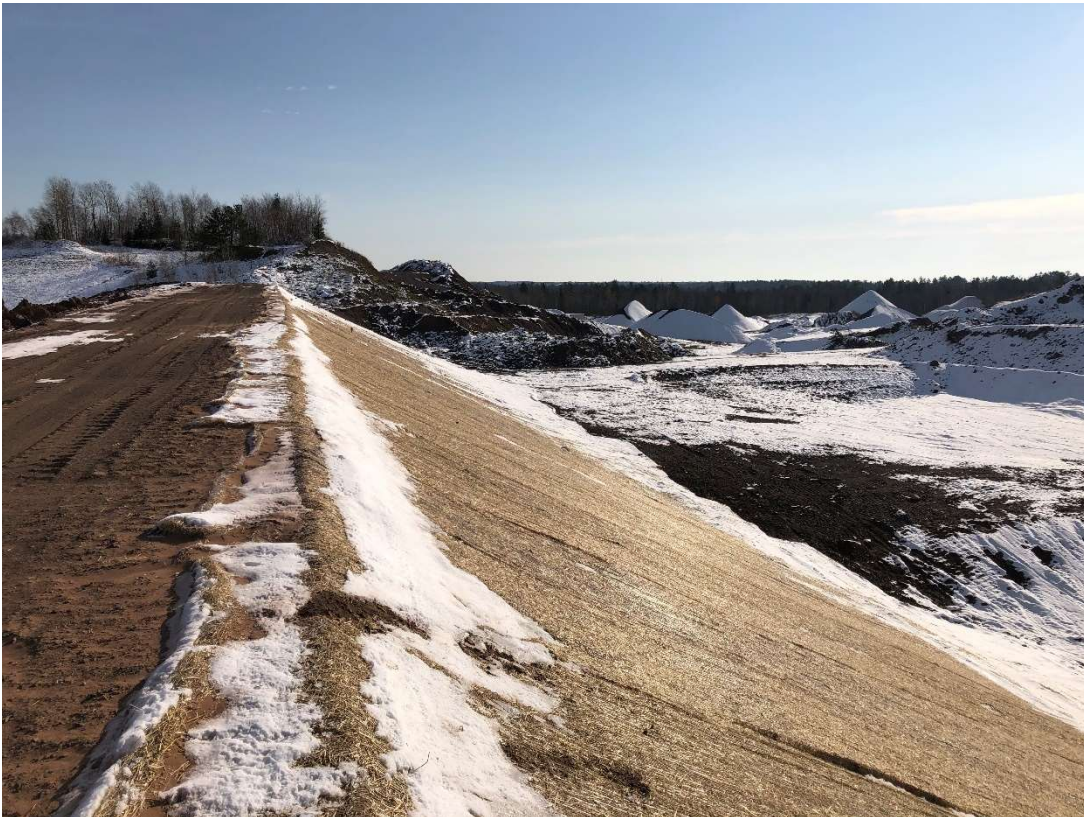
Location 7 – Looking East, Cell 6 Southern Berm

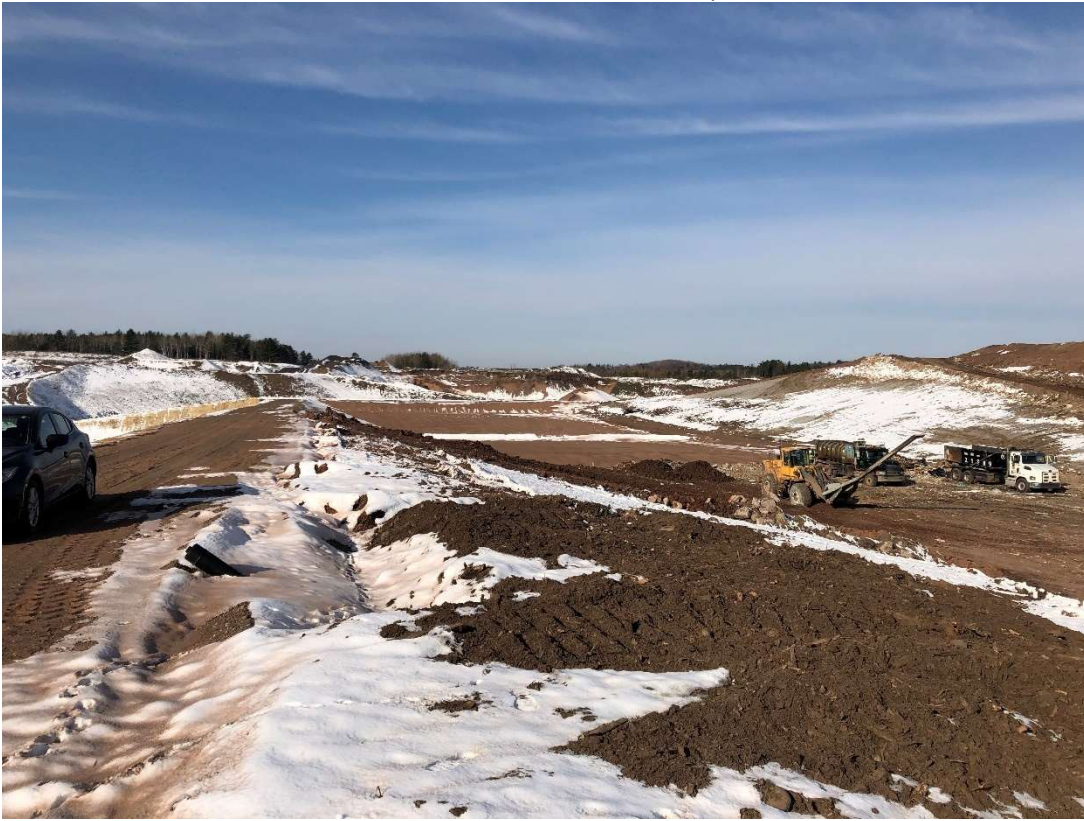
Location 8 – Looking West, Cell 6 Southern Anchor Trench

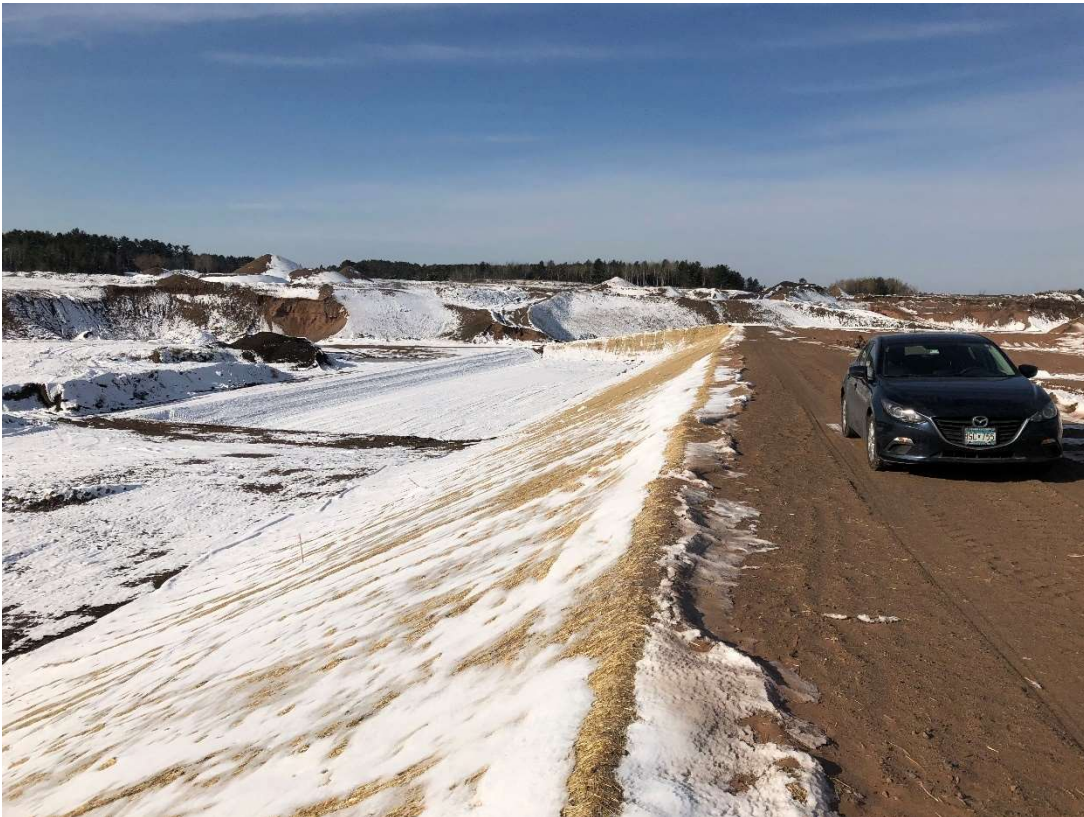
Location 8 – Looking West, Cell 6 Southern Berm

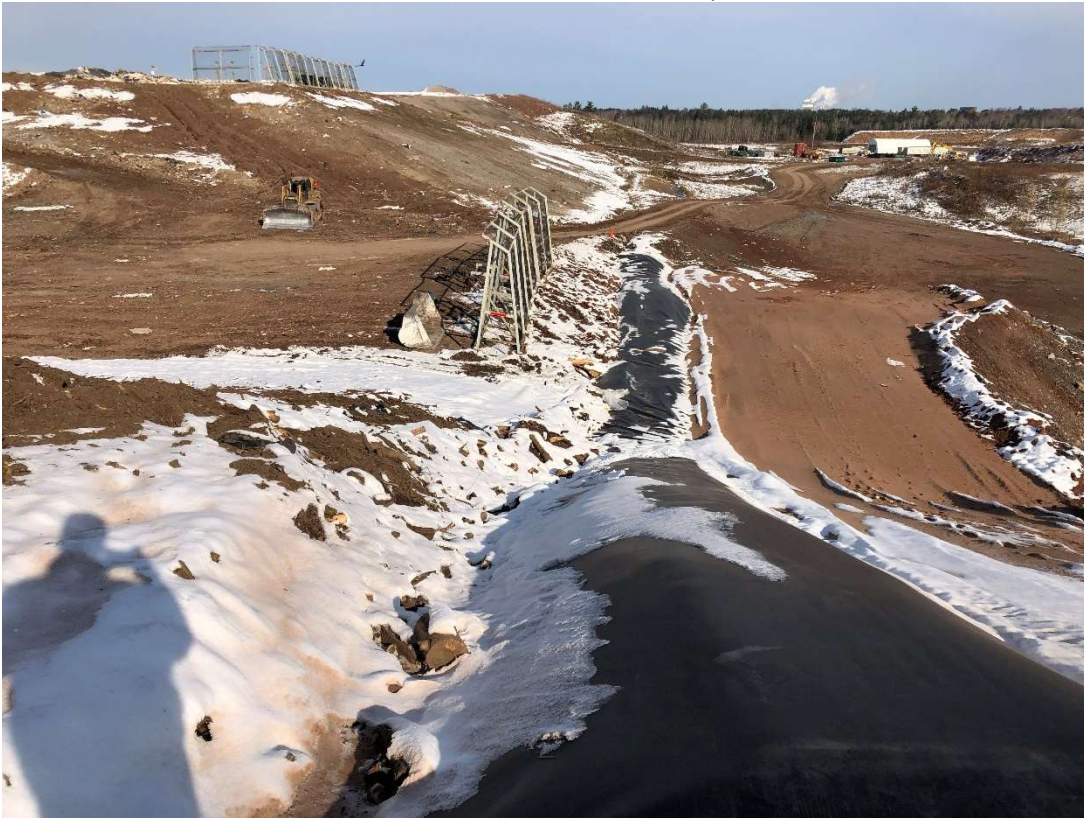
Location 8 – Looking North, Cell 6 Eastern Anchor Trench

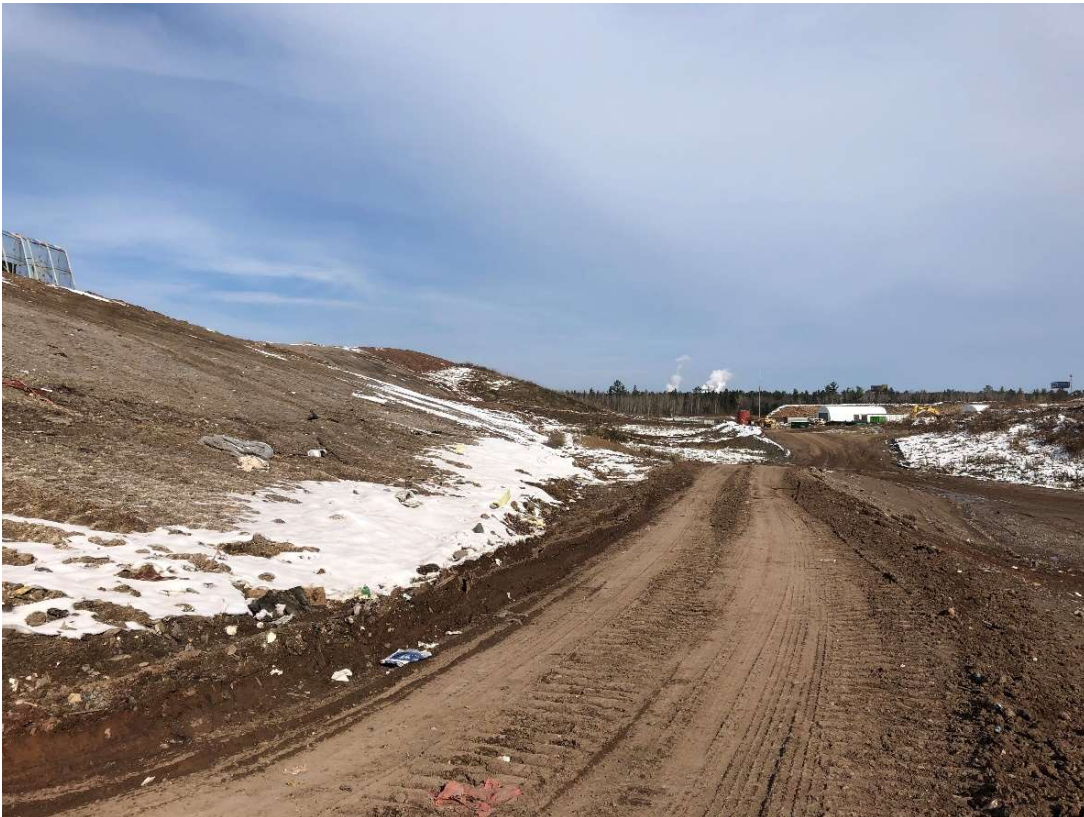
Location 9 – Looking North, Phase 4 Eastern LF Berm and Waste Slope

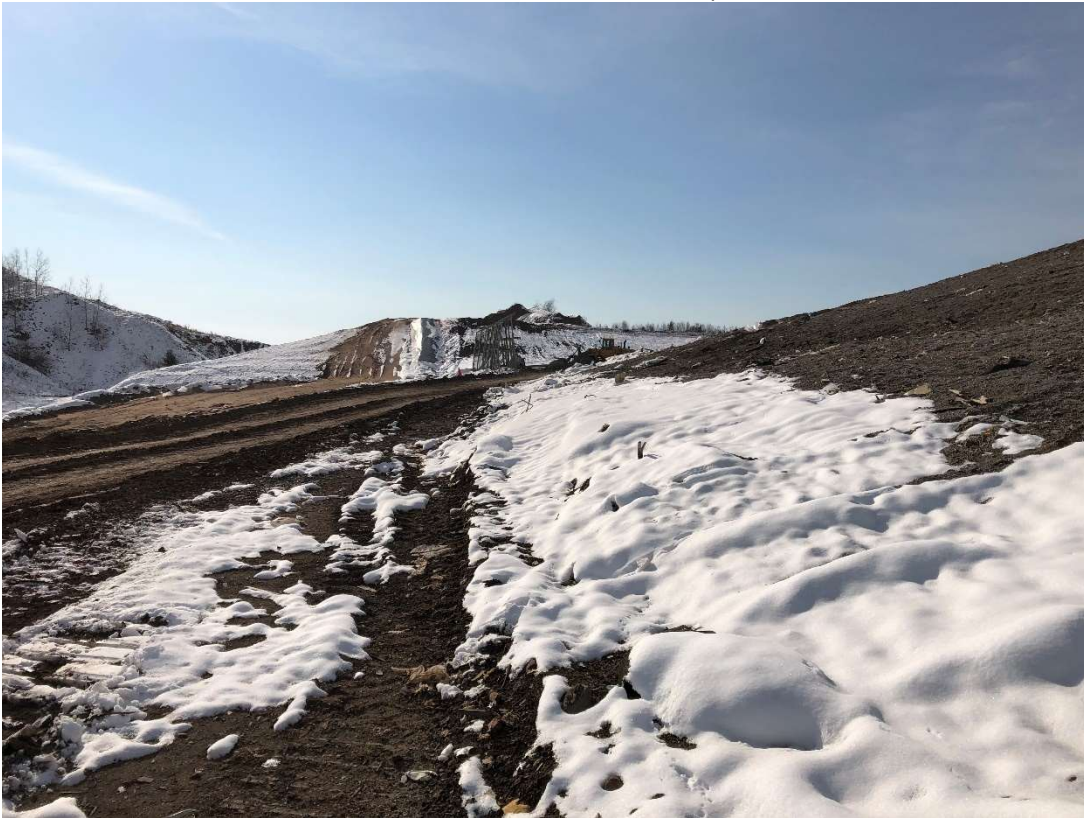
Location 9 – Looking South, Cell 6 Eastern Anchor Trench

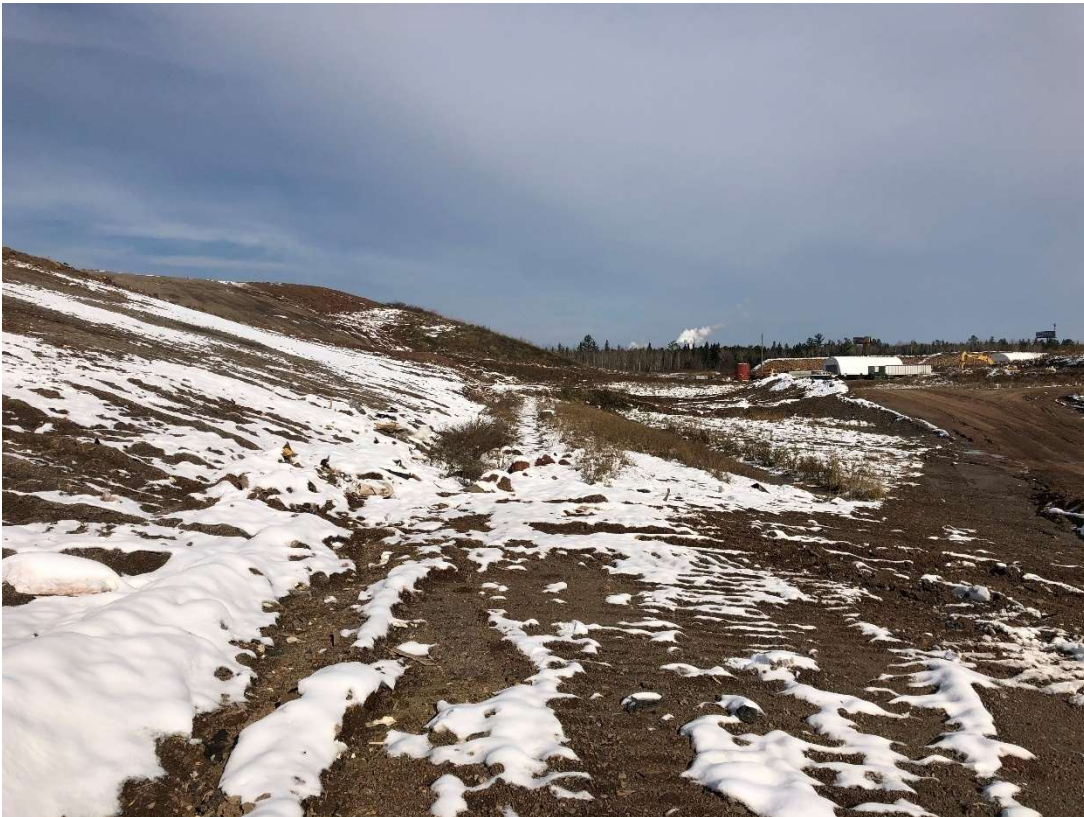
Location 9 – Looking North, Cell 6 Eastern Anchor Trench

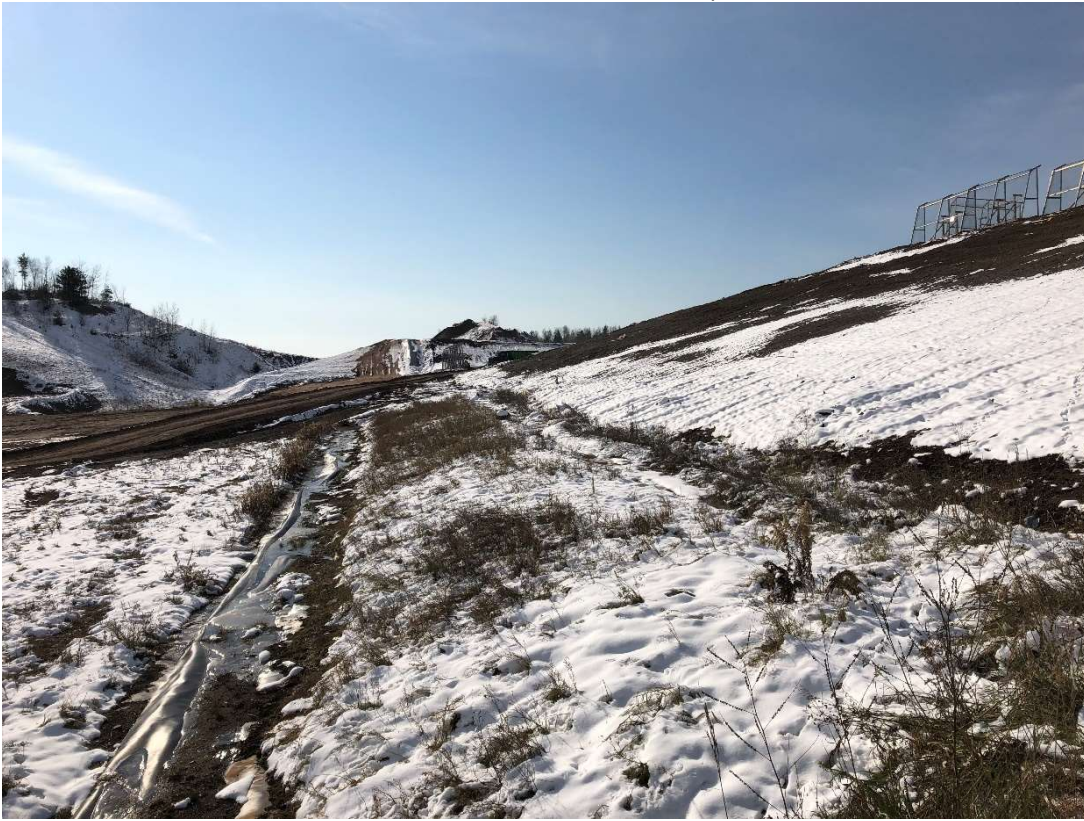
Location 10 – Looking South, Phase 4 Eastern Berm and Waste Slope

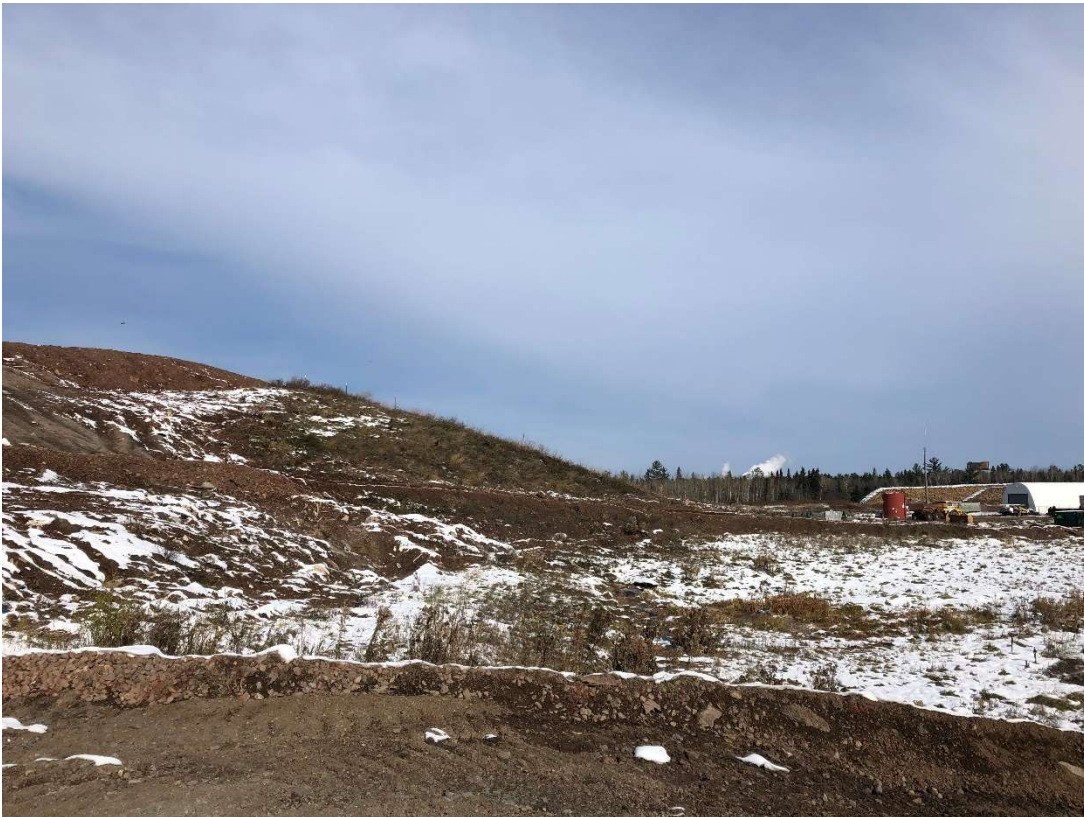
Location 10 – Looking North, Phase 4 Eastern Berm & Phase 1 Southeast Corner

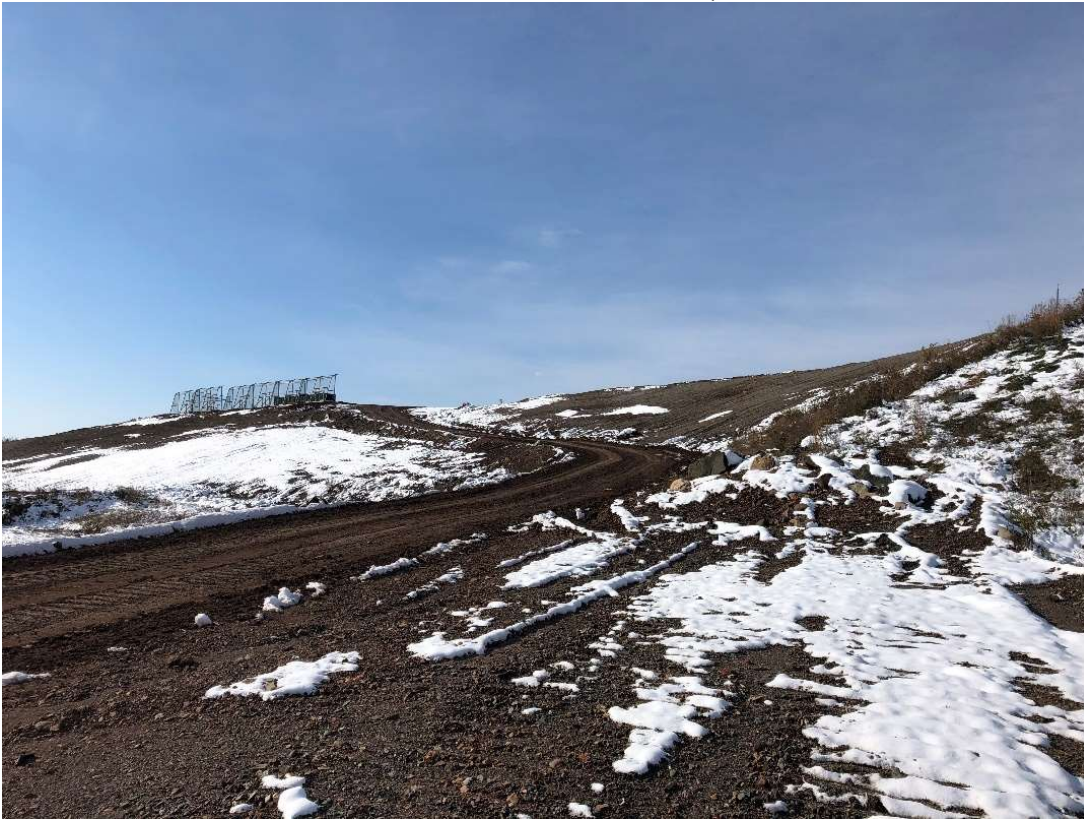
Location 11 – Looking Southwest, Phase 1 Southern Access Road

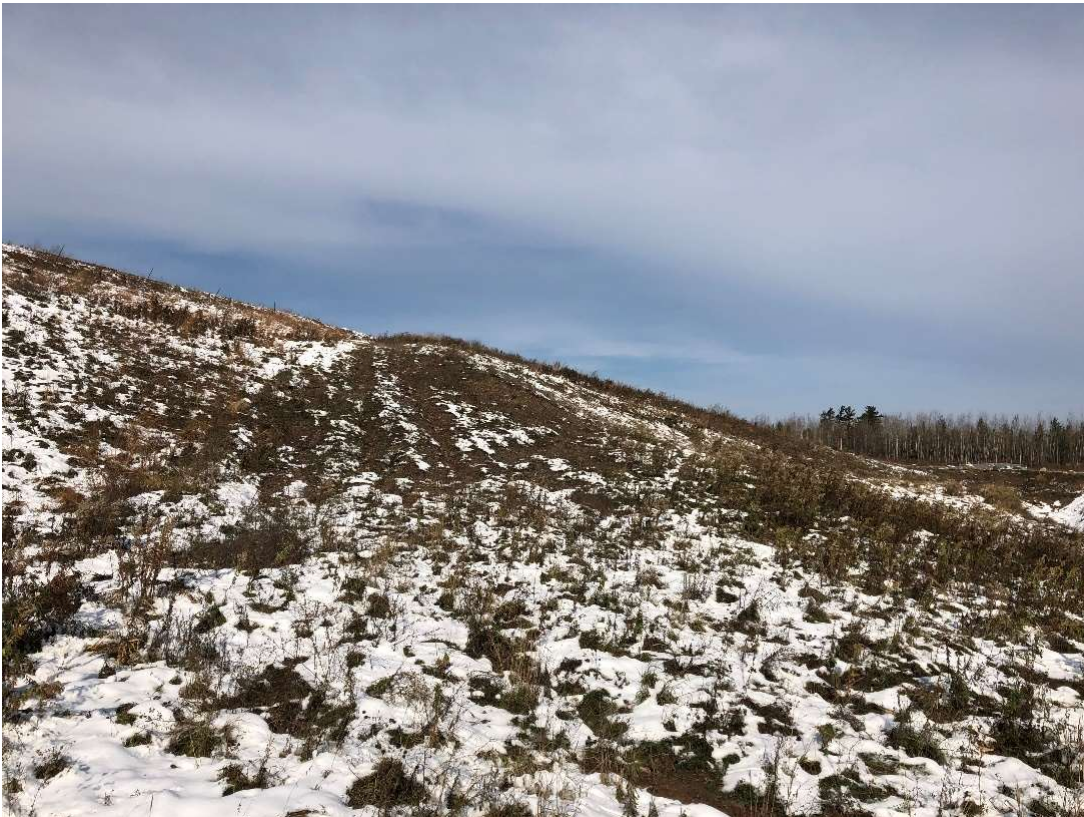
Location 11 – Looking North, Phase 1 Northern Access Road

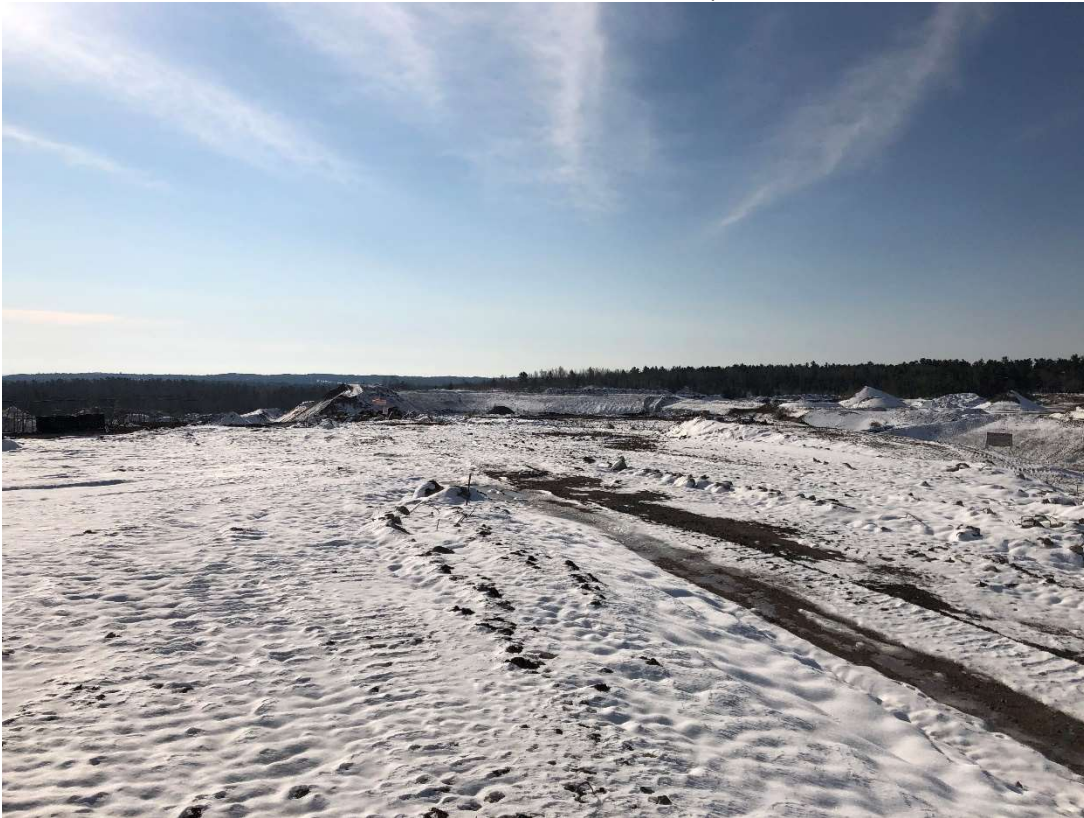
Location 12 – Looking South, Phase 2/3 Upper Lifts

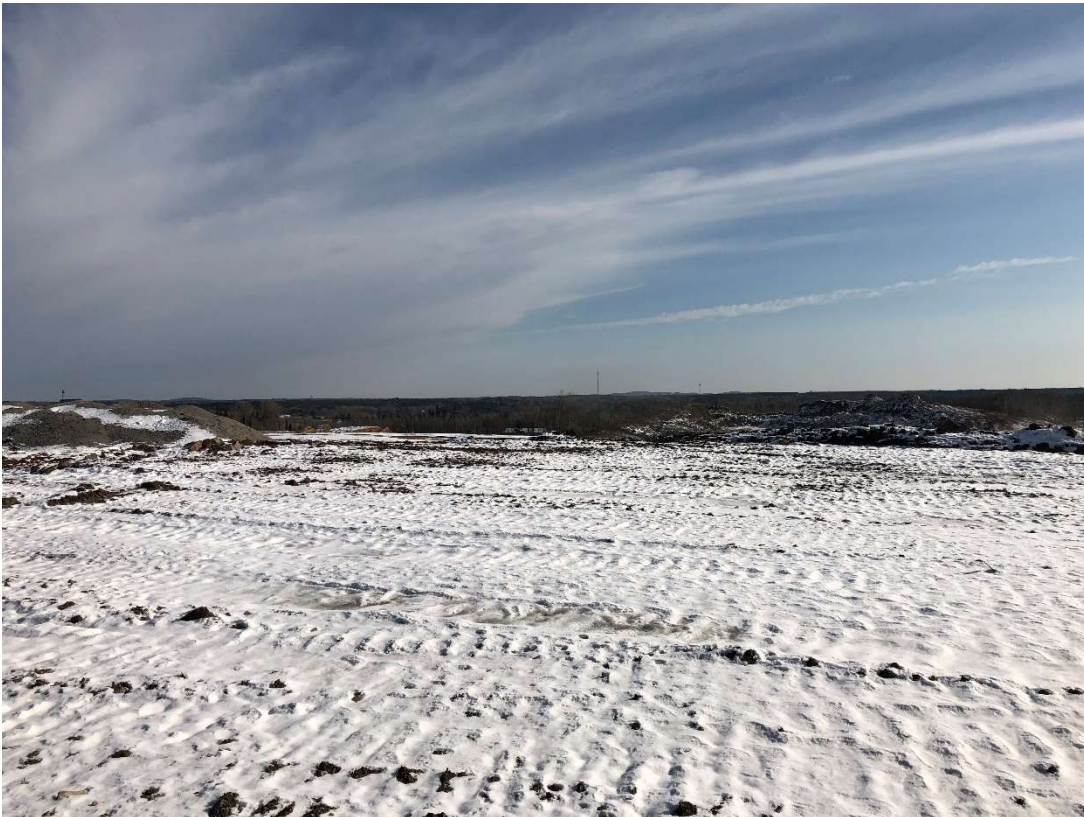
Location 12 – Looking East, Phase 2/1 Upper Lifts

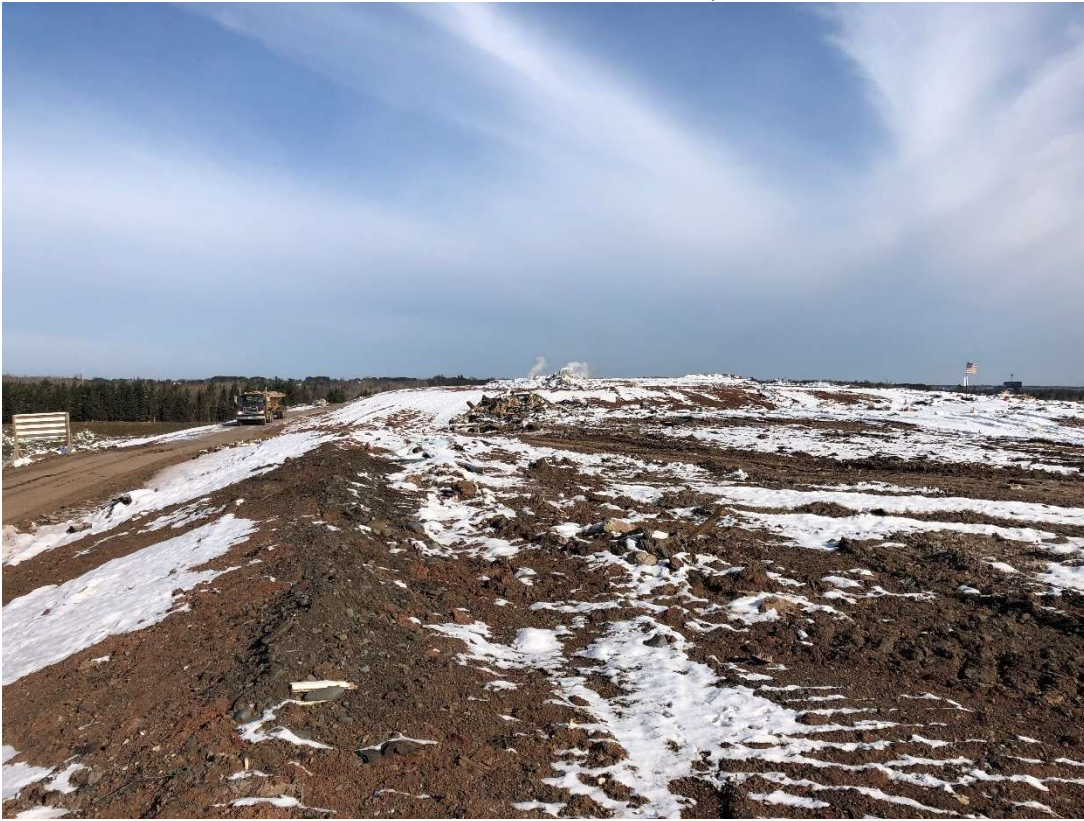
Location 13 – Looking North, Phase 3/4 Upper Lifts

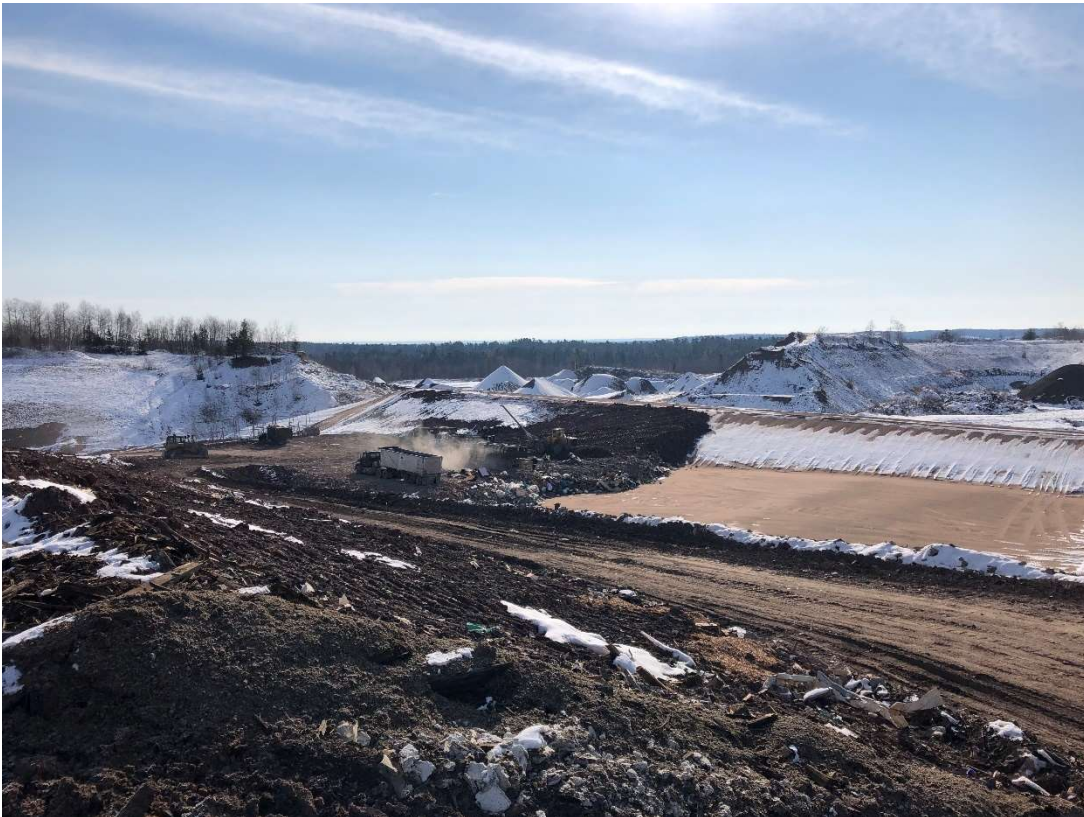
Location 13 – Looking Southeast, From Phase 3 Upper Lifts At Phase 5/6
