| To: | Geoff Strack, P.E. Waste Connections | From: | Bradley W Sullivan, P.E. Stantec Consulting Services, Inc. |
| File: | 227704387 | Date: | January 7, 2022 |

Reference: SKB Environmental Cloquet Landfill, dba Shamrock Landfill, Inc. 2021 Annual CCR Inspection Report

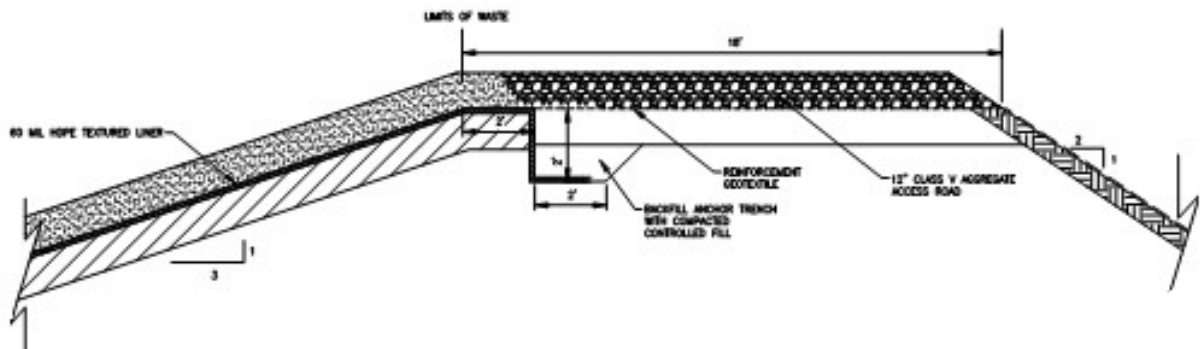
Typical Landfill Berm Detail

Most of the facility's landfill cell embankments were constructed using on-site borrow material, which consisted of silty clay and clayey sand type soils. The fill was placed and compacted to 95% of Standard Proctor Dry Density in lift thicknesses ranging from 8 inches to 12 inches. The final subgrade surface was proof rolled prior to geosynthetics installation. A typical perimeter section taken from the Phase 3 and 4 Construction Documentation Report prepared by Wenck in September 2015 is shown below.

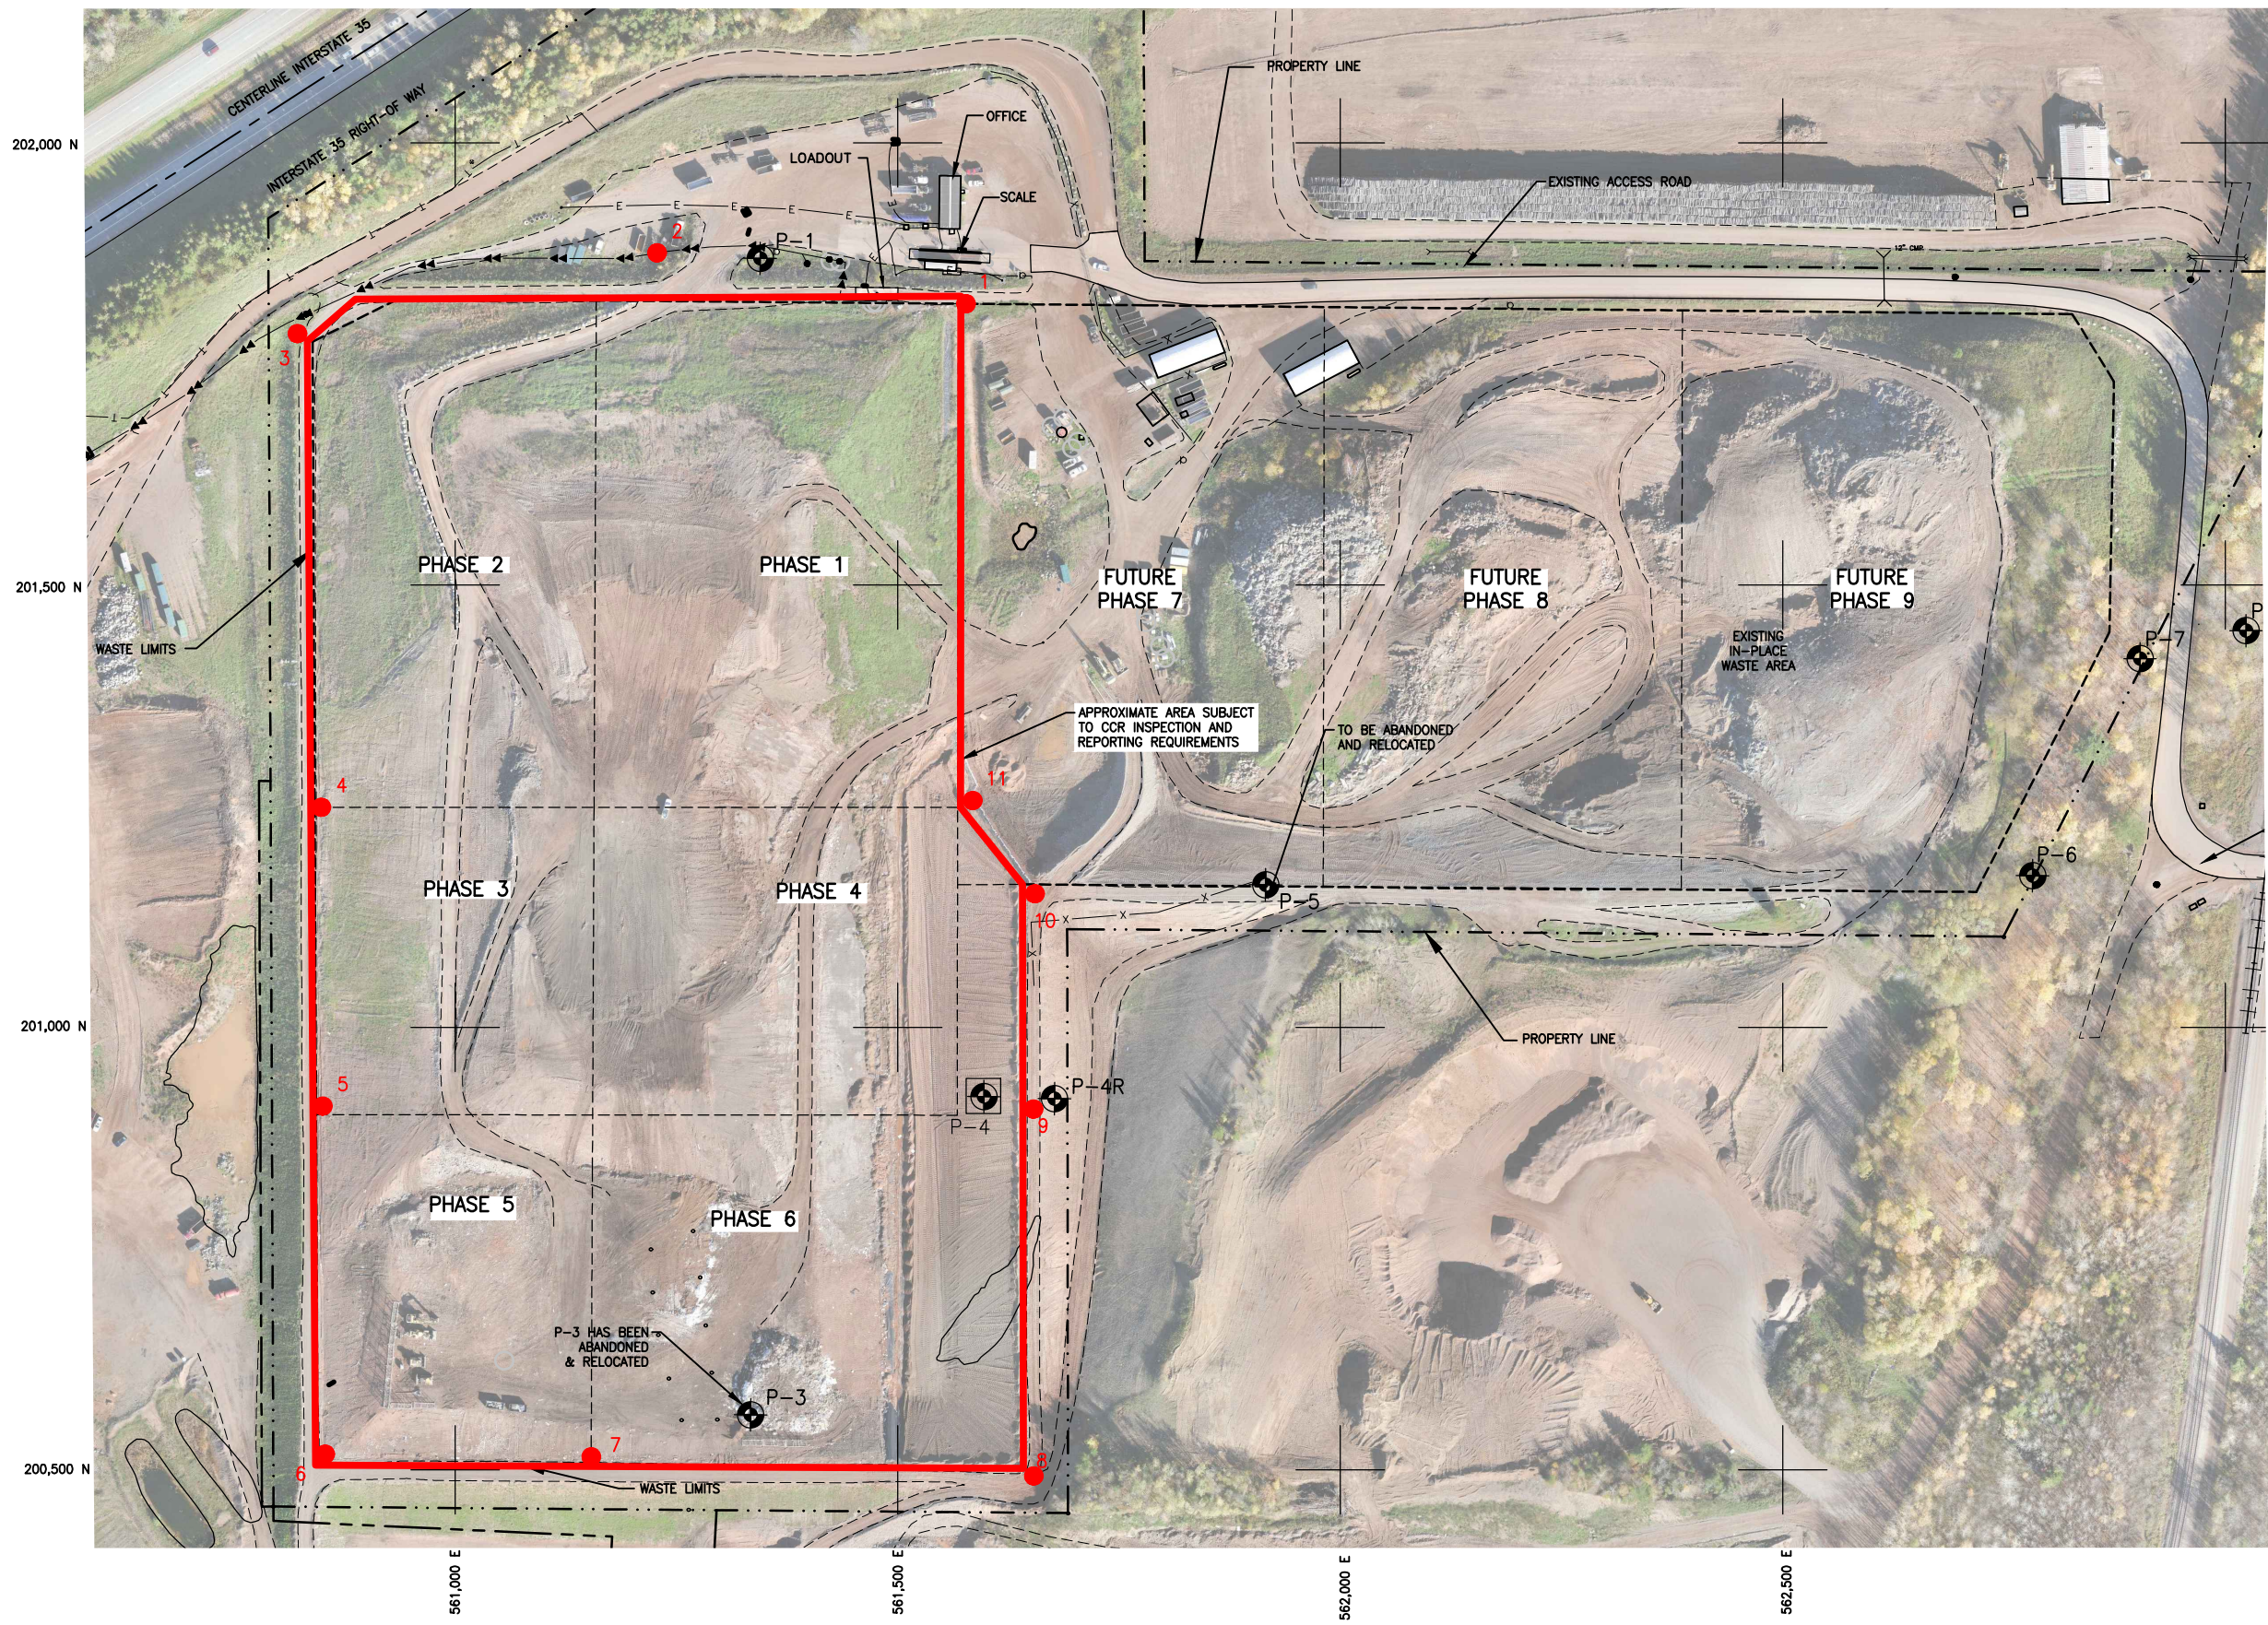
| SHEET TITLE | | | |
|---|---|---|---|
| FIGURE 1 | | 0 | |

Photos were taken during the inspection. Figure 1 presents the photo locations, and Attachment 1 contains a photo log and the photos taken.

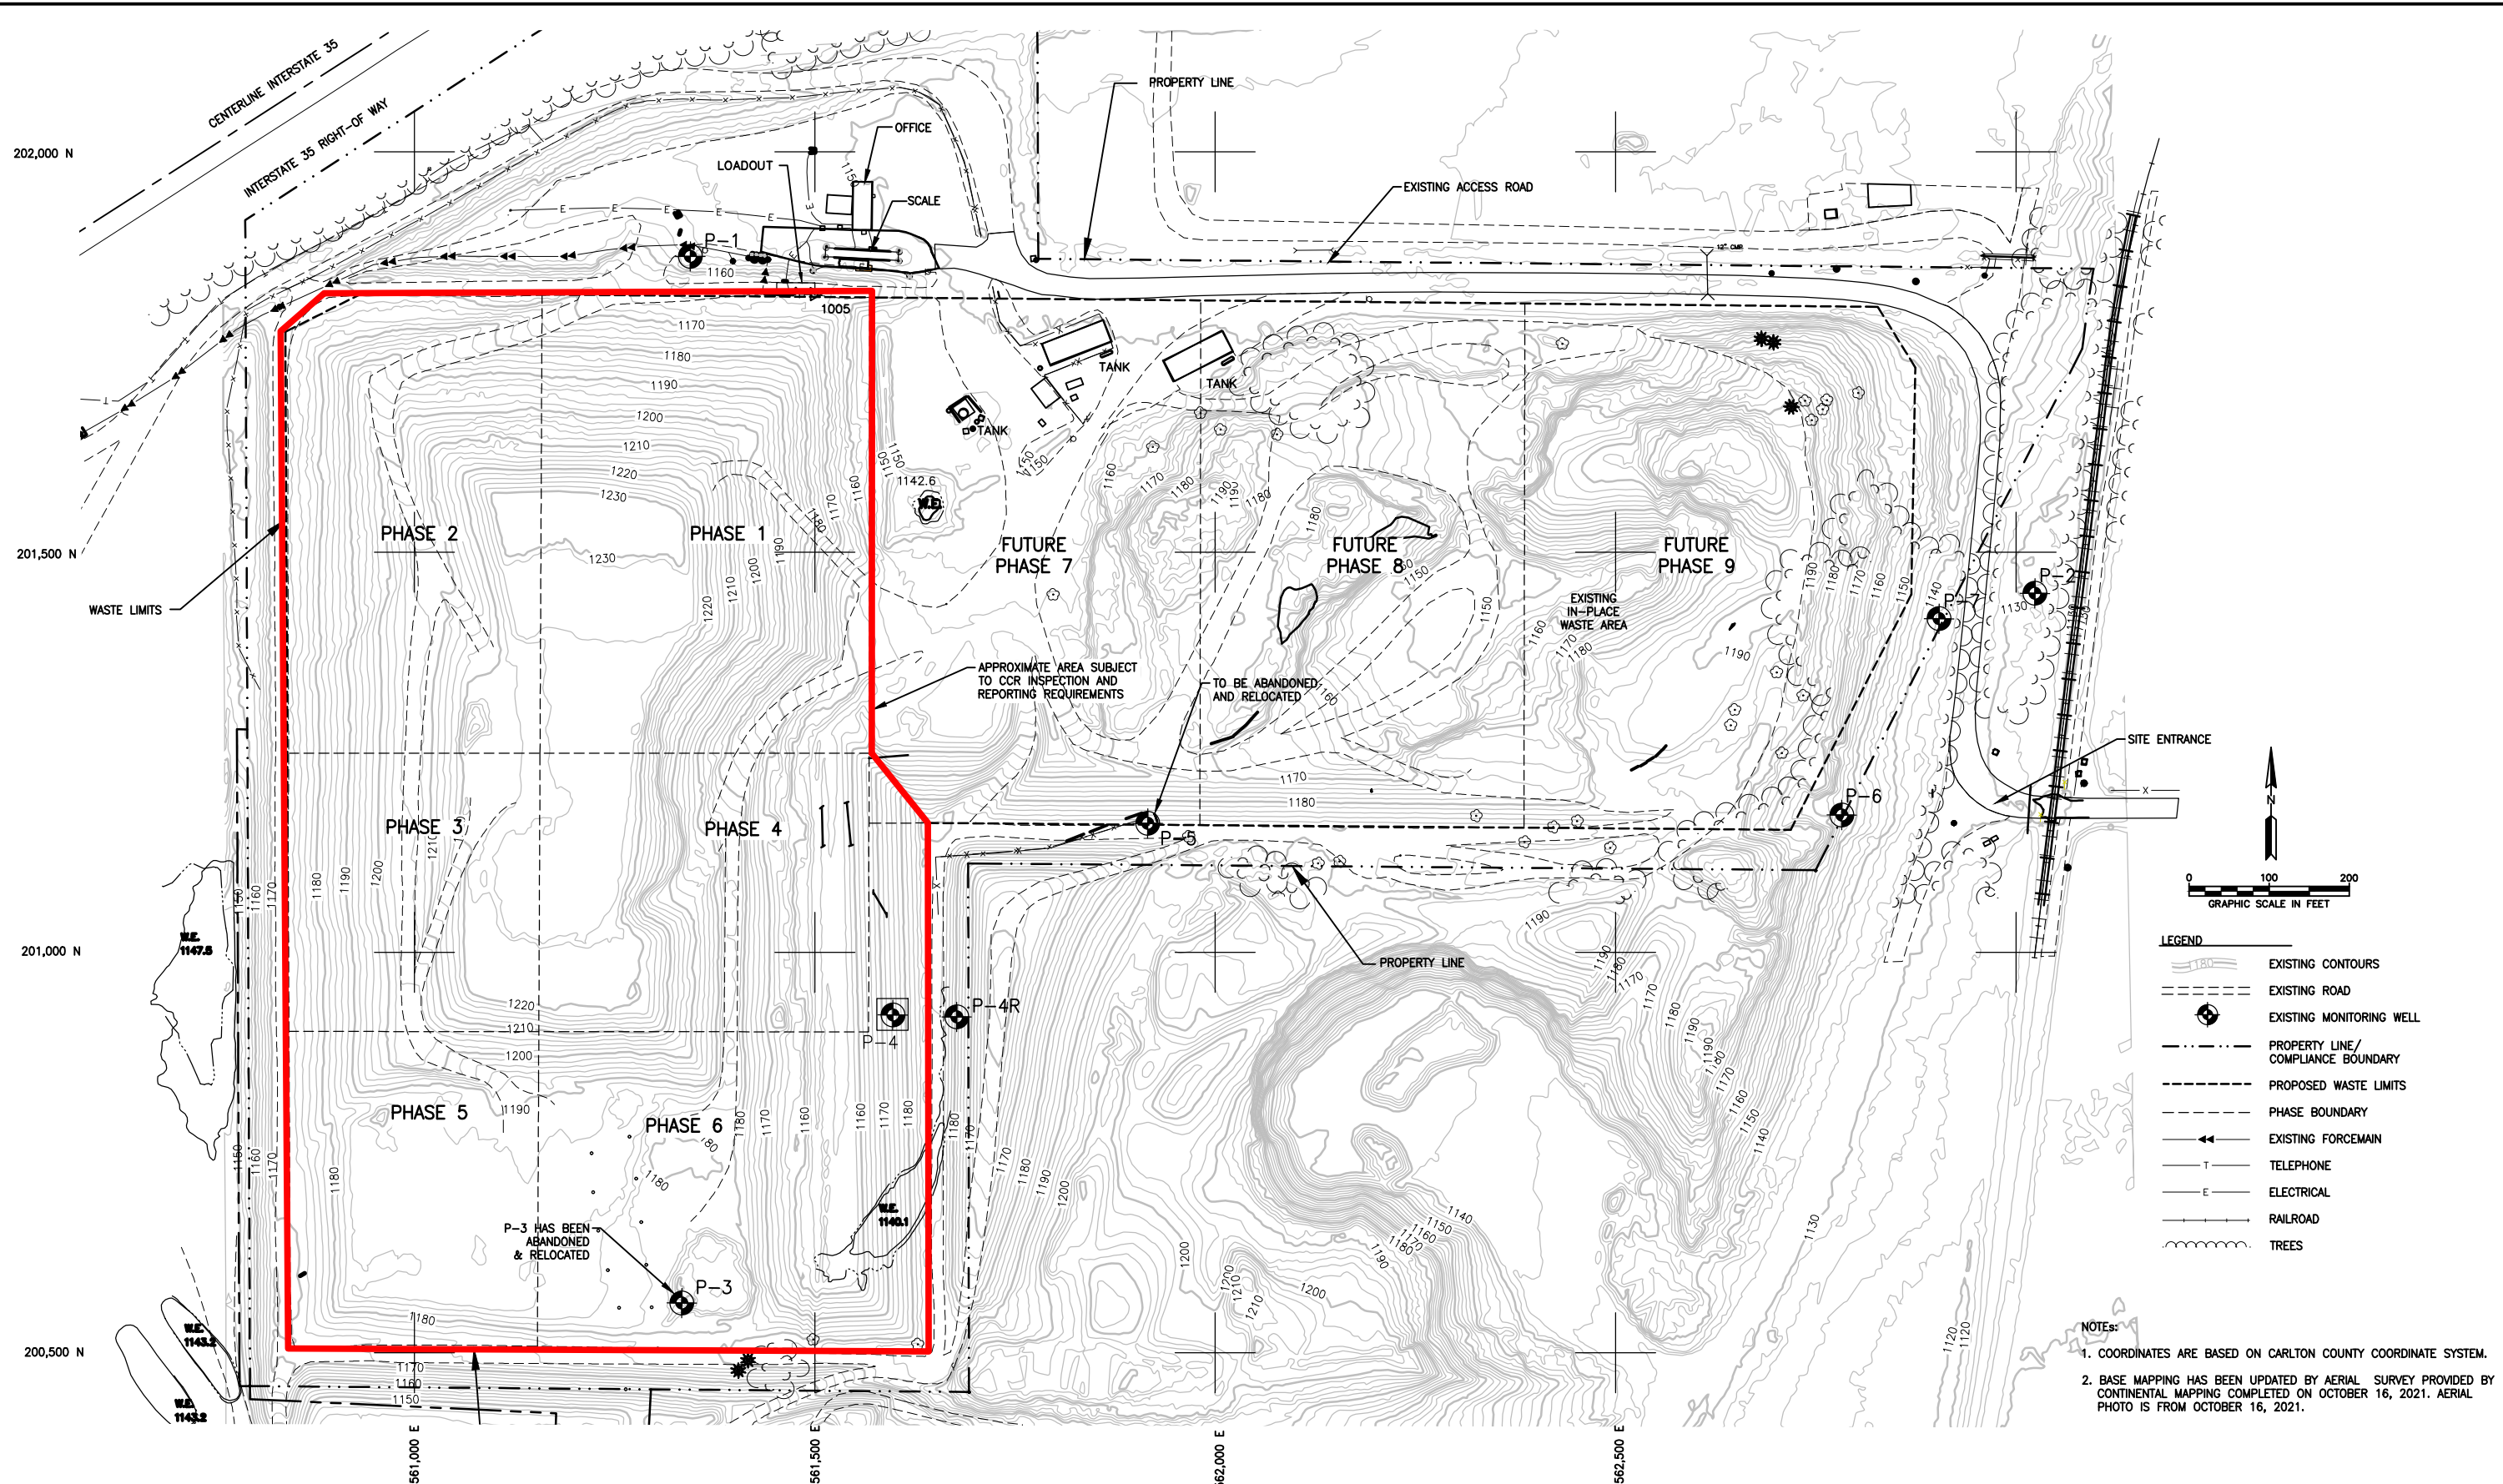
| 227704387 | FIGURE 2 | | |

Other than the construction of the remaining areas of Phases 4 and 6, there were no apparent changes to the embankment geometry of Phases 1 through 6 when compared to the permit drawings or the past inspection reports. The annual aerial photogrammetry survey was performed on October 16, 2021, which the estimated in-place volume of total waste (including all accepted wastes) is based on. A comparison 2021 and 2020 aerial survey confirm that the embankment and slope topography is substantially unchanged with no significant movement. The 2021 aerial survey is included as Figure 2.

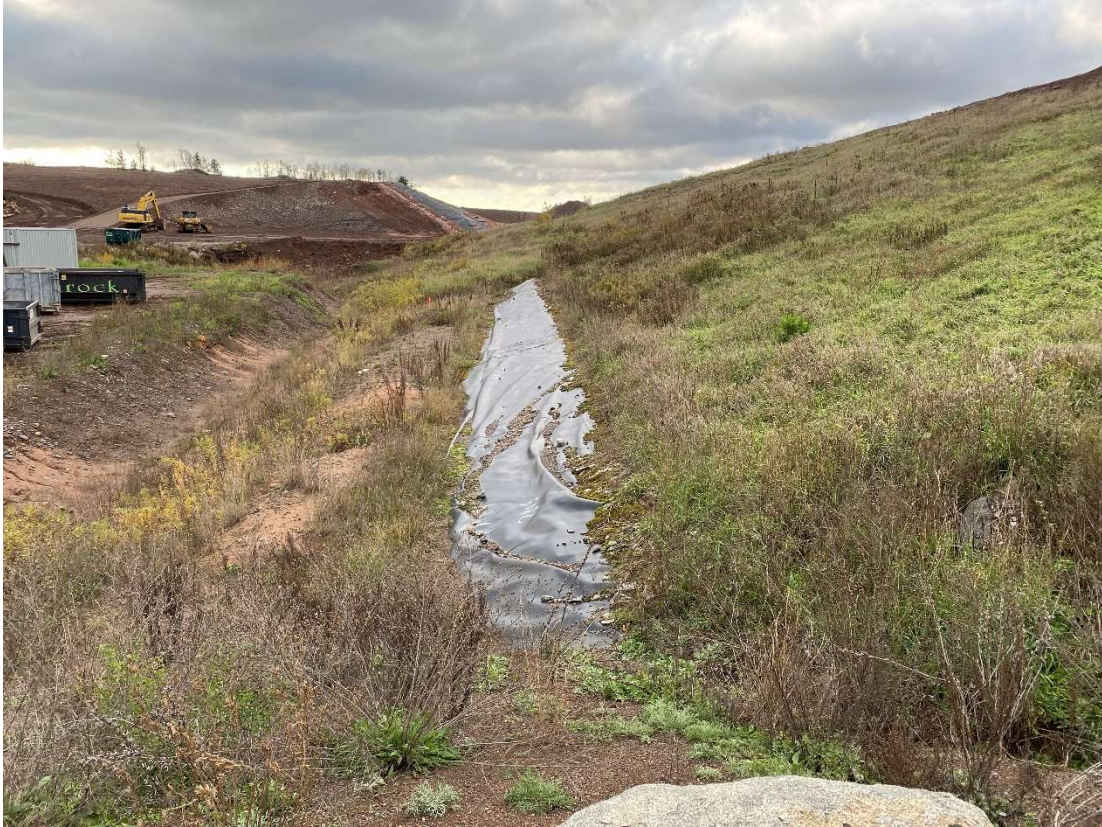
Location 1 – Looking South, Phase 1 Eastern Berm

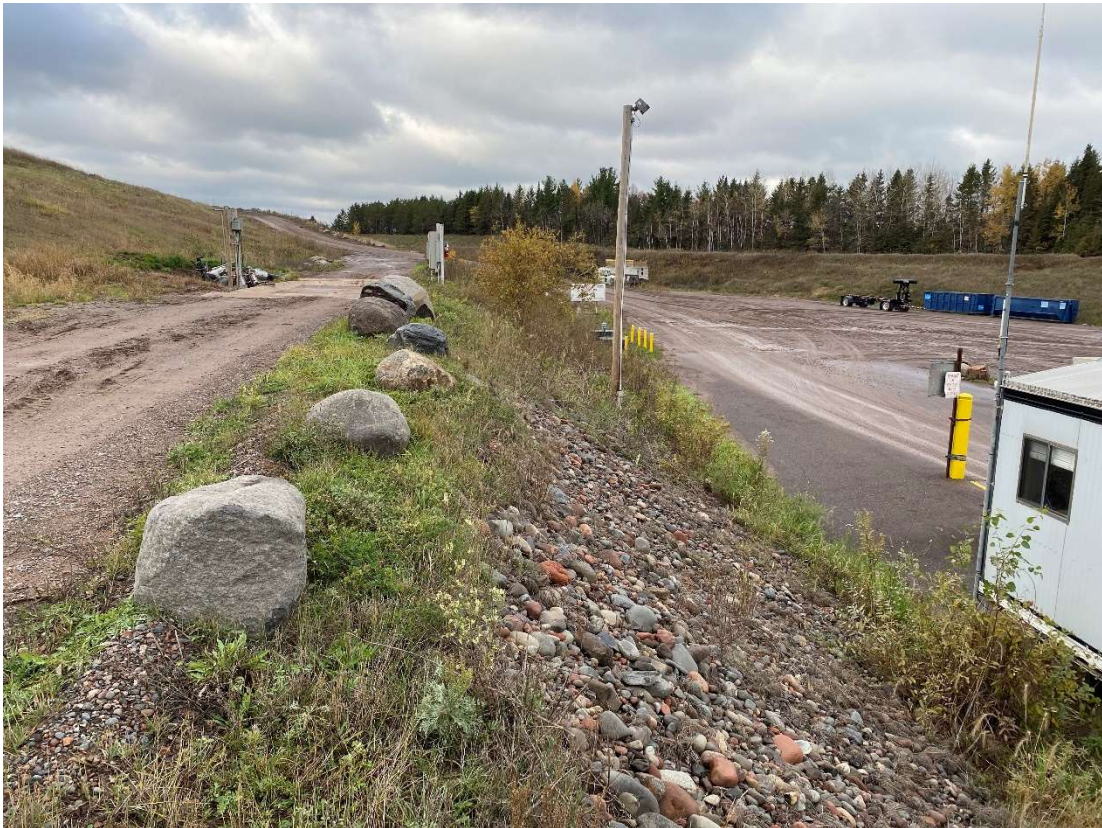
Location 1 – Looking West, Phase 1 Northern Berm

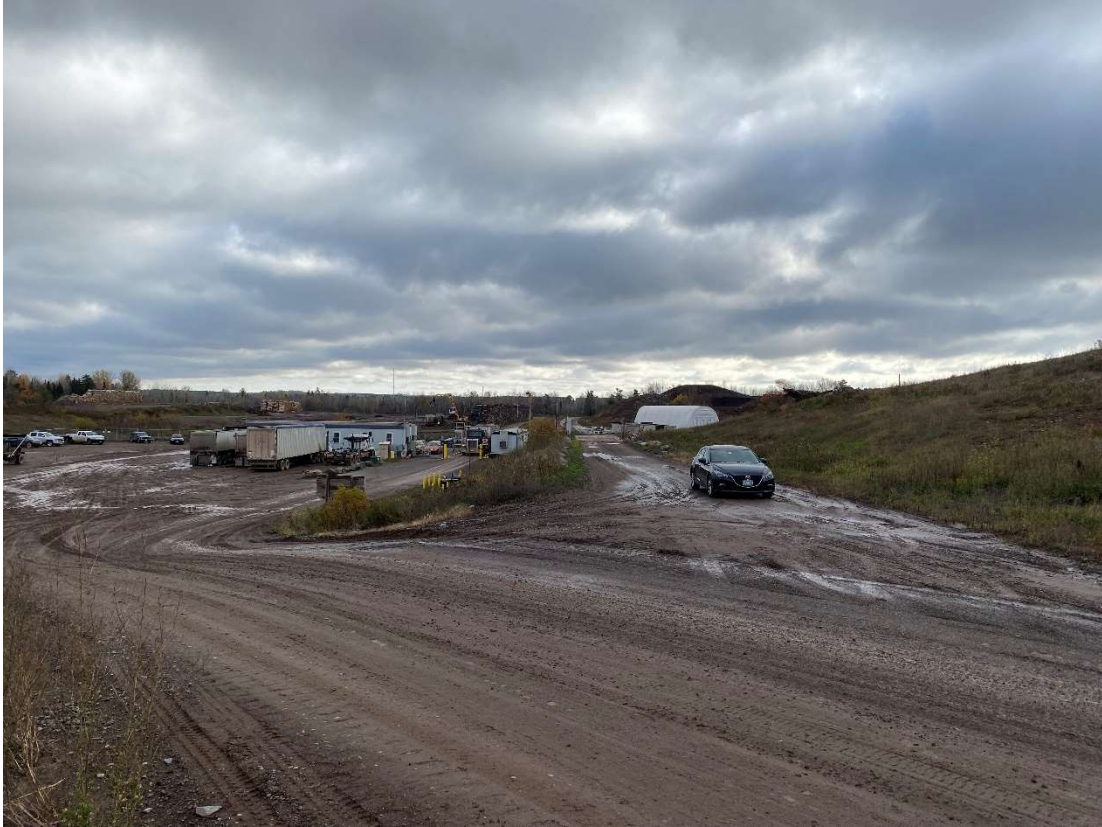
Location 2 – Looking East, Phase 1 Northern Waste Slope

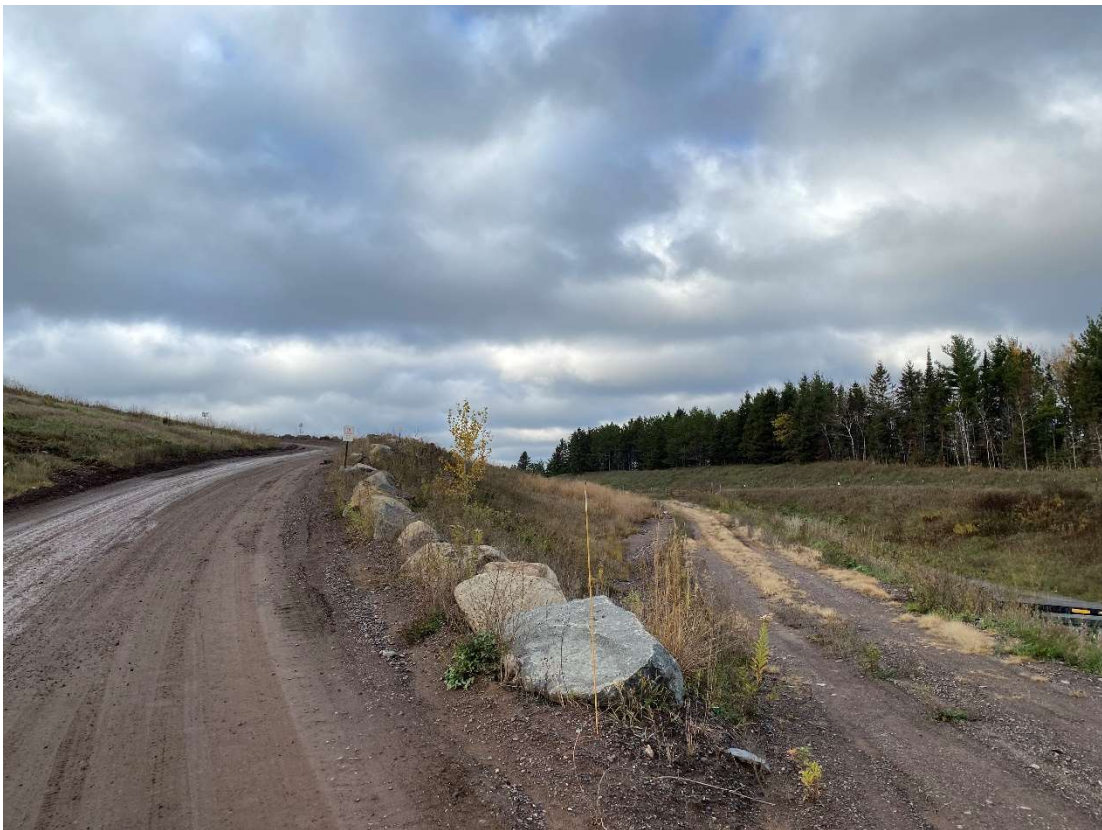
Location 2 – Looking West, Phase 2 Northern Waste Slope & Berm

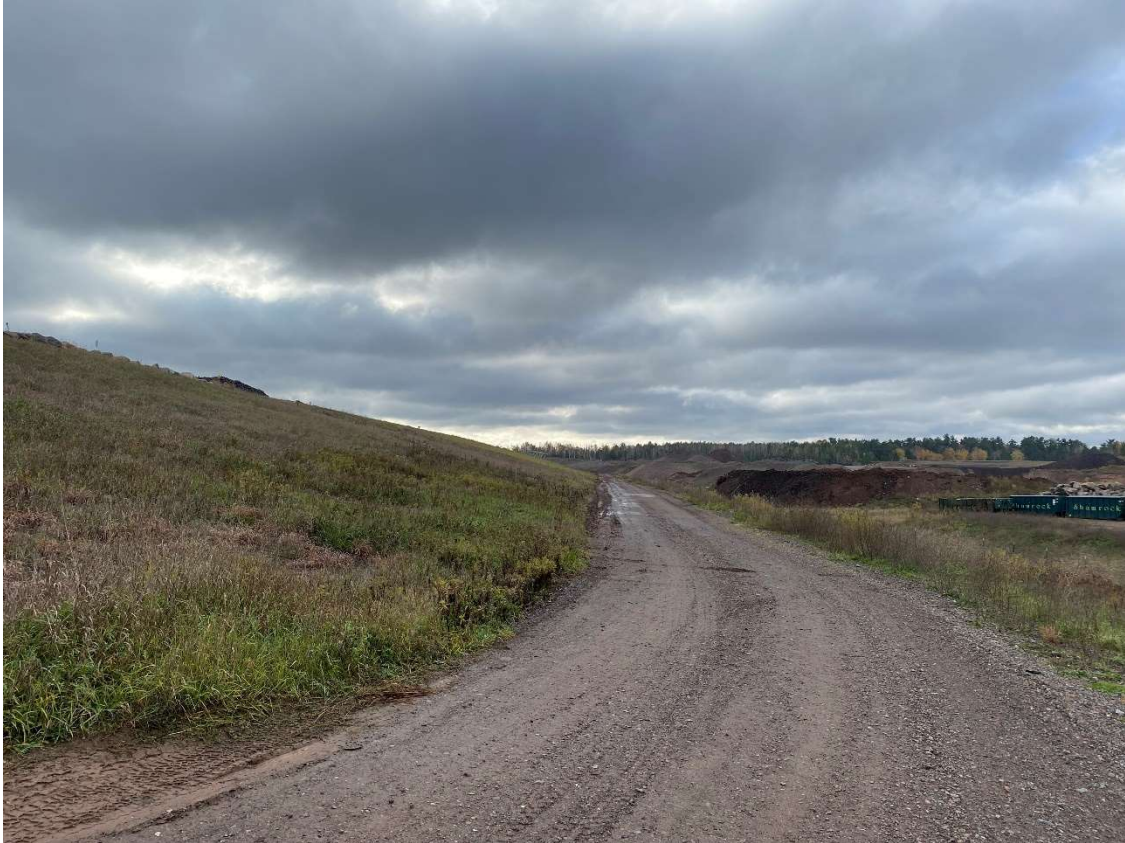
Location 3 – Looking South, Phase 2 Perimeter Road

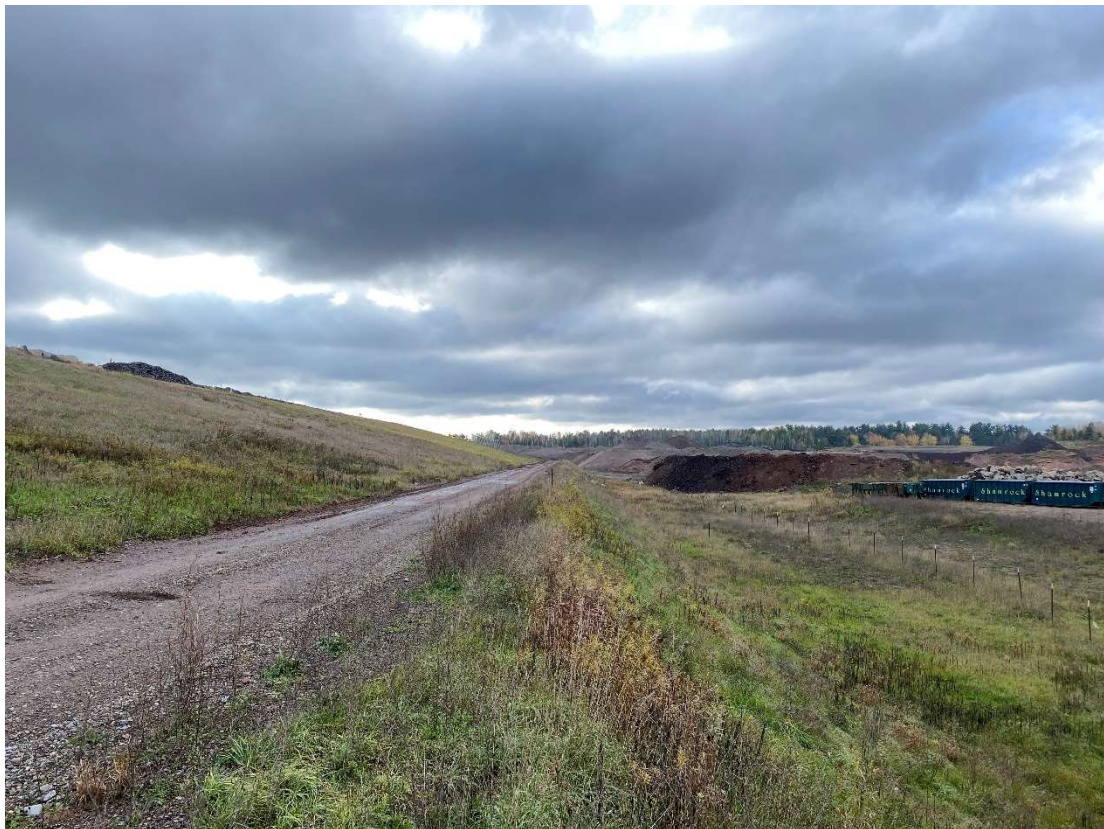
Location 3 – Looking South, Phase 2 Western Berm

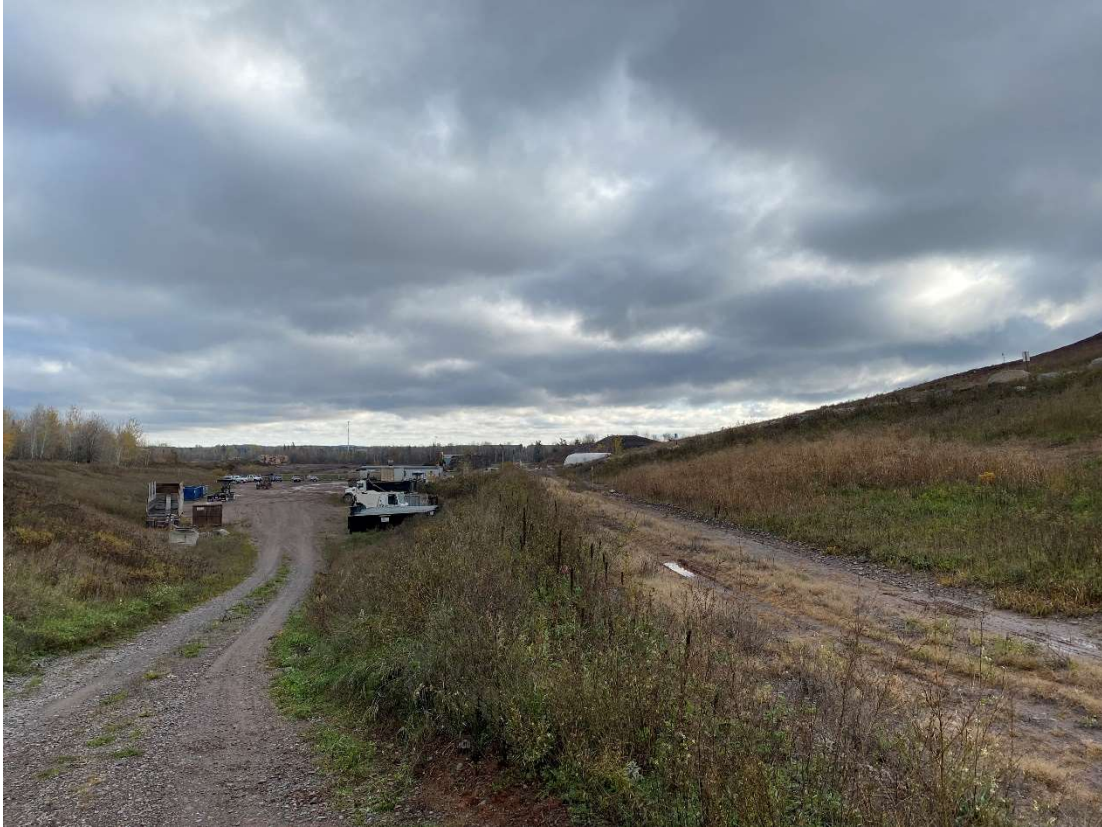
Location 3 – Looking East, Phase 2 Road & Berm

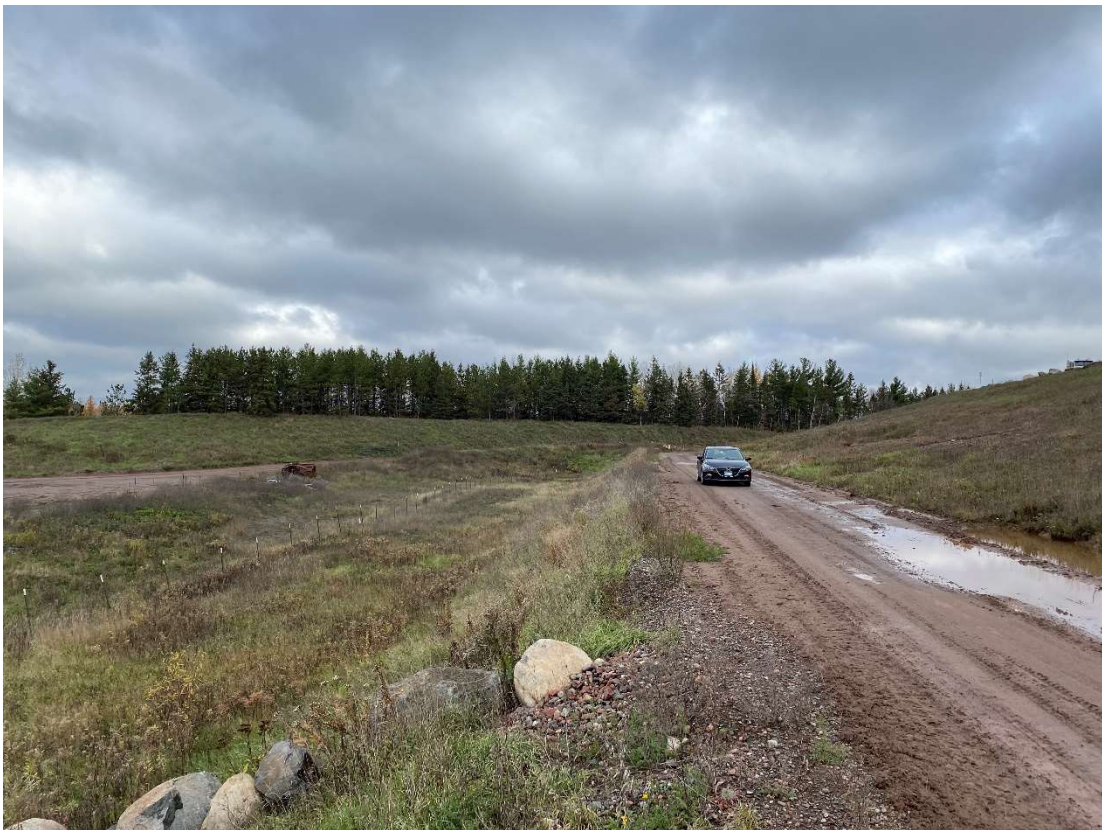
Location 4 – Looking North, Phase 2 Western Berm

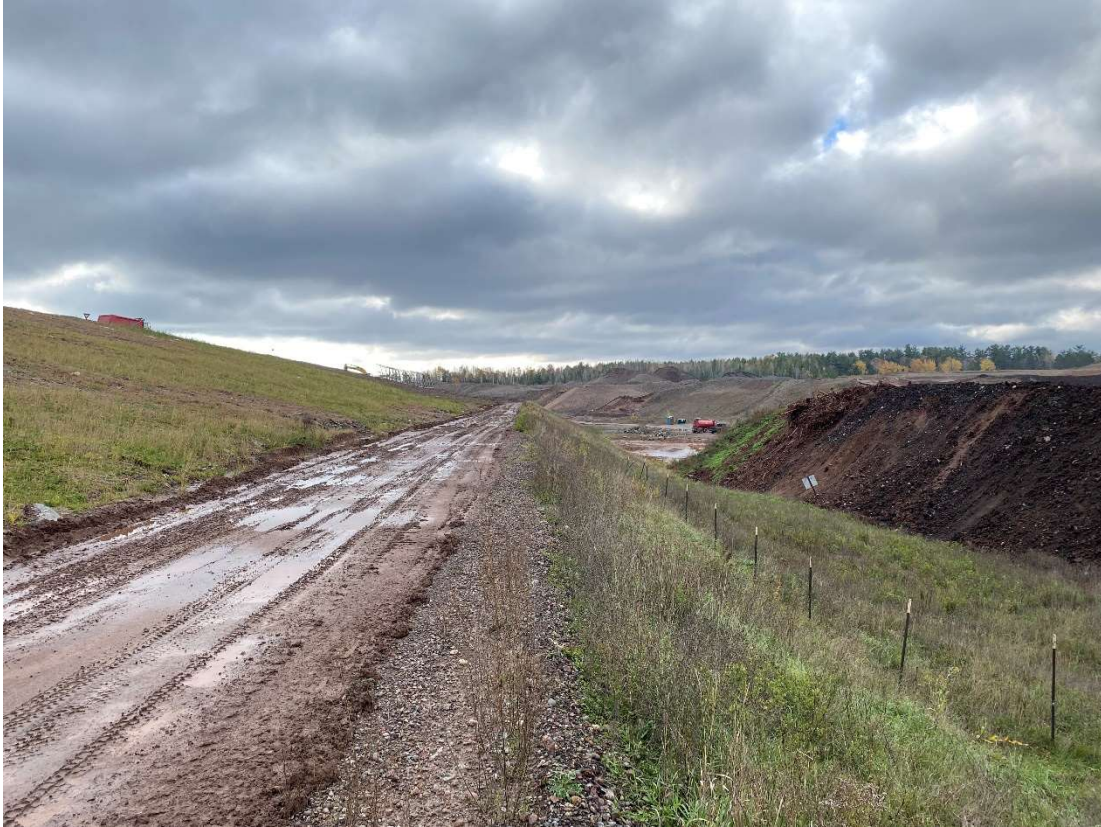
Location 4 – Looking South, Phase 3 Western Berm

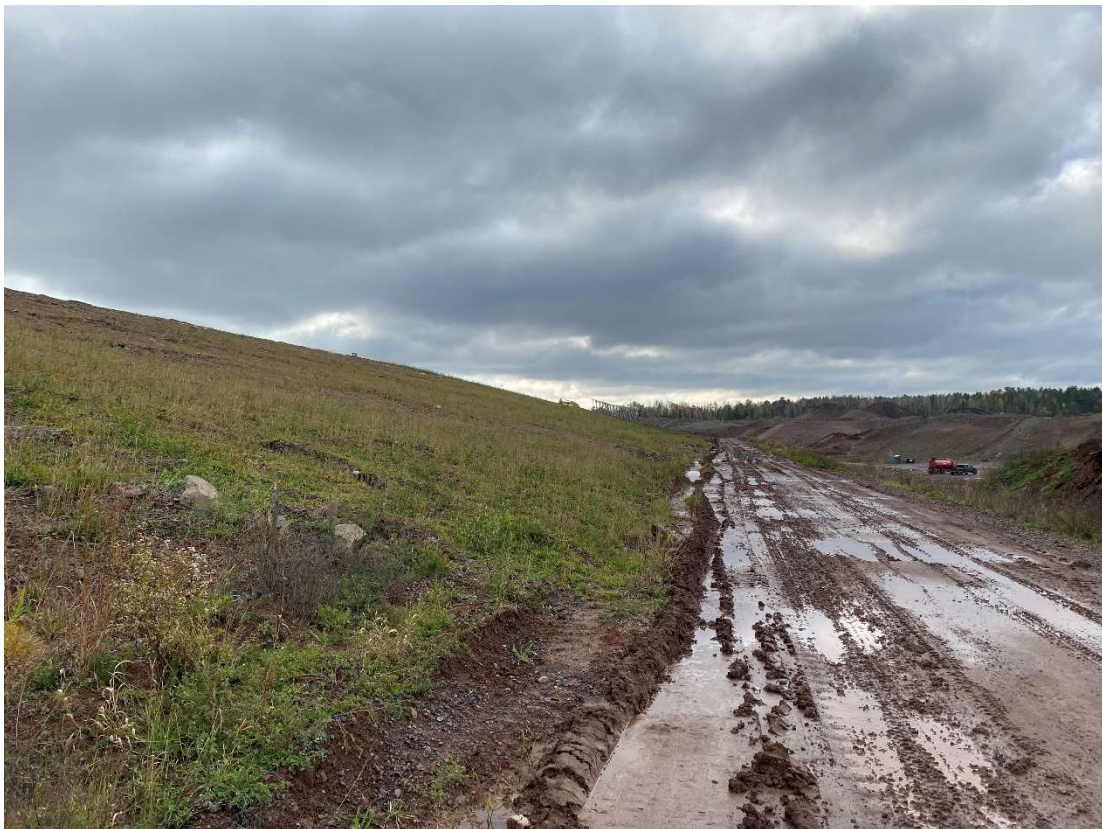
Location 4 – Looking South, Phase 3 Waste Slope

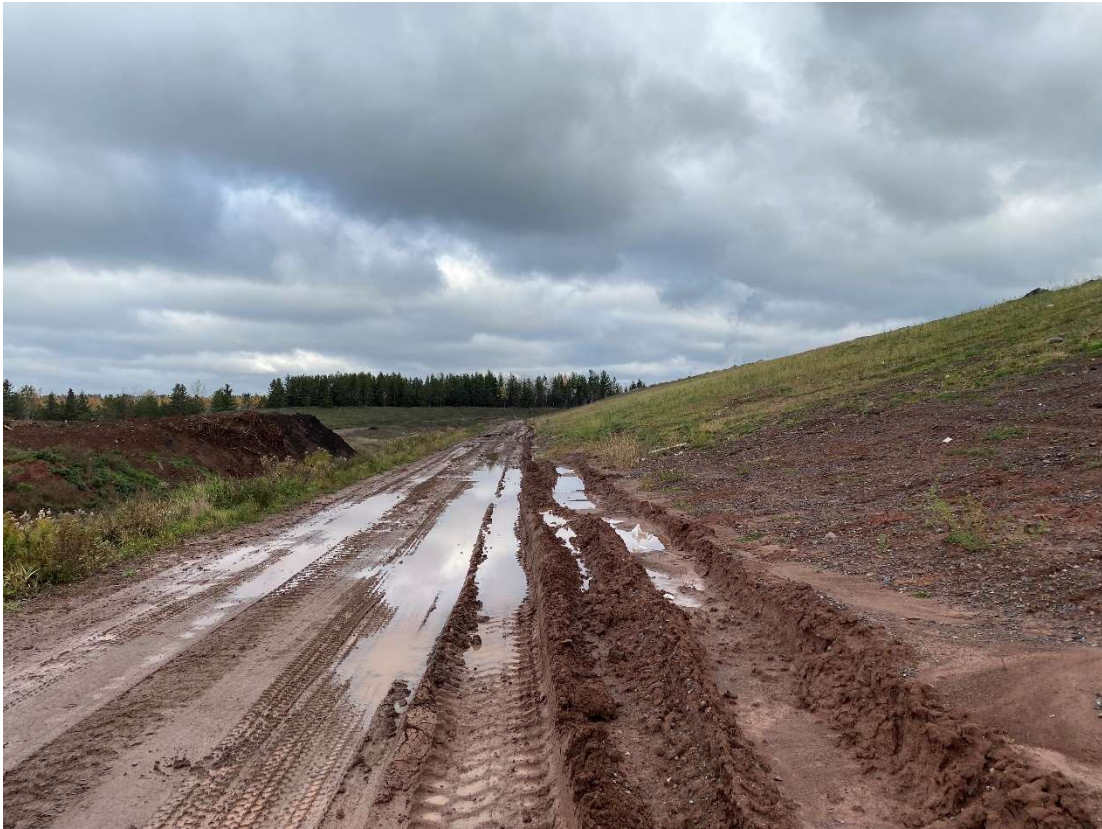
Location 5 – Looking North, Phase 3 Western Waste Slope

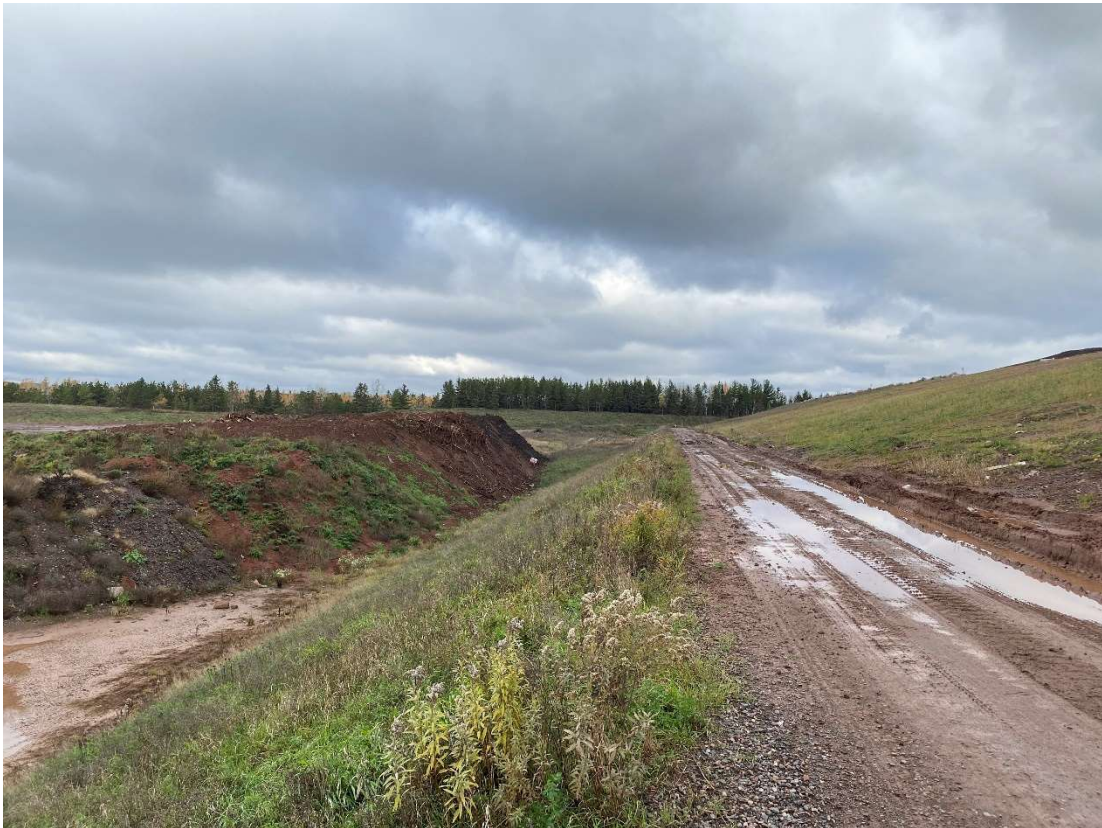
Location 5 – Looking North, Phase 3 LF Western Road

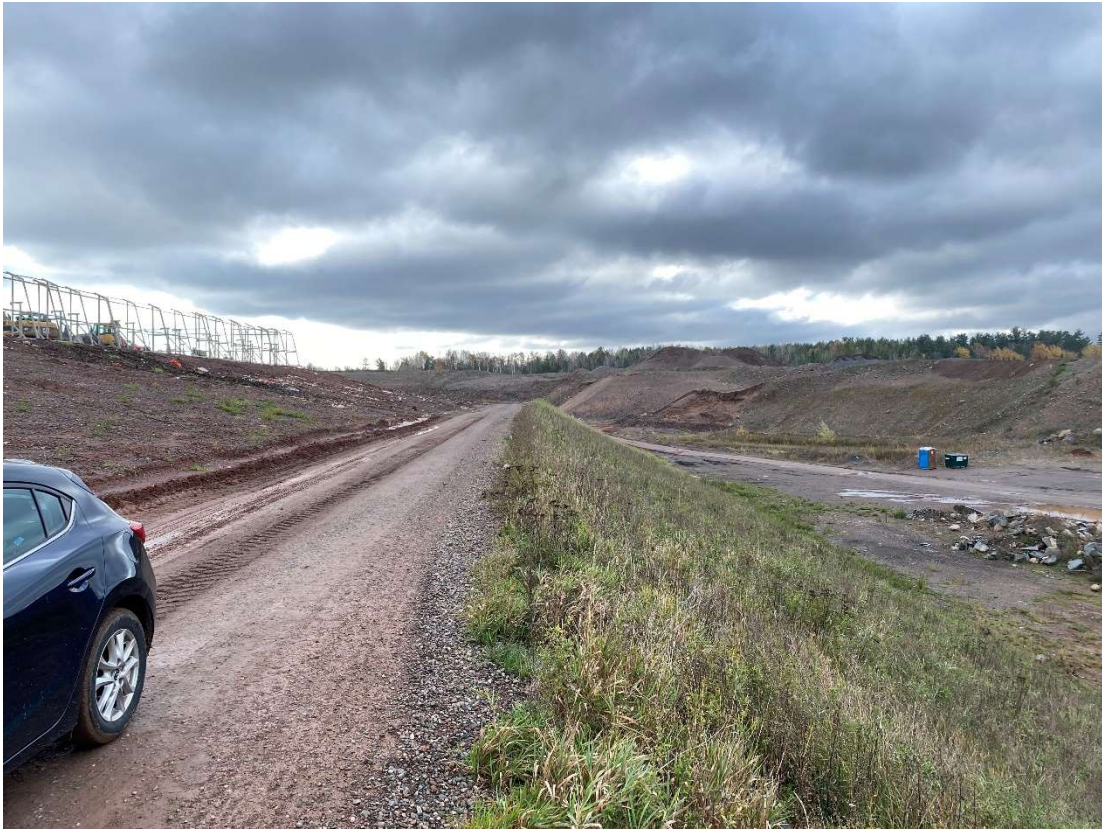
Location 5 – Looking South, Phase 6 Western LF Berm

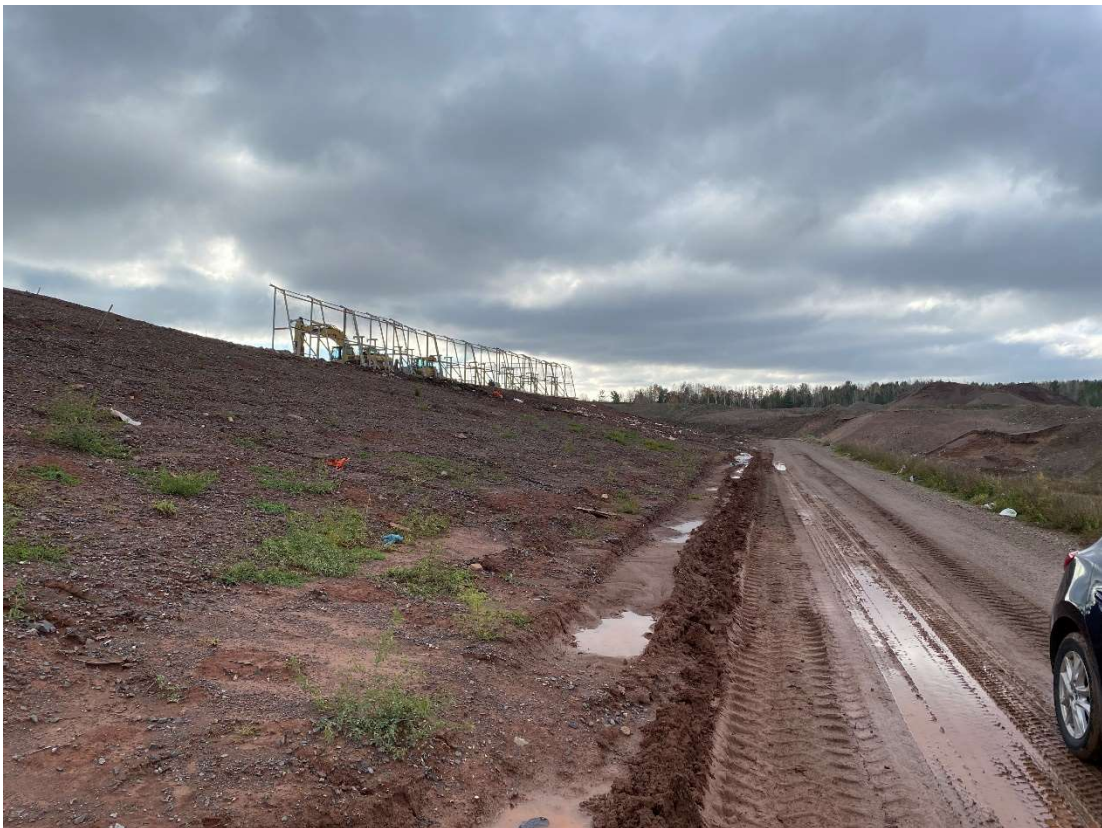
2021 Shamrock Landfill CCR Inspection
Location 5 – Looking South, Phase 5 Interior

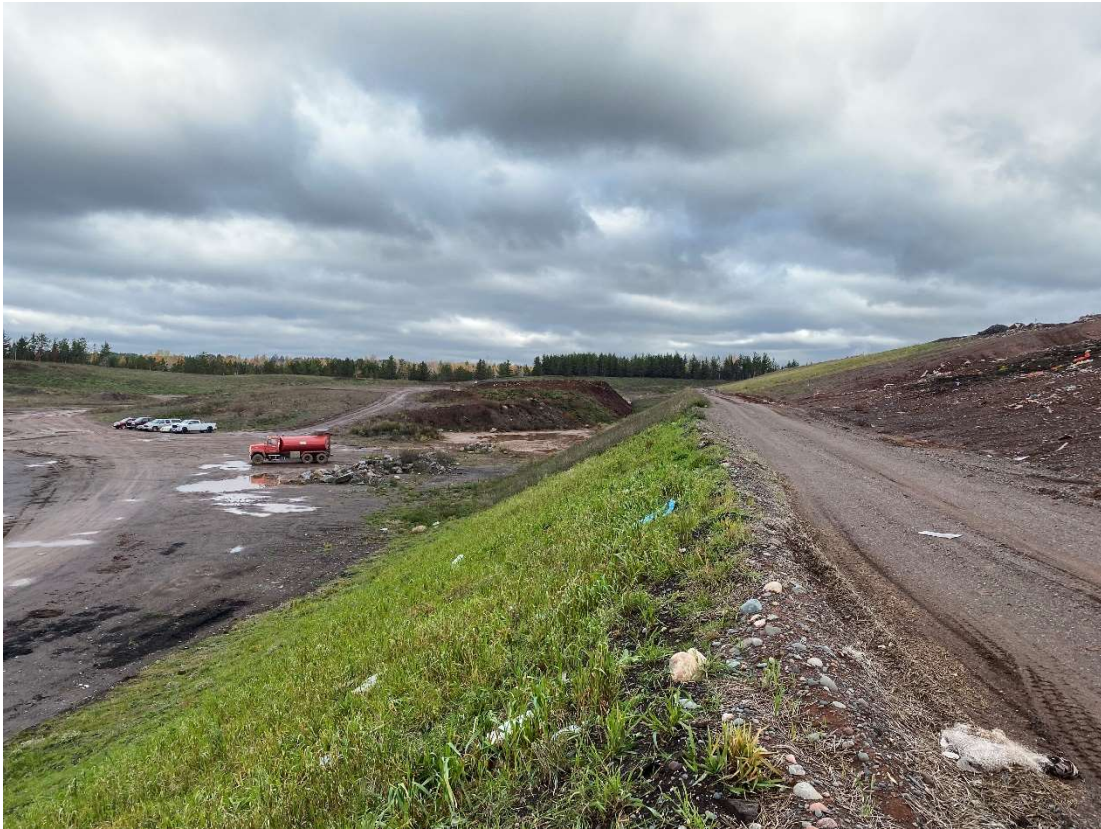
Location 6 – Looking North, Phase 6 Western LF Berm

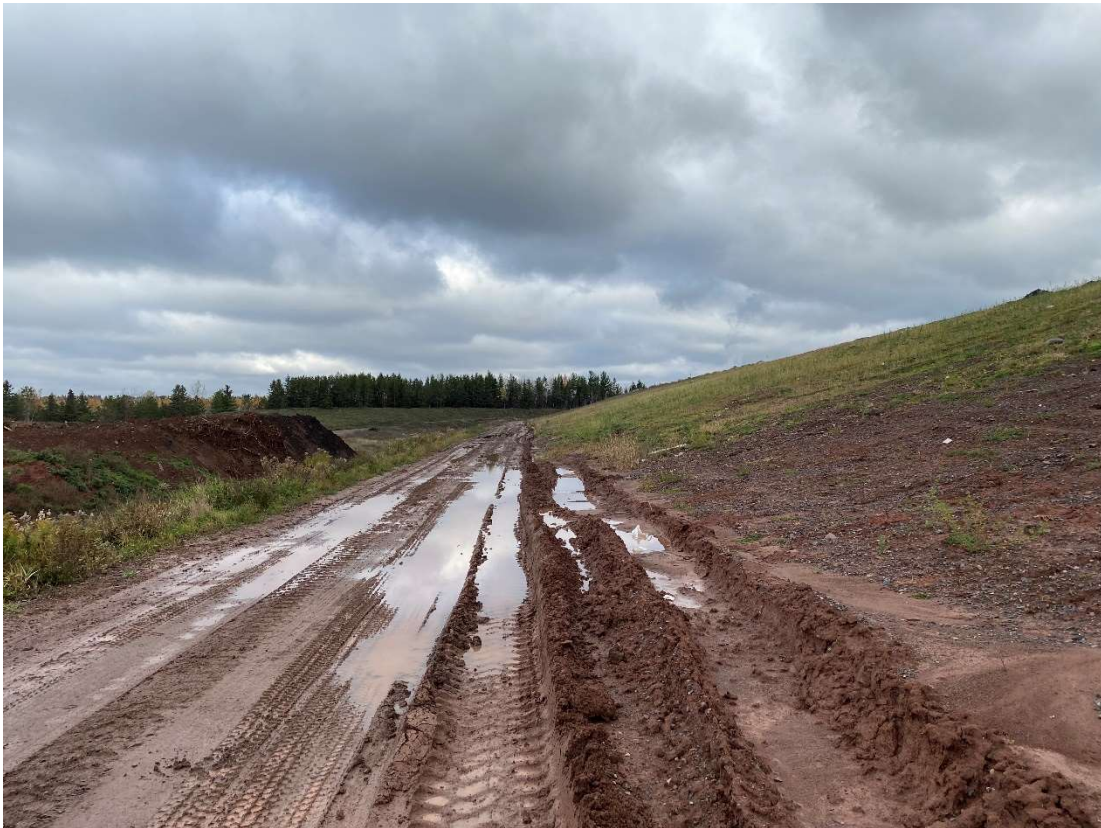
Location 6 – Looking North, Phase 6 Interior (Future Waste Slope)
