| To: | Geoff Strack, P.E. Waste Connections | From: | Bradley W Sullivan, P.E. Stantec Consulting Services, Inc. |
| File: | 227704387 | Date: | January 7, 2022 |

Reference: SKB Environmental Cloquet Landfill, dba Shamrock Landfill, Inc. 2021 Annual CCR Inspection Report

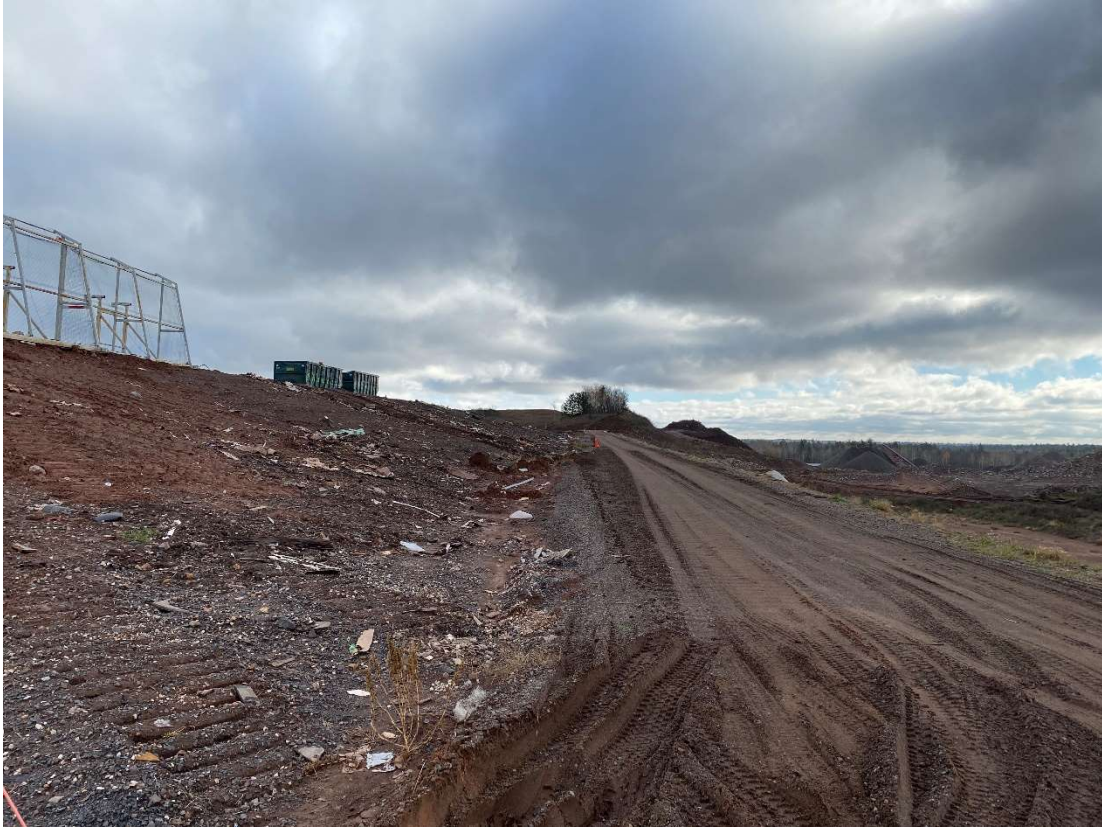
Location 6 – Looking East, Phase 5/6 Southern Anchor Trench

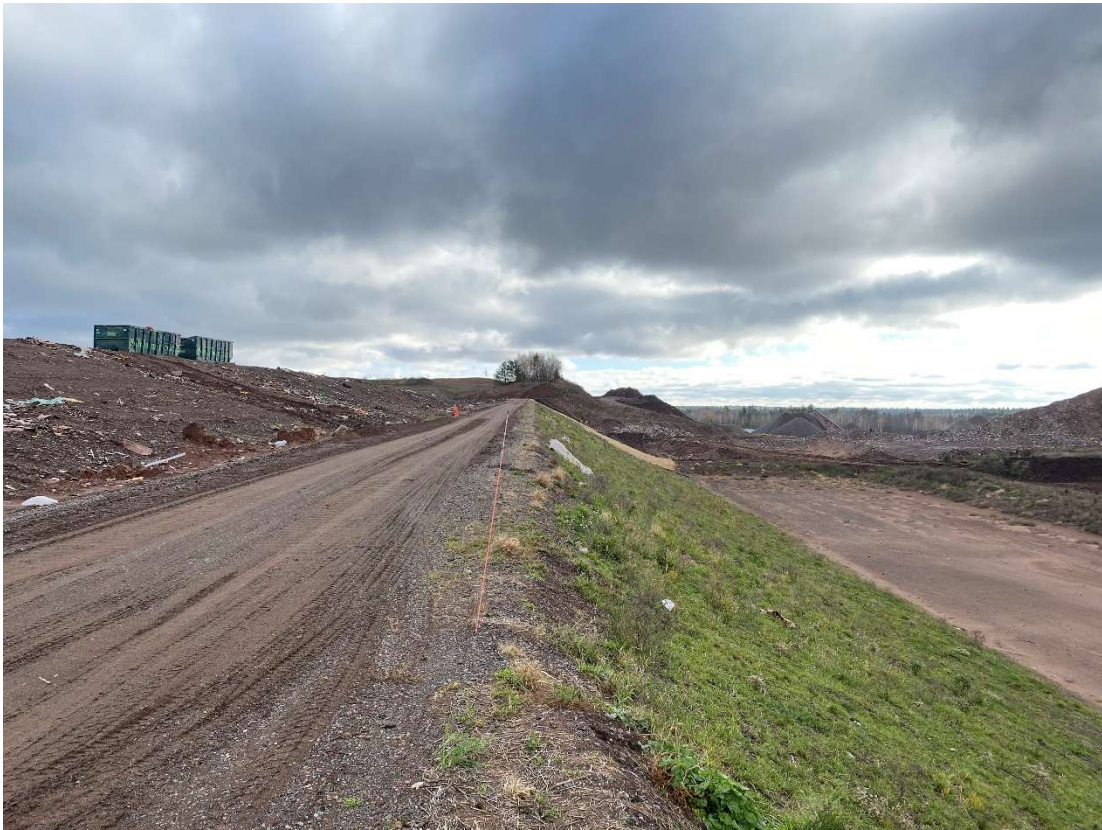
Location 6 – Looking East, Phase 5/6 Southern Berm

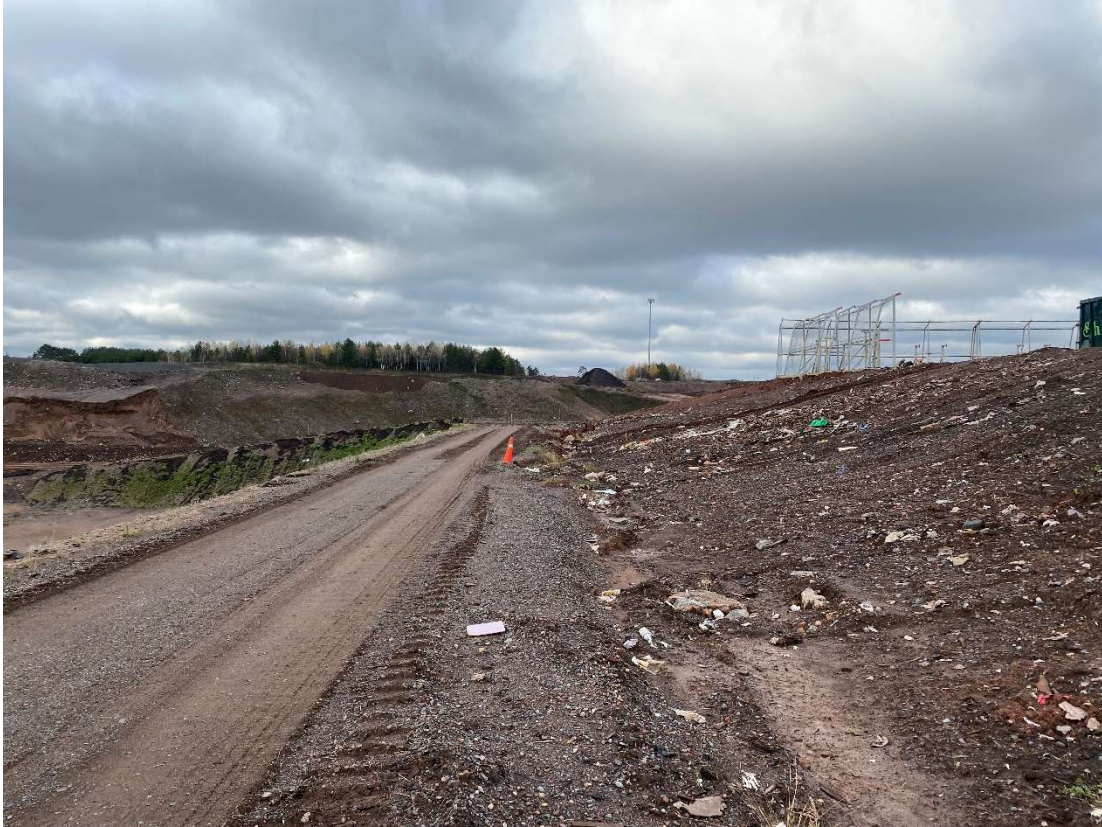
Location 7 – Looking West, Cell 5 Southern Anchor Trench

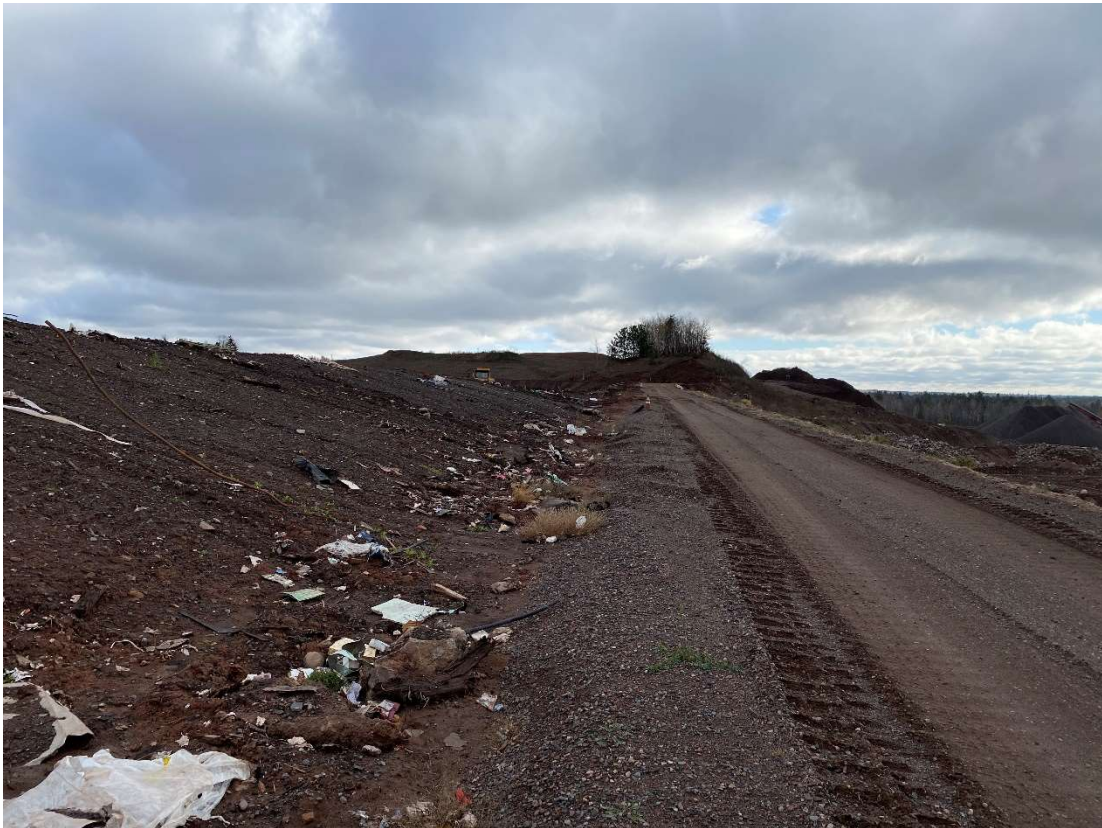
Location 7 – Looking East, Cell 6 Southern Anchor Trench

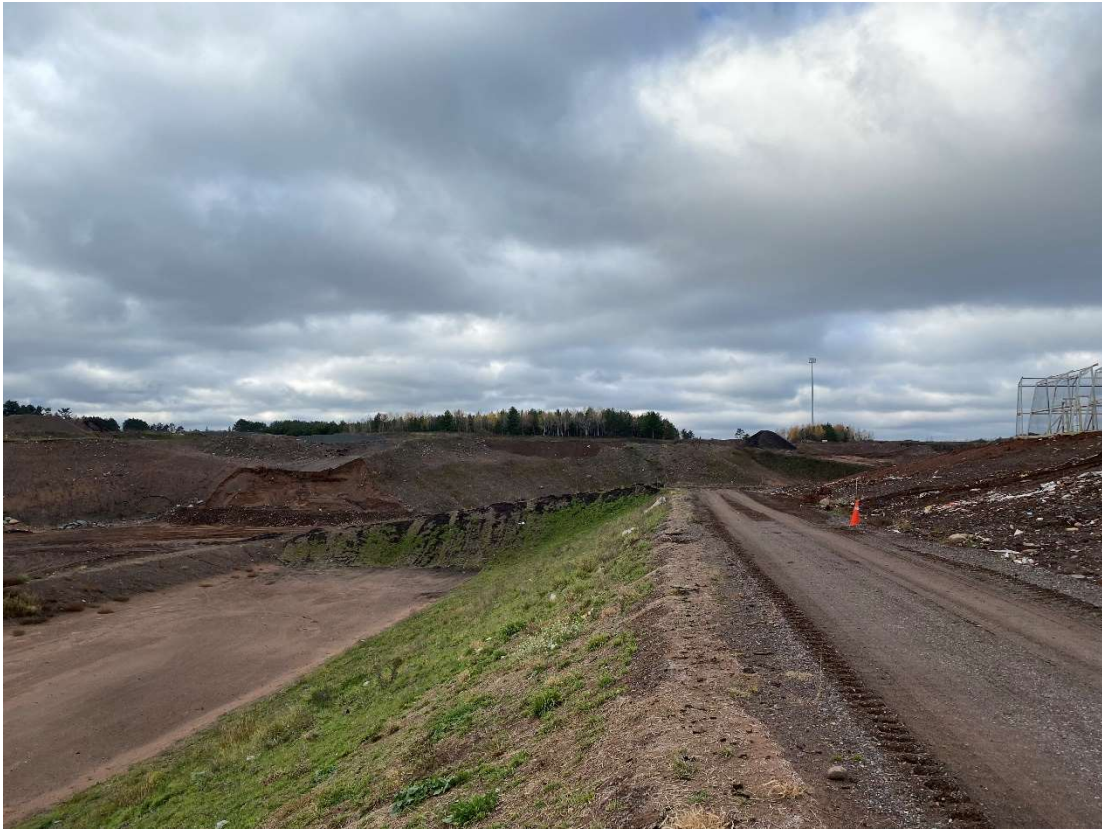
Location 7 – Looking West, Cell 5 Southern Berm

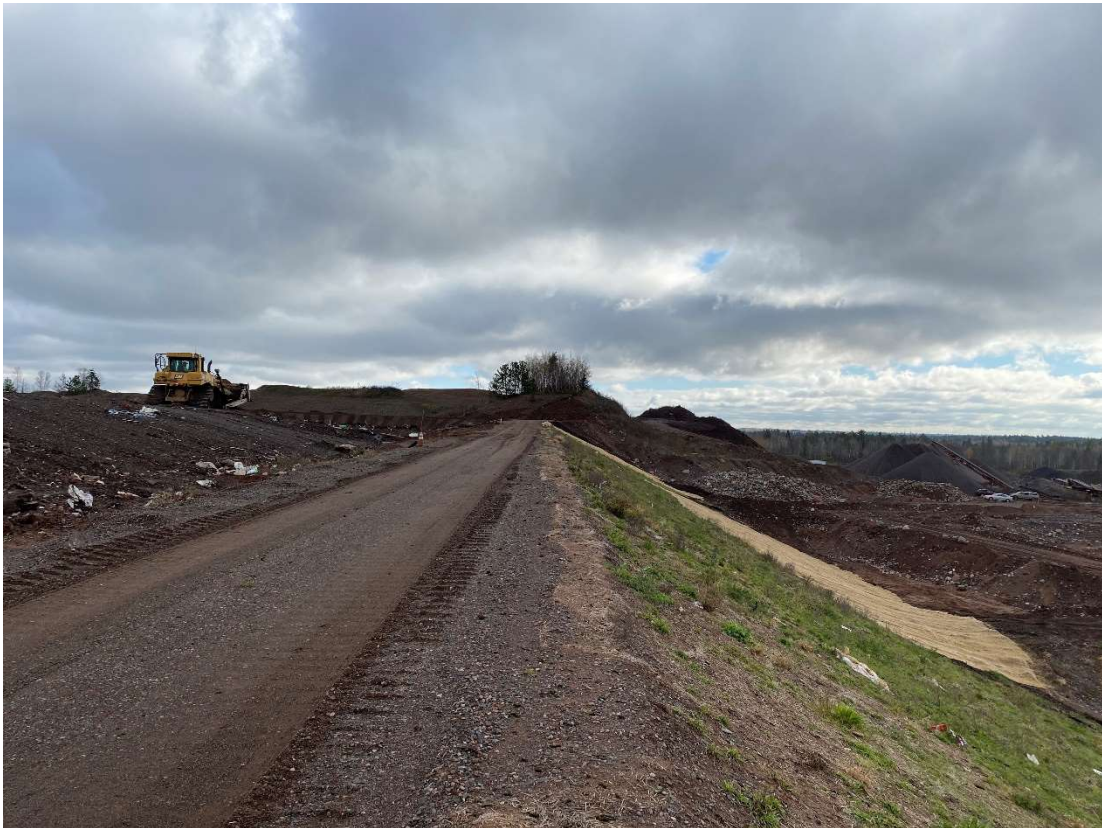
Location 7 – Looking East, Cell 6 Southern Berm

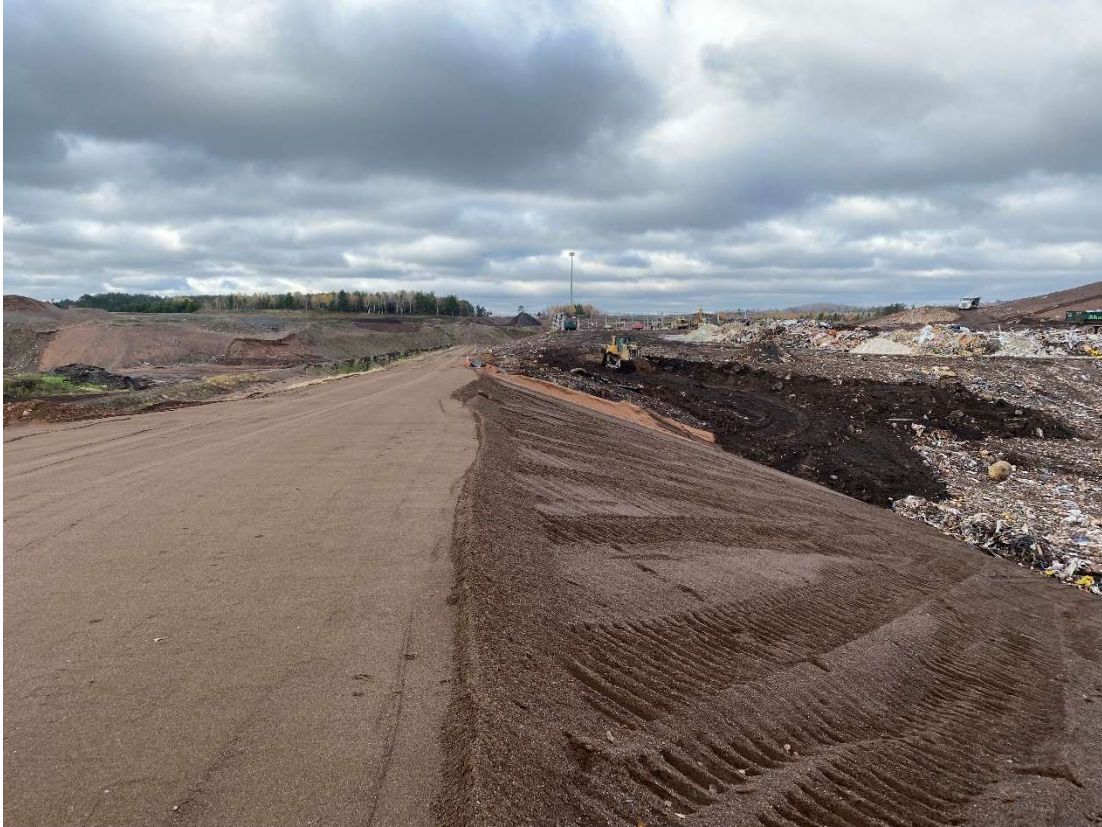
Location 8 – Looking West, Cell 6 Southern Anchor Trench

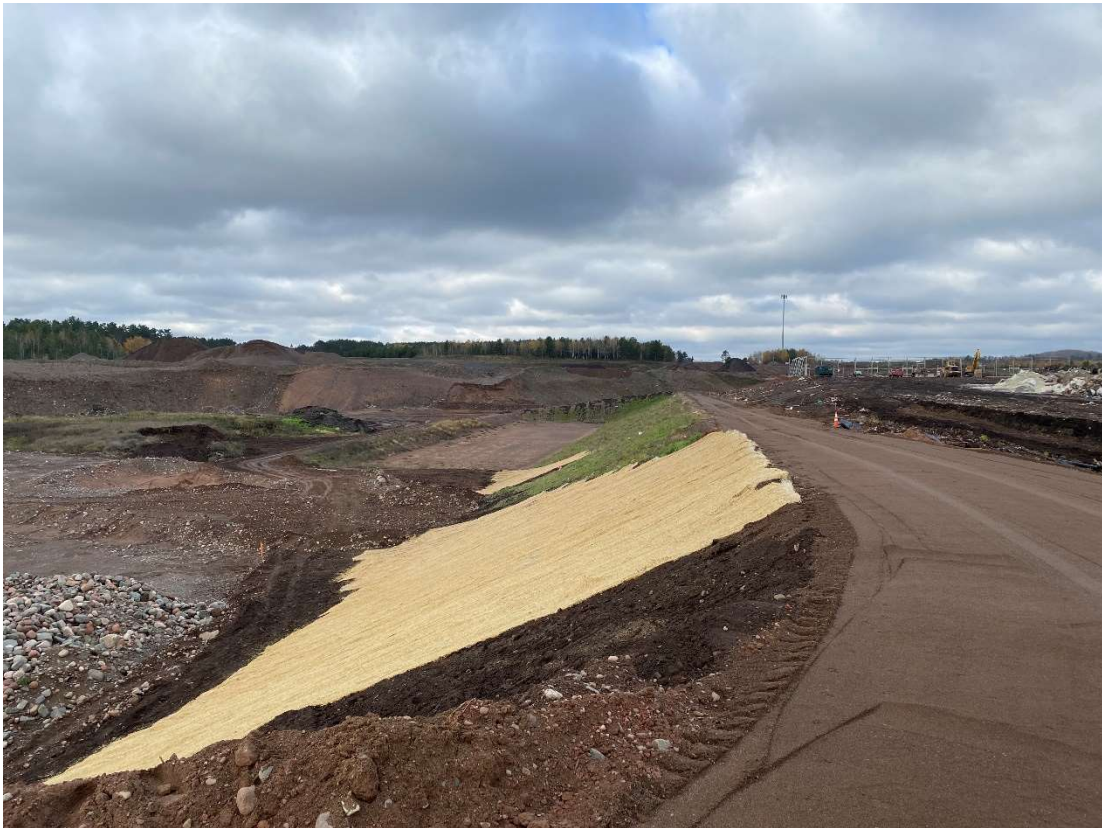
Location 8 – Looking West, Cell 6 Southern Berm

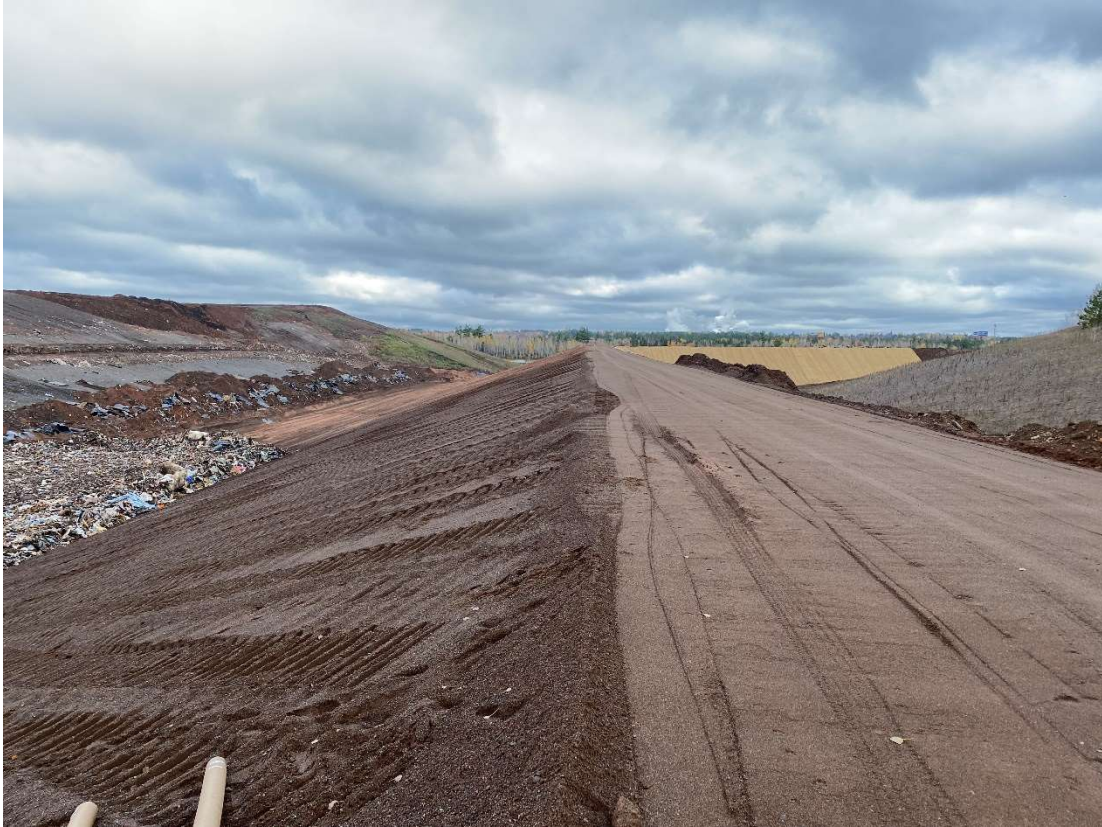
Location 8 – Looking North, Cell 6 Eastern Anchor Trench

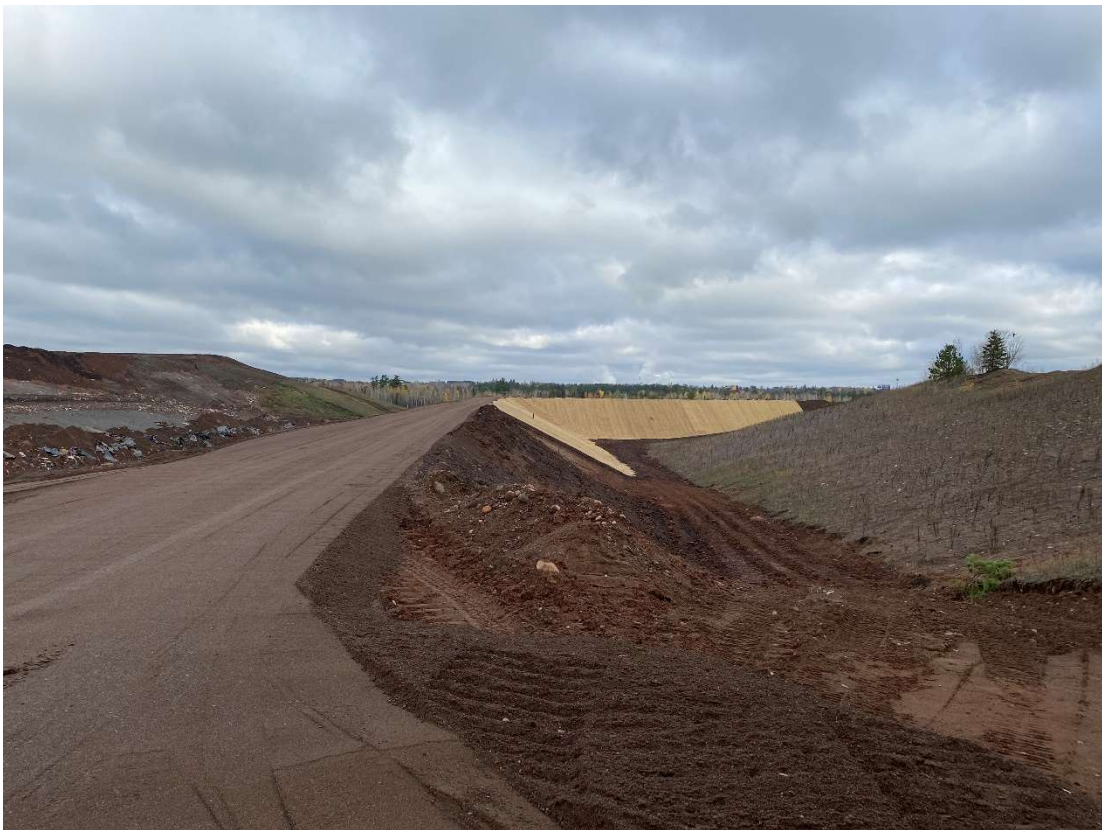
Location 8 – Looking North, Cell 6 Eastern Berm

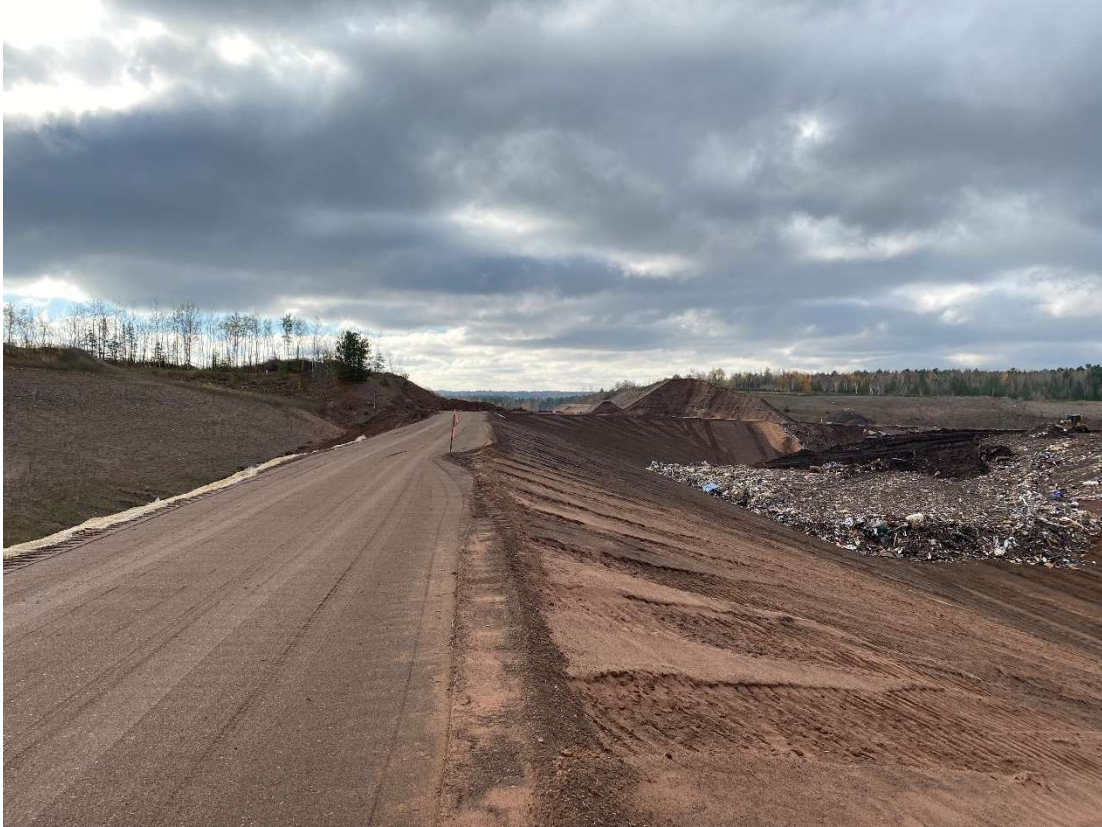
Location 9 – Looking south, Phase 6 eastern anchor trench

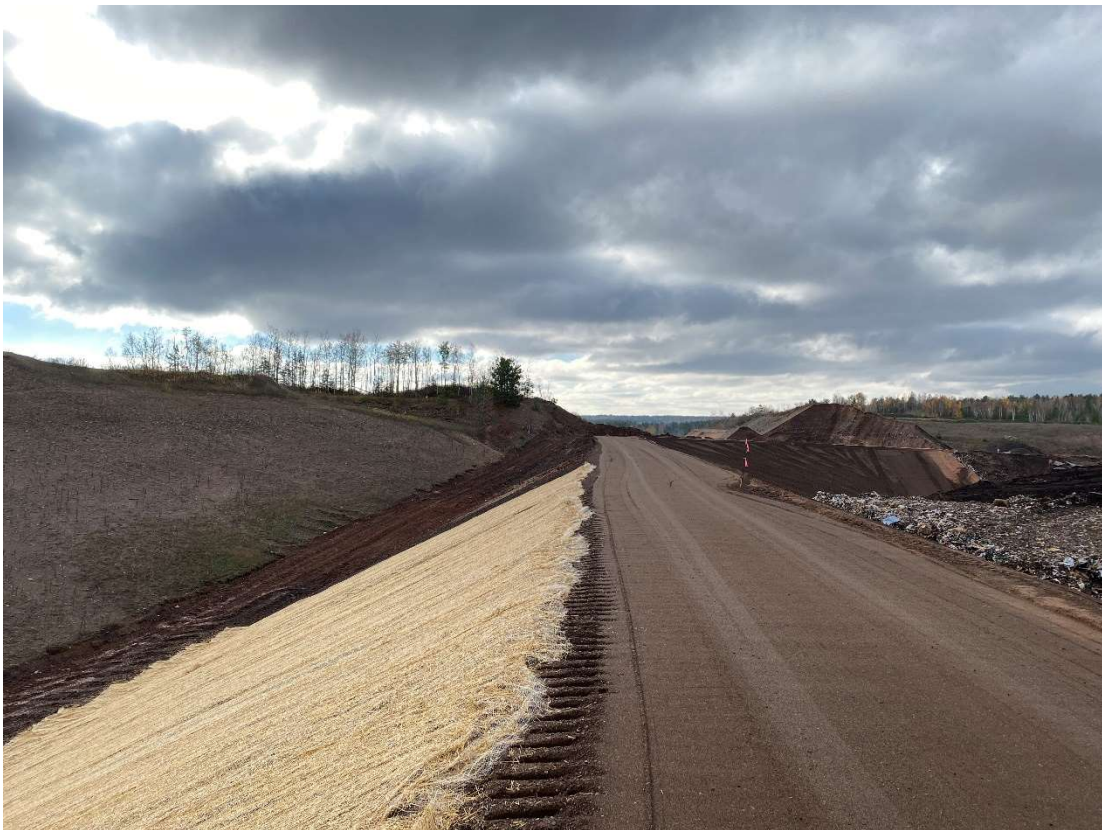
Location 9 – Looking south, Phase 6 outer landfill berm

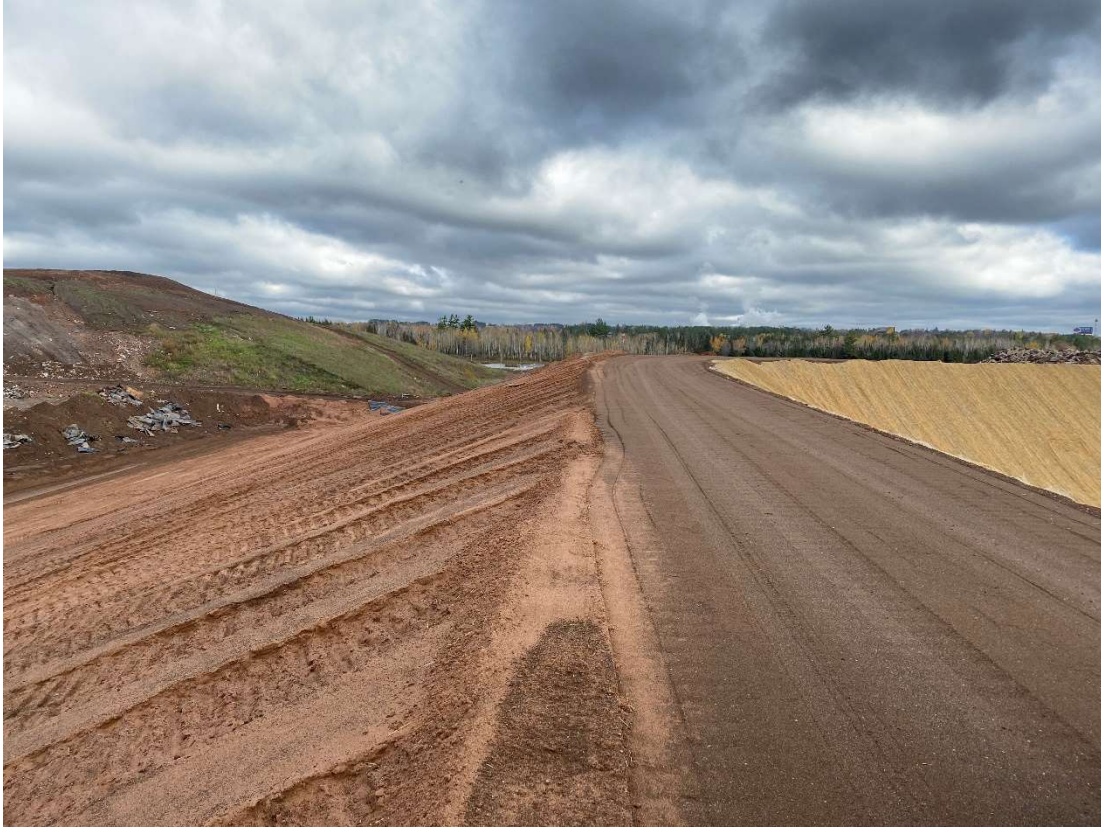
Location 9 – Looking north, Cell 4 eastern anchor trench

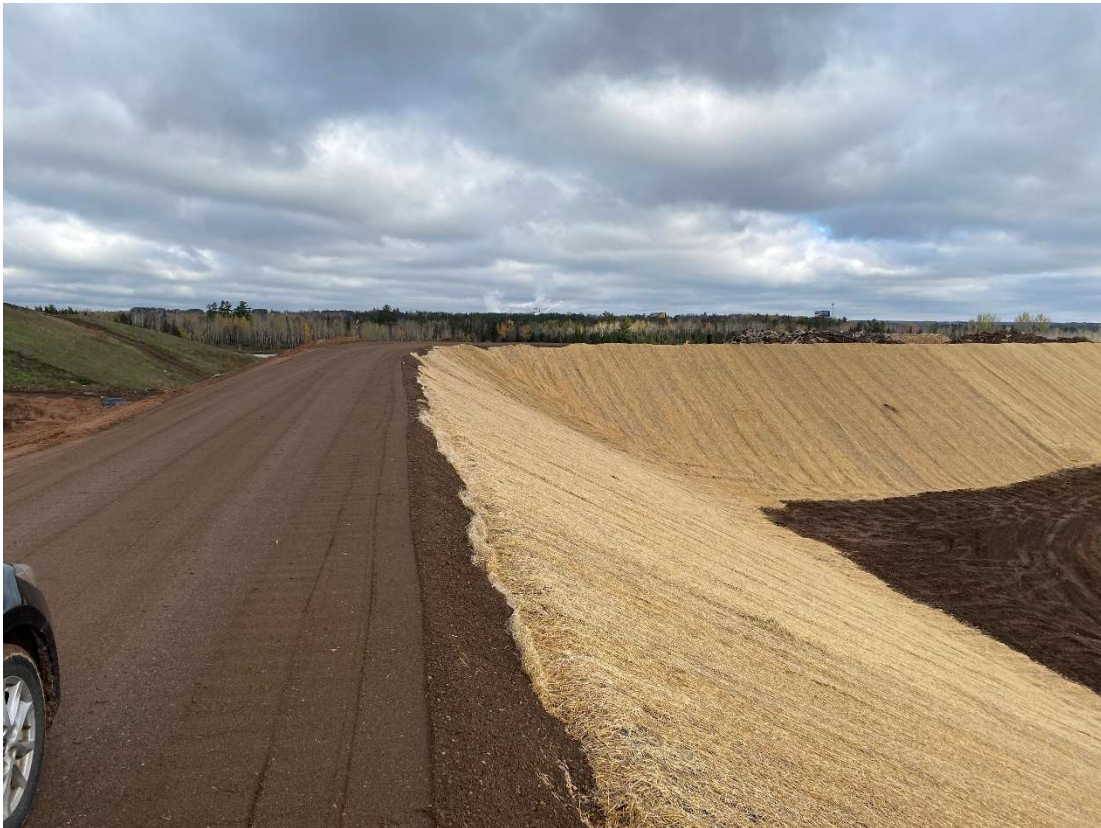
Location 9 – Looking north, Cell 4 outer landfill berm

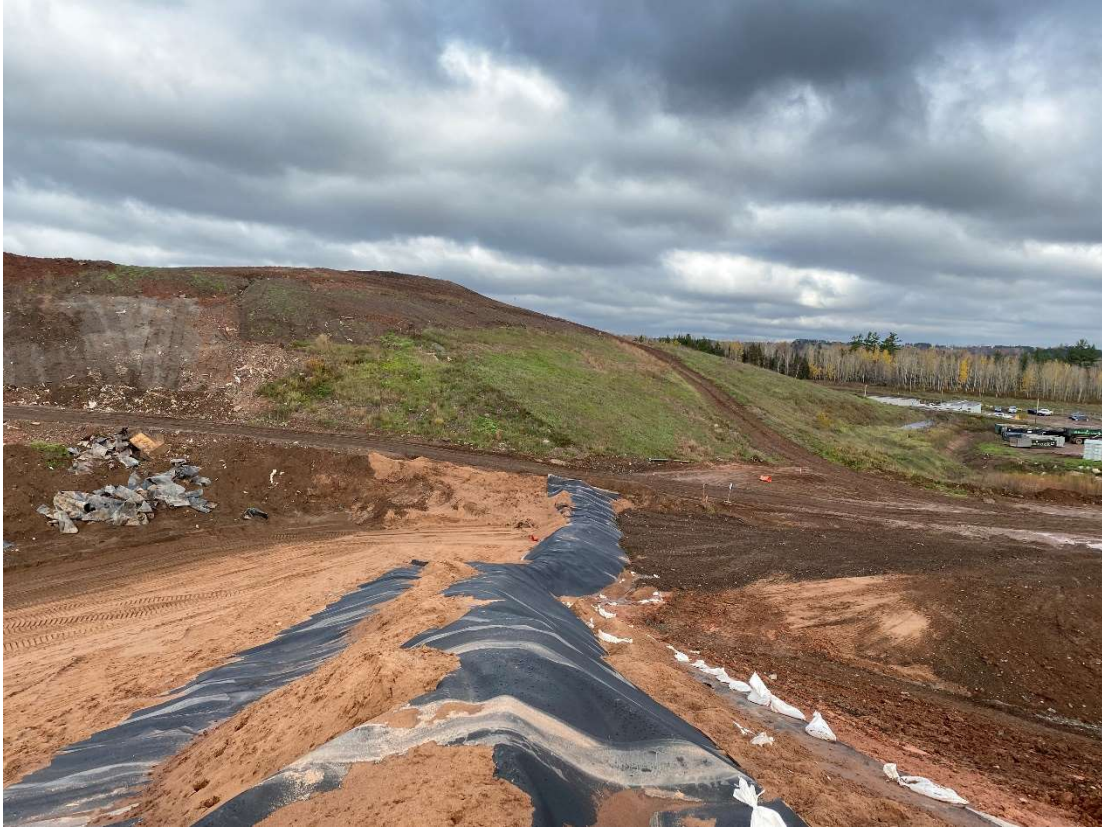
Location 10 – Looking northwest, Phase 4 eastern berm

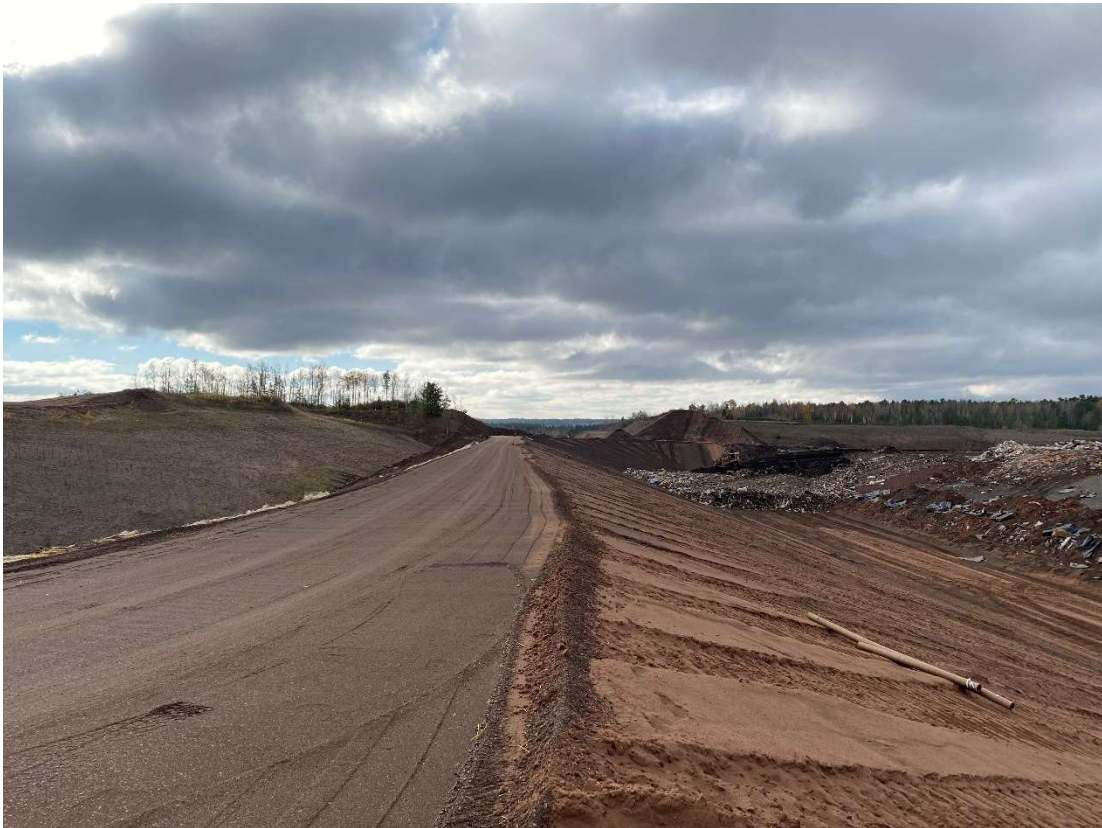
Location 10 – Looking north, Phase 4 anchor trench

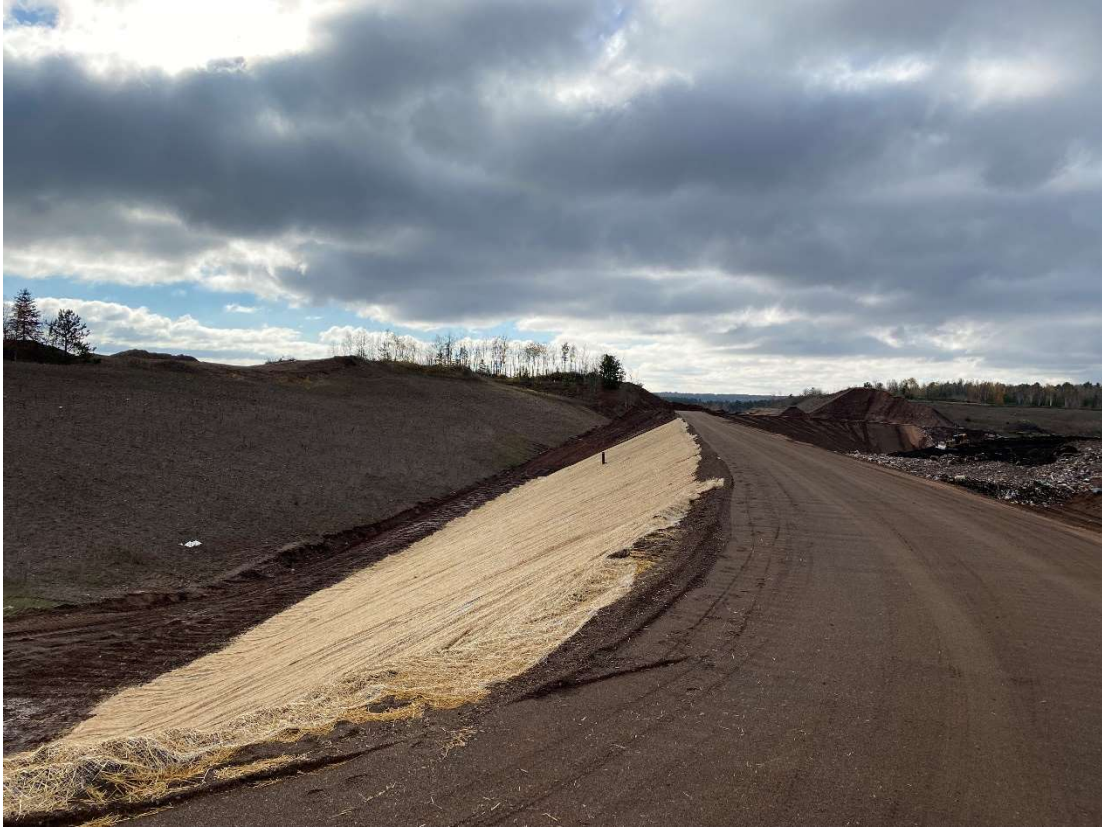
Location 10 – Looking north, Phase 4 outer landfill berm

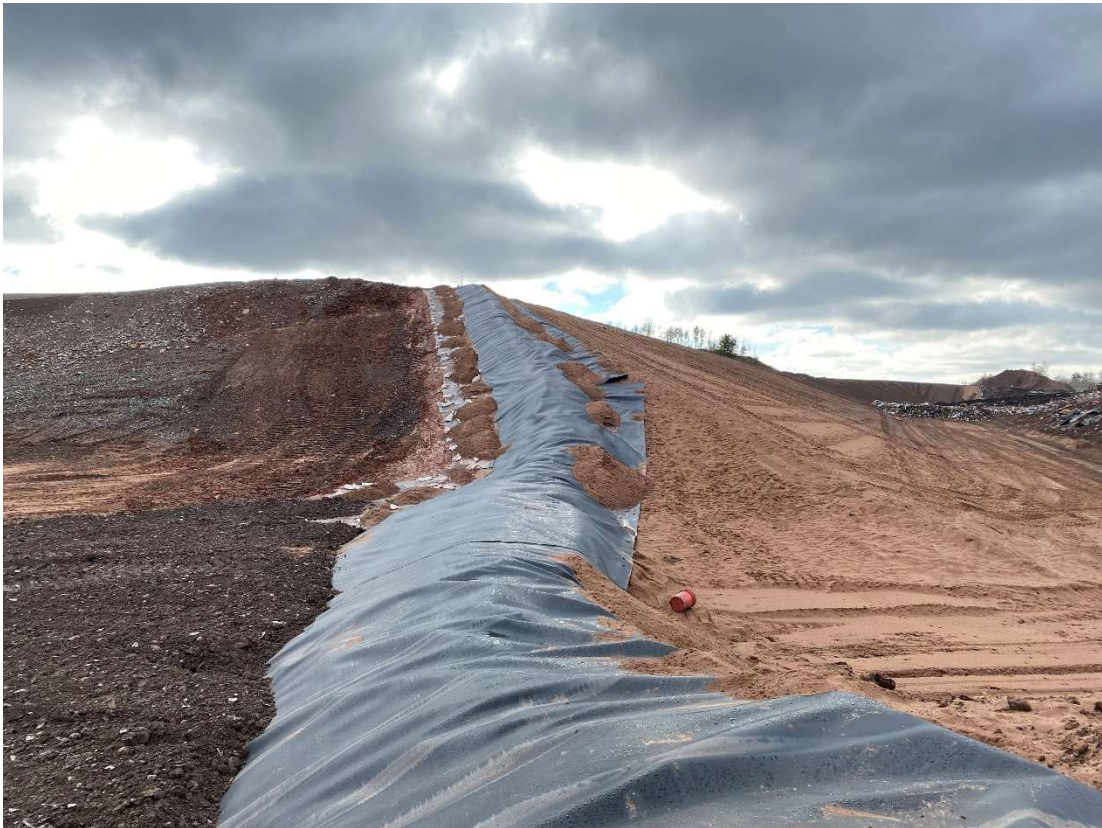
Location 11 – Looking Southwest, Phase 4 Southern rainflap

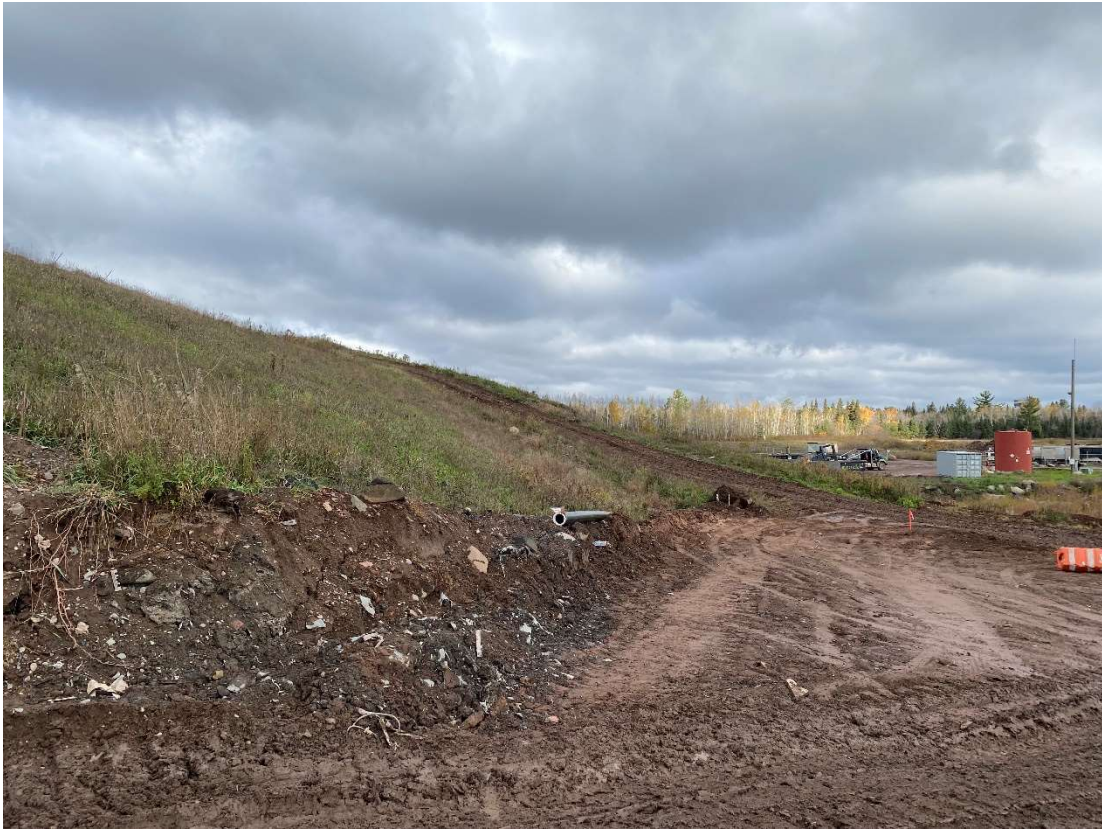
Location 11 – Looking North, Phase 1 anchor trench
