Reference: SKB Environmental Cloquet Landfill, dba Shamrock Landfill, Inc. 2022 Annual CCR Inspection Report

CCR Landfill Inspection Report

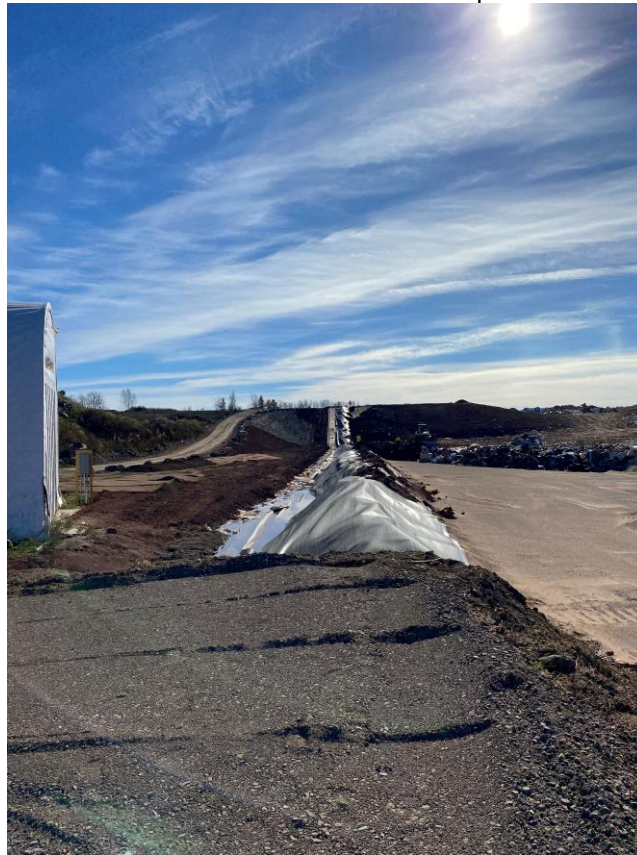
Location 1 – Looking South, Phase 7A Eastern Berm

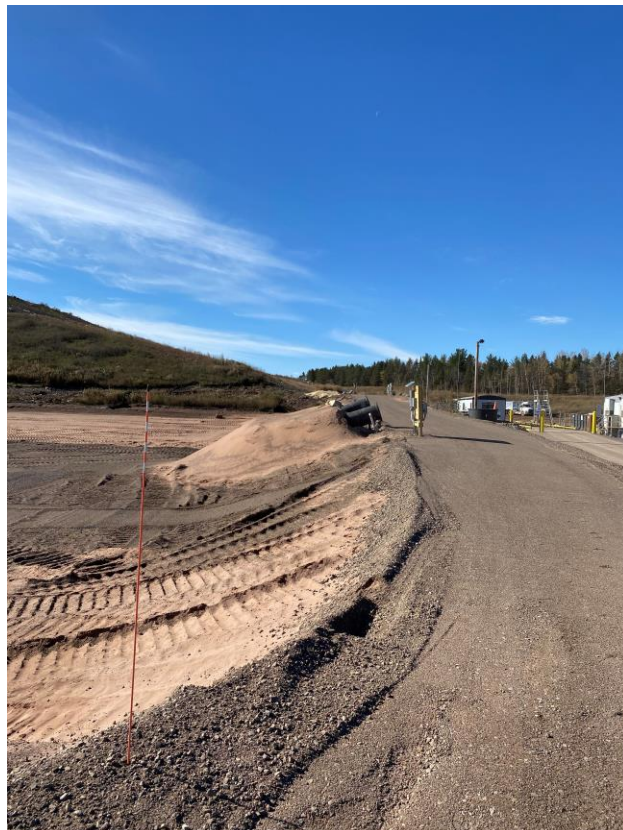
Location 1 – Looking West, Phase 7A Northern Berm

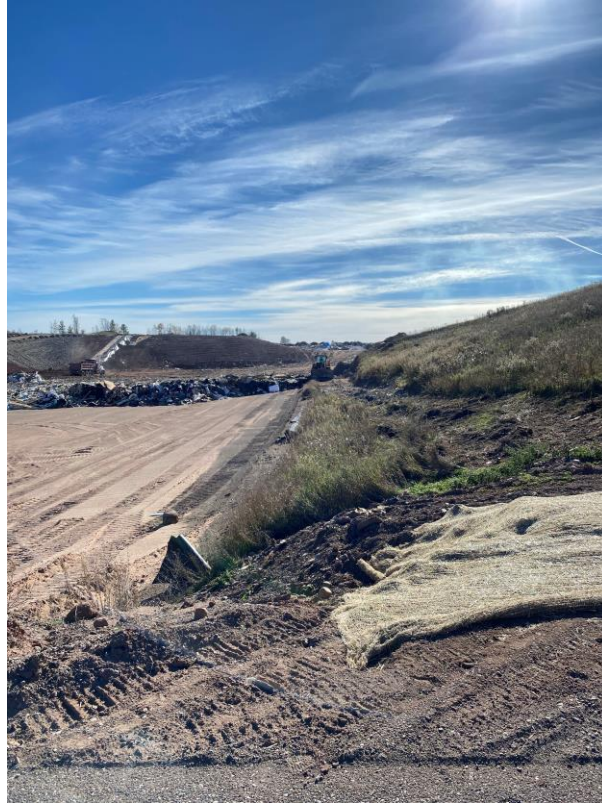
Location 2 – Looking South, Phase 1 Eastern Berm

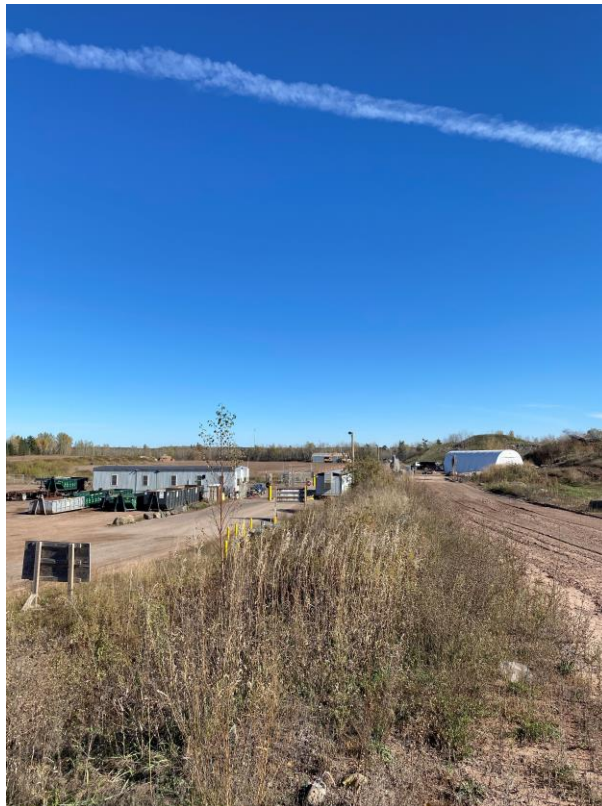
Location 3 – Looking East, Phase 1 Northern Berm

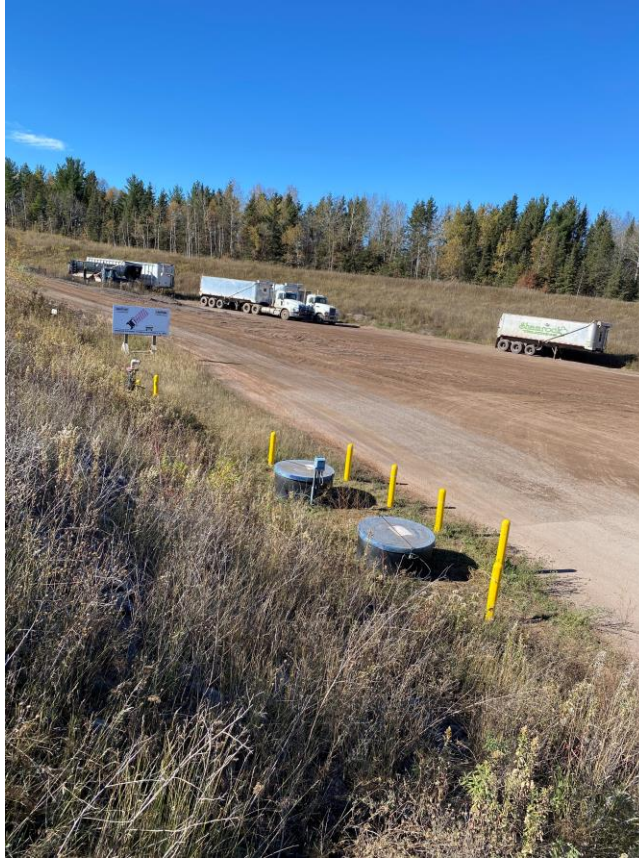
Location 3 – Looking North Phase 1

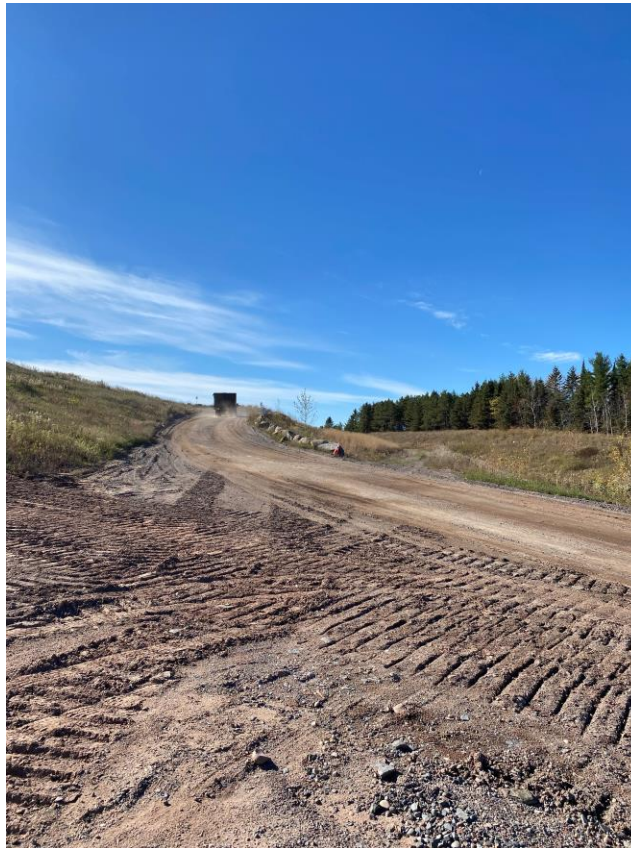
Location 3 – Looking West, Phase 2 Northern Waste Slope & Berm

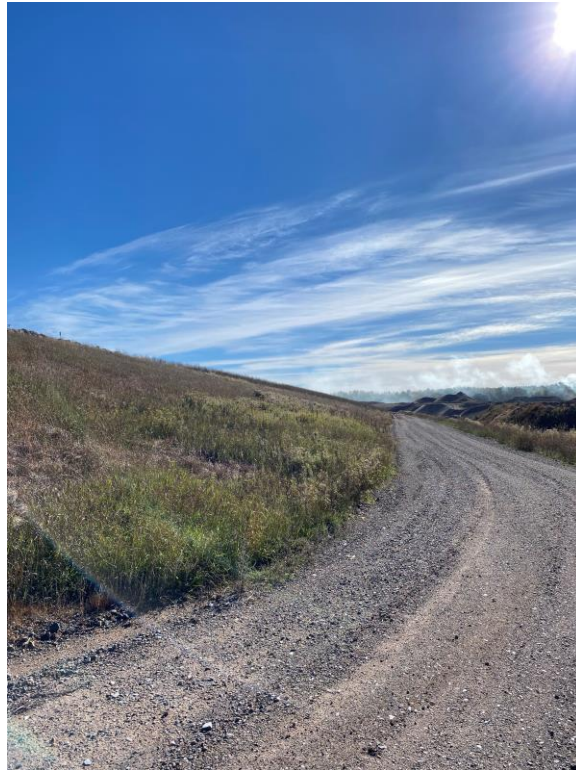
Location 4 – Looking South, Phase 2 Perimeter Road

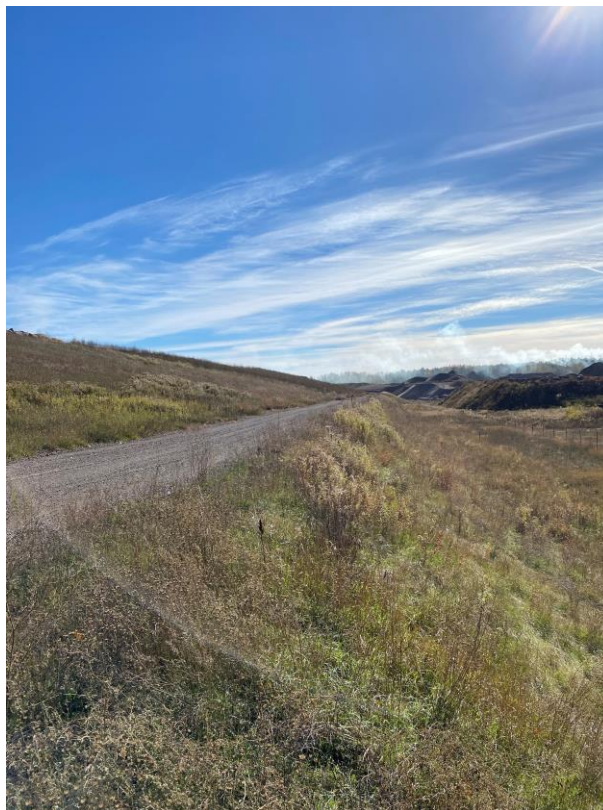
Location 4 – Looking South, Phase 2 Western Berm

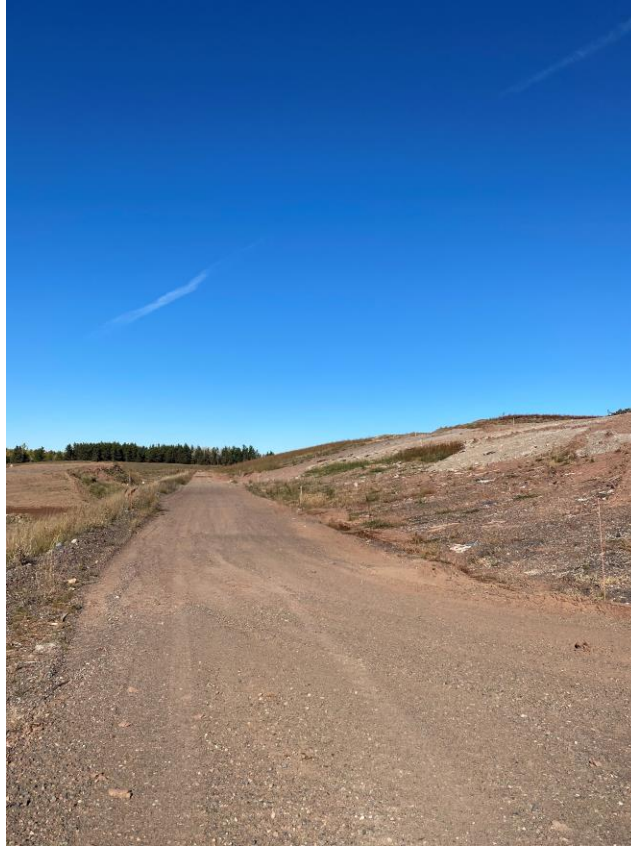
Location 5 – Looking North, Phase 2, 3, 5 Road & Berm

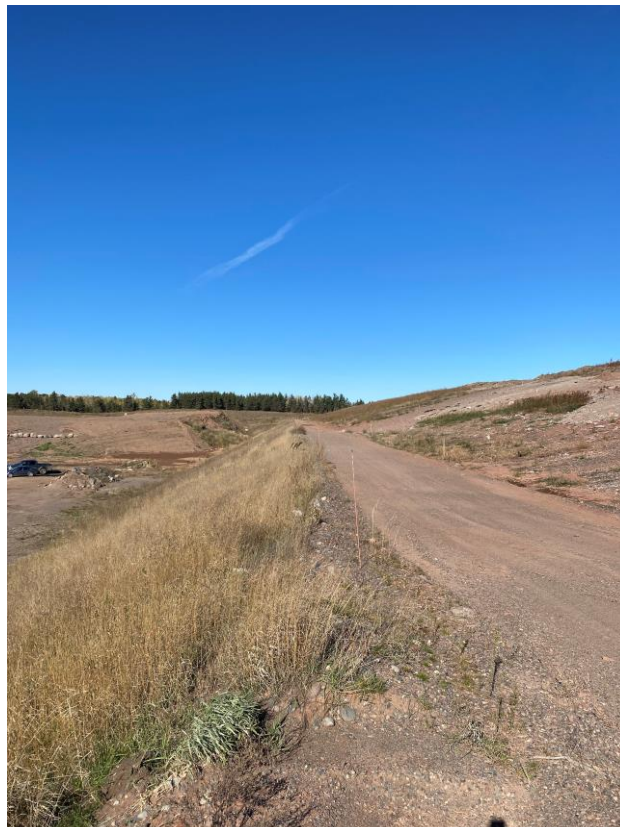
Location 5 – Looking North, Phase 2, 3, 5 Western Berm

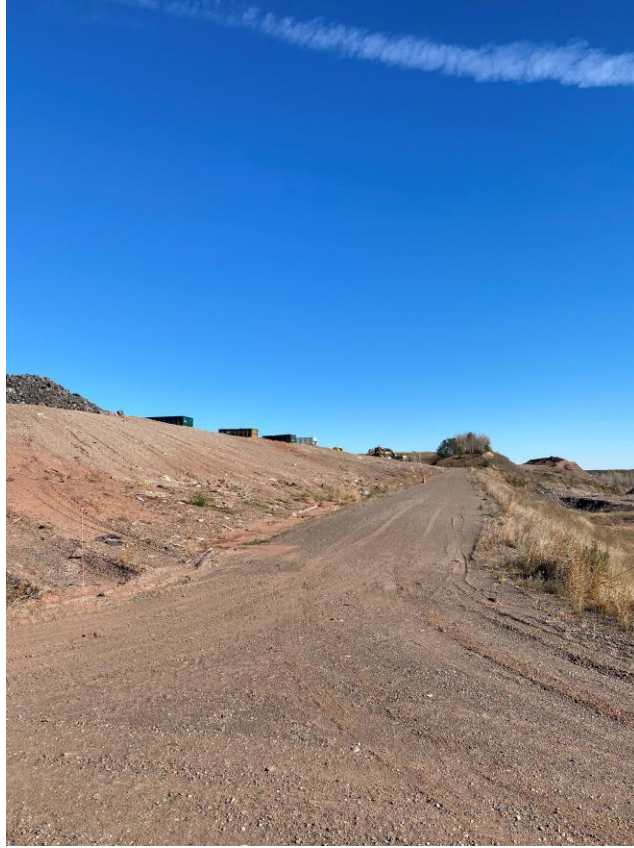
Location 5 – Looking East, Phase 5 Southern Road

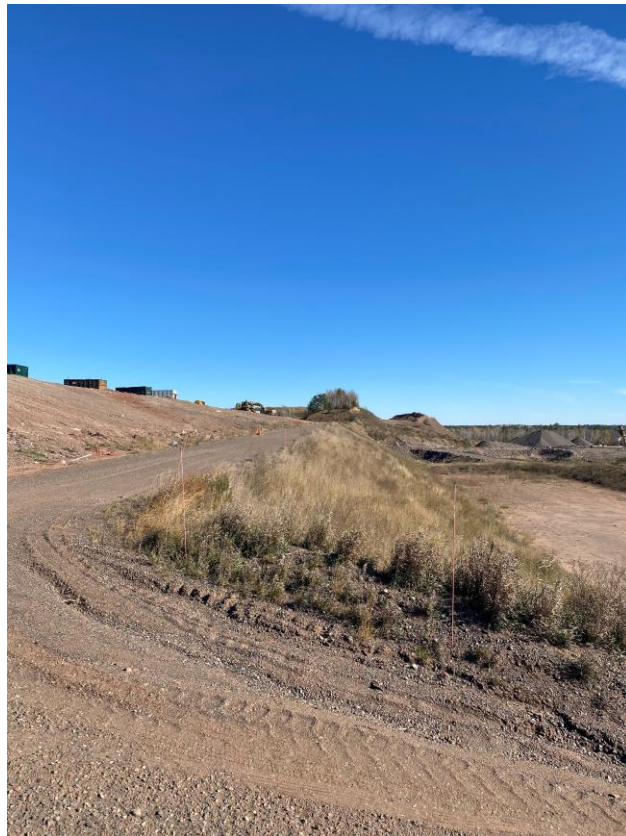
Location 5 – Looking East, Phase 5 Southern Berm

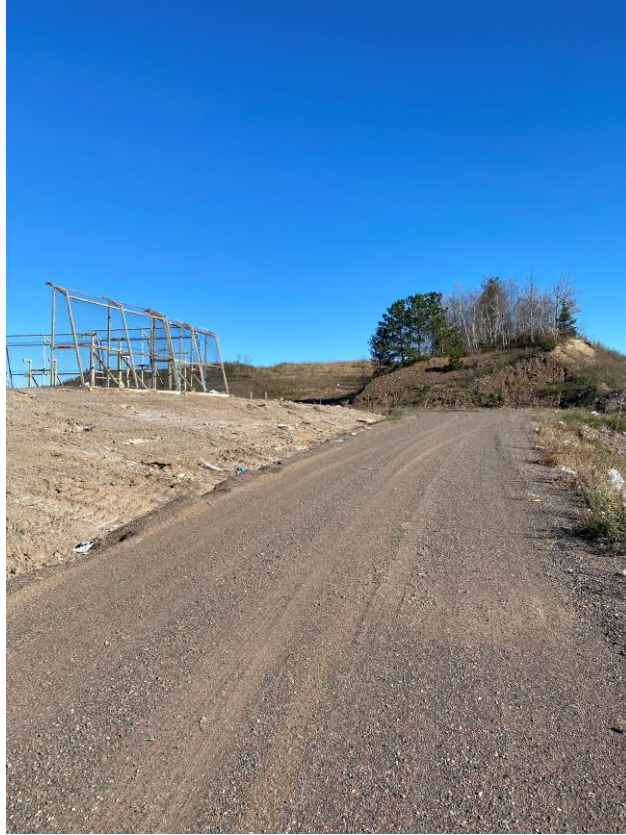
Location 6 – Looking East, Phase 6 Southern Road

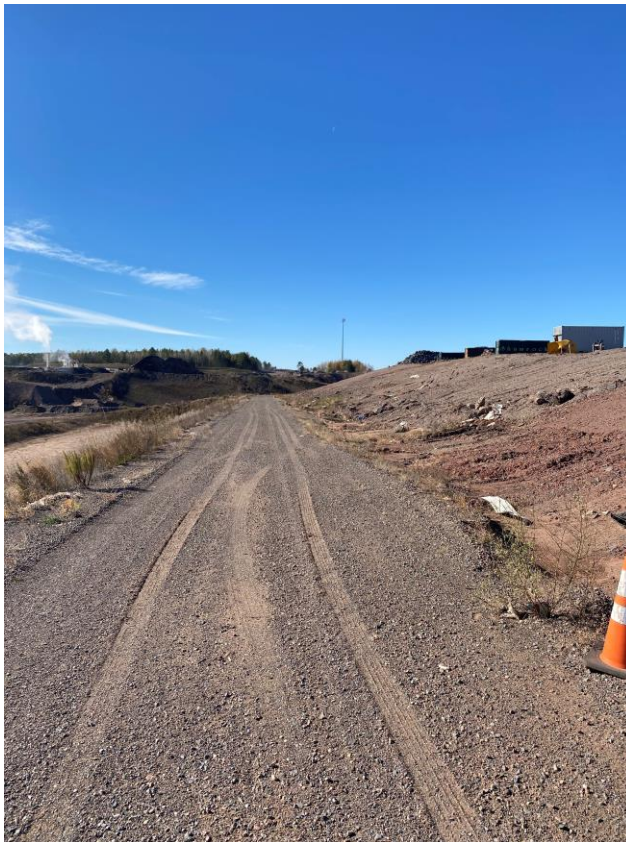
Location 6 – Looking West, Phase 6 Southern Road

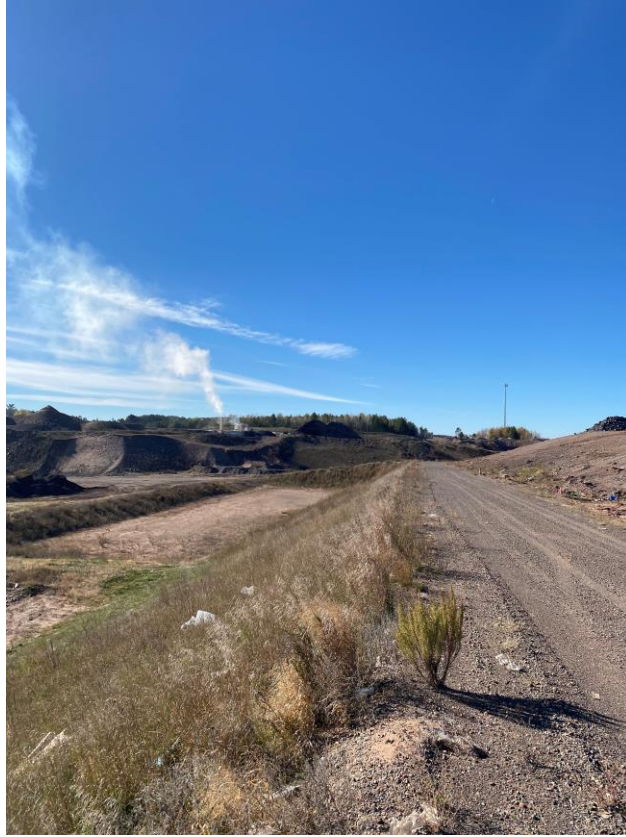
Location 6 – Looking West, Phase 6 South LF Berm

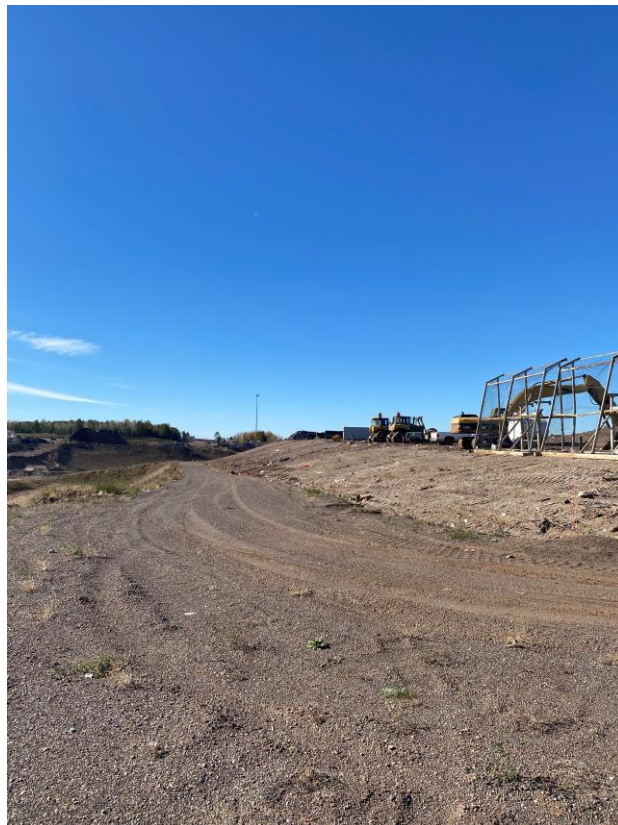
Location 7 – Looking West, Phase 6

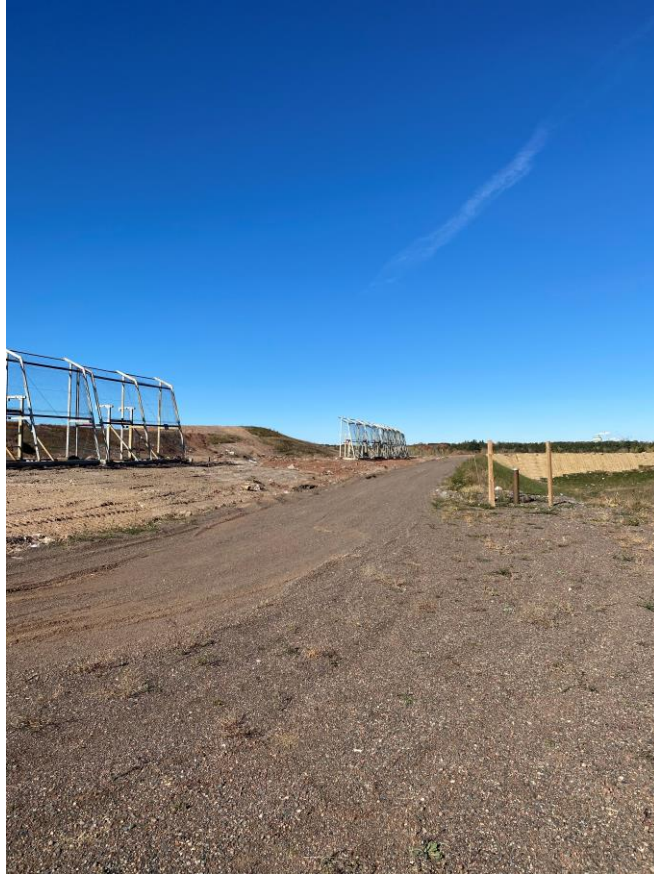
Location 7 – Looking North, Phase 6 Eastern Road

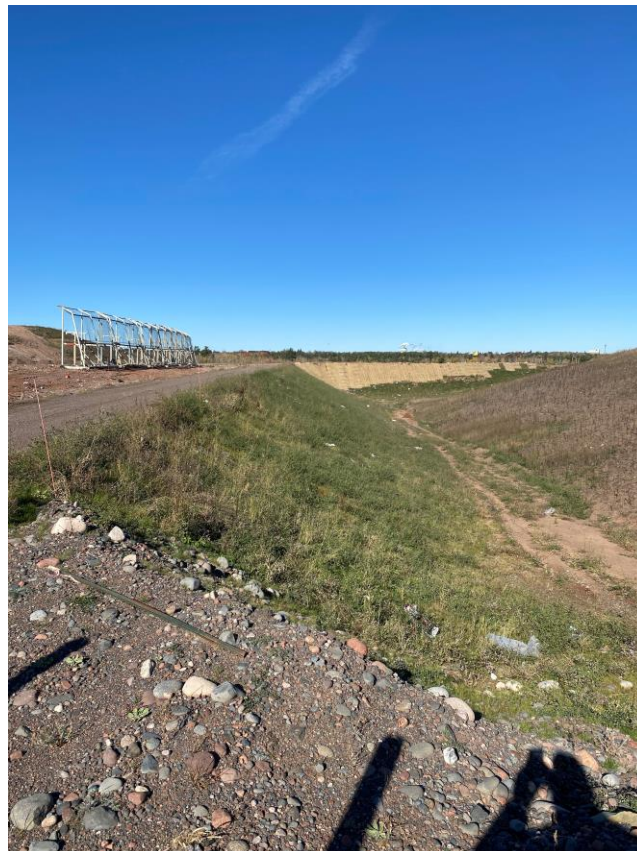
Location 7 – Looking North, Phase 6 Eastern Berm

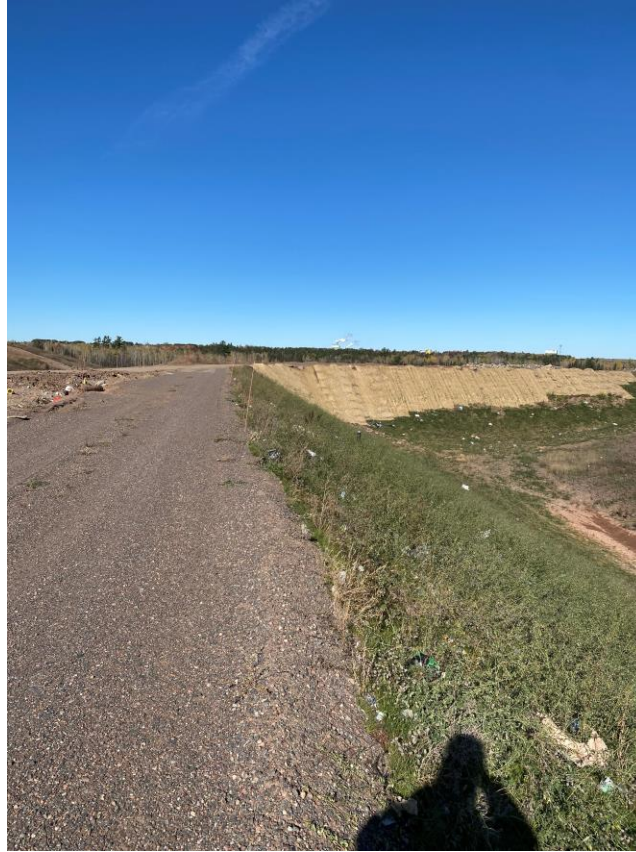
Location 8 – Looking North Phase 4 Berm

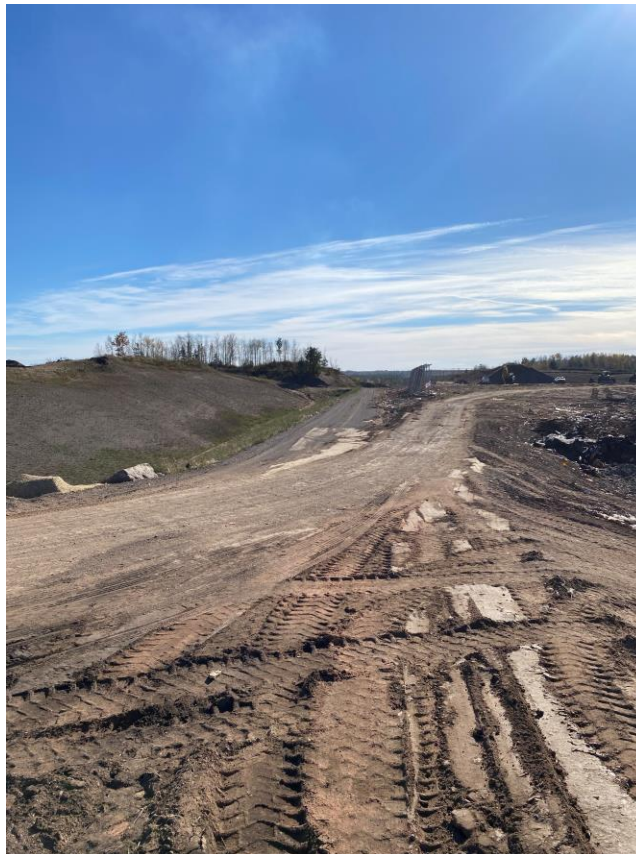
Location 9 – Looking South, Phase 4 East Road

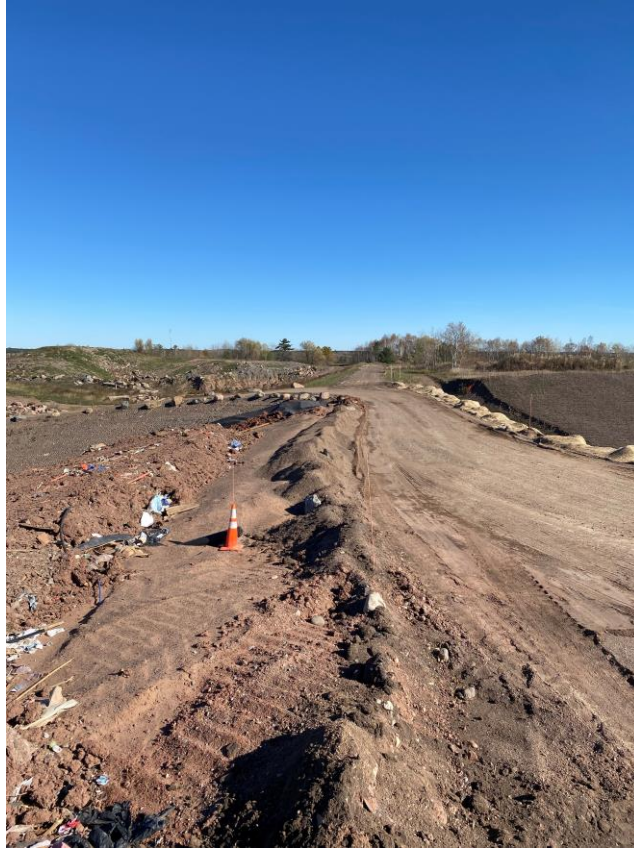
Location 9 – Looking East, Cell 7 Southern Anchor Trench

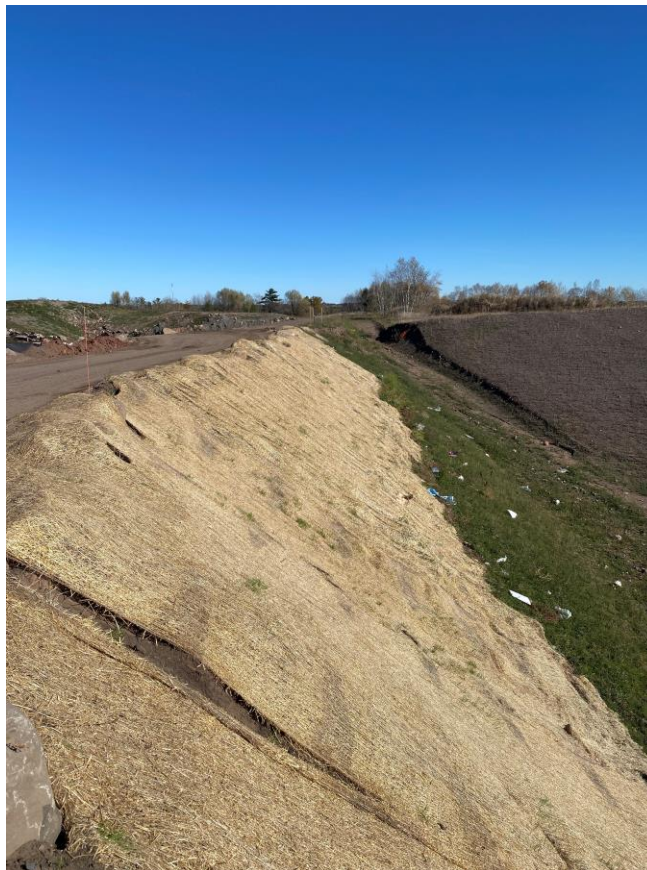
Location 9 – Looking East, Cell 7 Berm

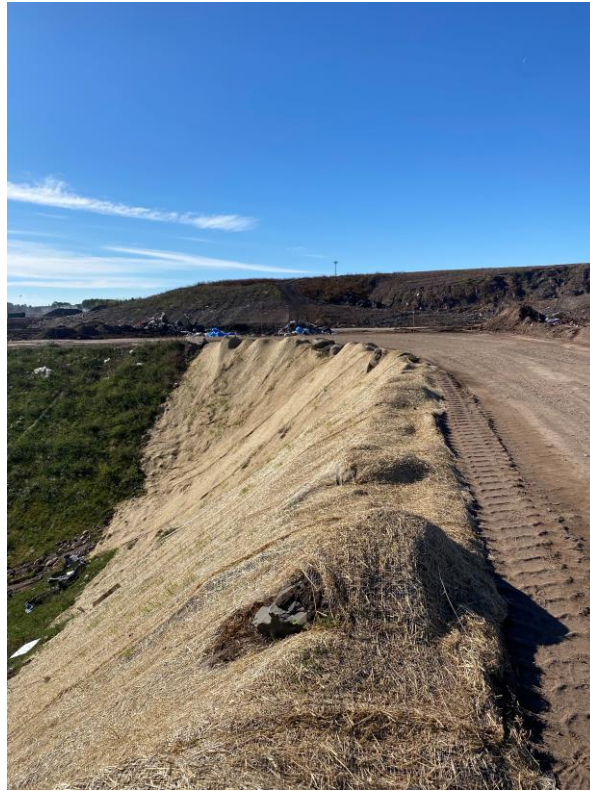
Location 10 – Looking West, Cell 7 Southern Berm

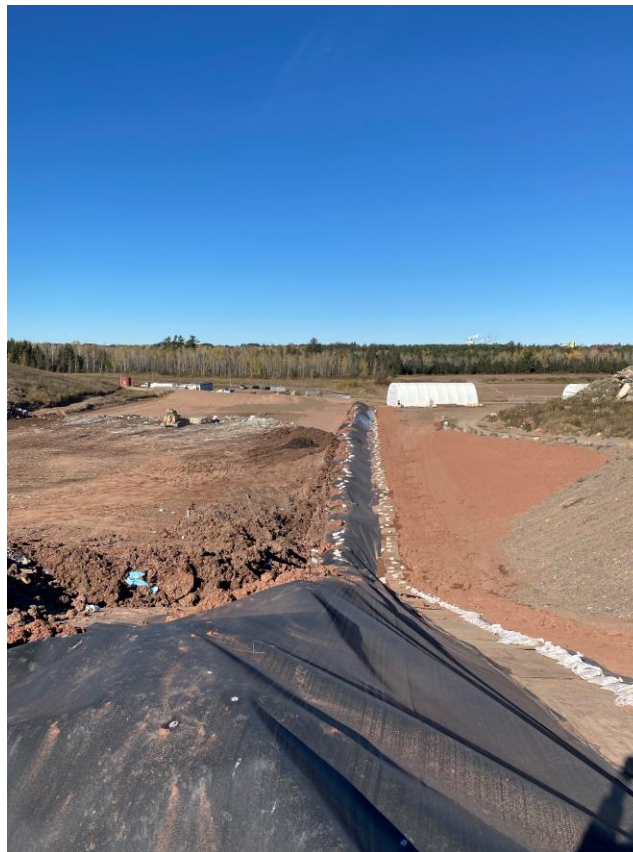
Location 10 – Looking North, Cell 7 Eastern Berm

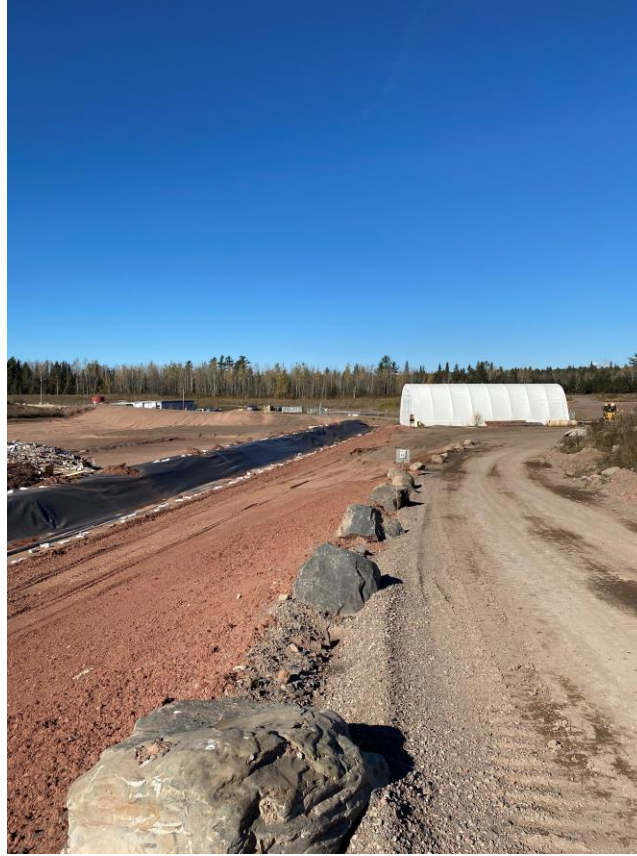
Location 11 – Looking North, Cell 7 Eastern Berm

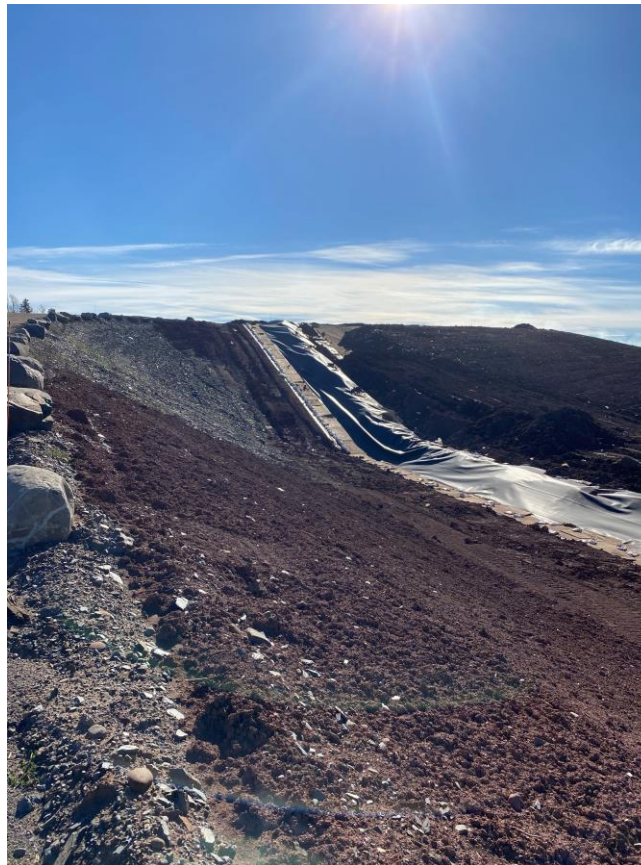
Location 11 – Looking South, Cell 7 Eastern Berm
