Reference: **SKB Environmental Cloquet Landfill, dba Shamrock Landfill, Inc. 2024 Annual CCR Inspection Report**

Reference: Shamrock Landfill, Inc. 2024 Annual CCR Inspection Report

SEAL	SUB CONSULTANT	PRIME CONSULTANT	PROJECT TITLE 2024 CCR INSPECTION REPORT	SHEET TITLE PHOTO LOCATIONS

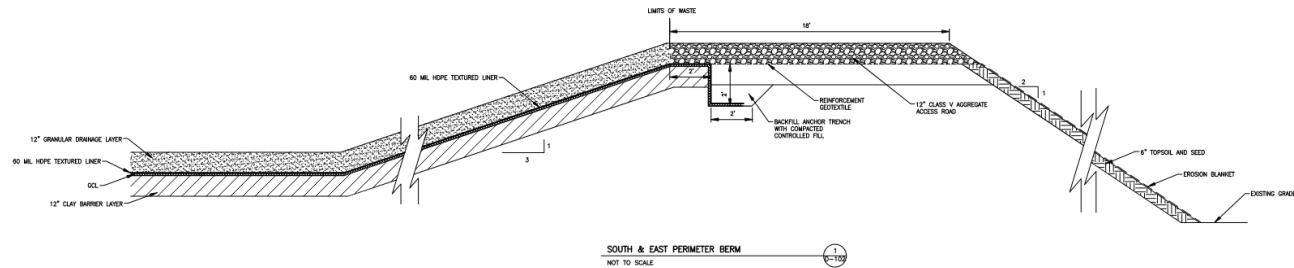
Typical Landfill Berm Detail

Most of the facility's landfill cell embankments were constructed using on-site borrow material, which consisted of silty clay and clayey sand type soils. The fill was placed and compacted to 95% of Standard Proctor Dry Density in lift thicknesses ranging from 8 inches to 12 inches. The final subgrade surface was proof rolled prior to geosynthetics installation. A typical perimeter section taken from the Phase 7 Construction Documentation Report prepared by Stantec in September 2022 is shown below.

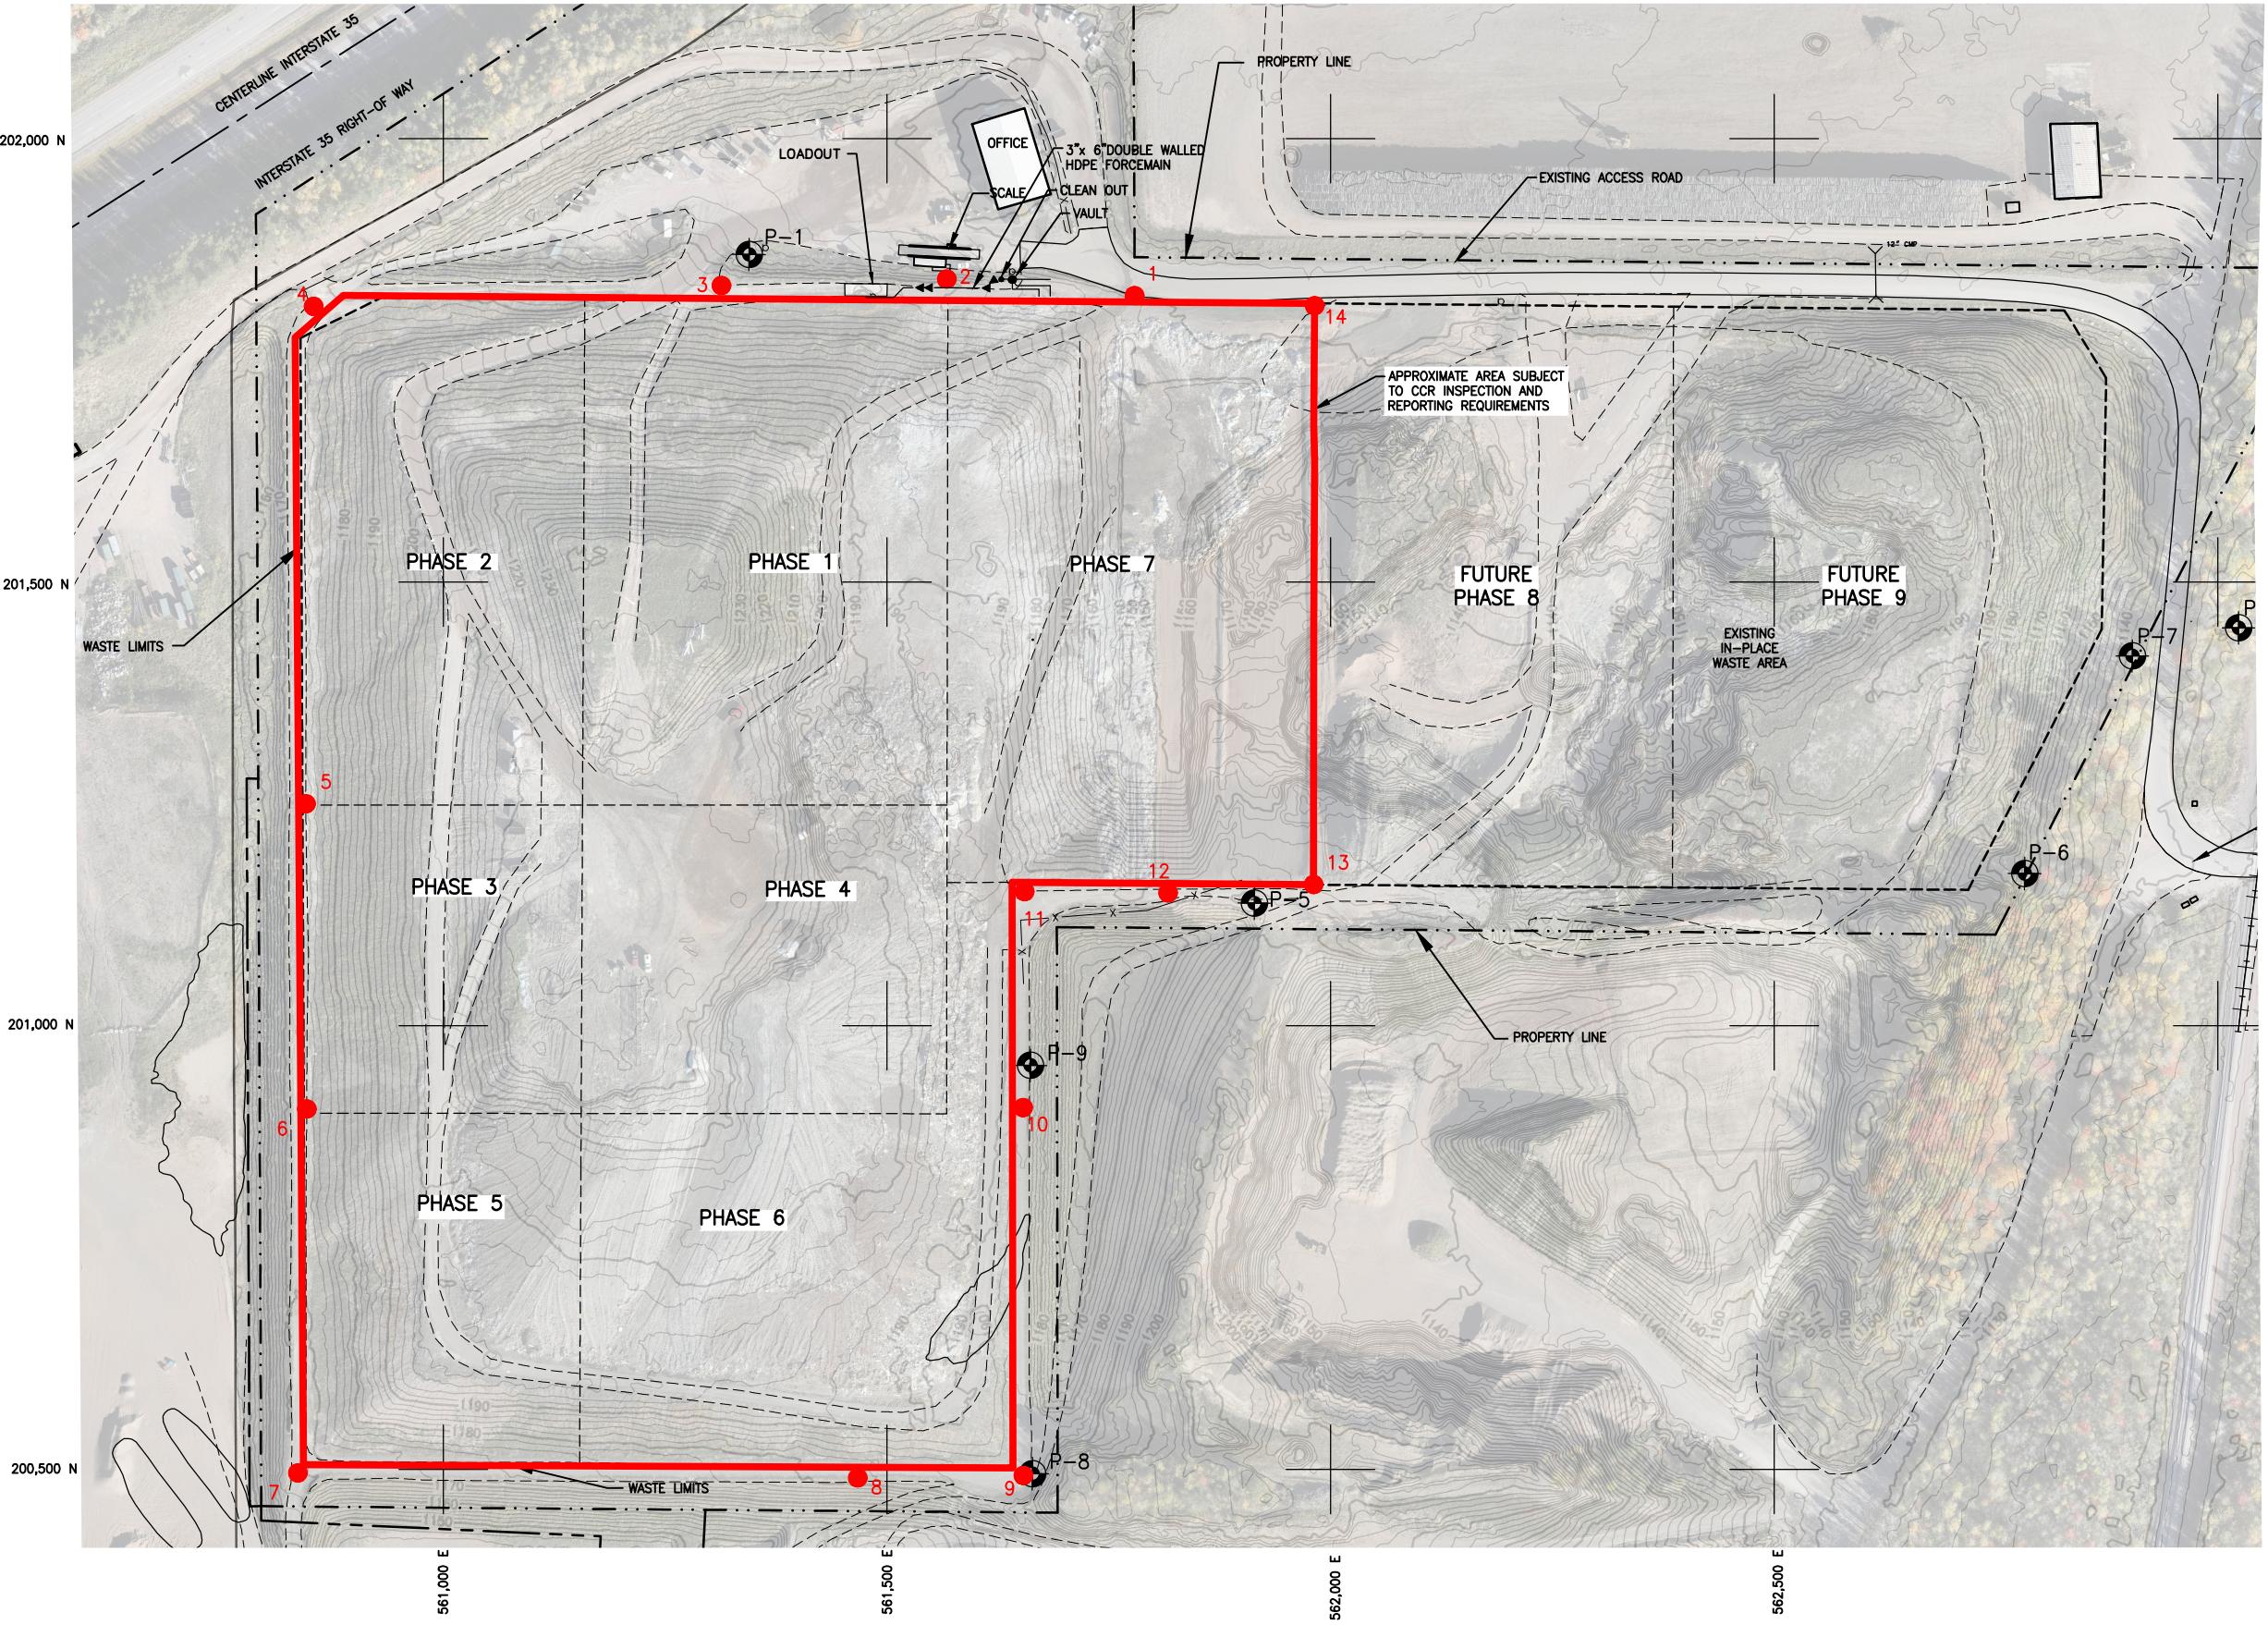
Photos were taken during the inspection. Figure 1 presents the photo locations, and Attachment 1 contains a photo log and the photos taken.

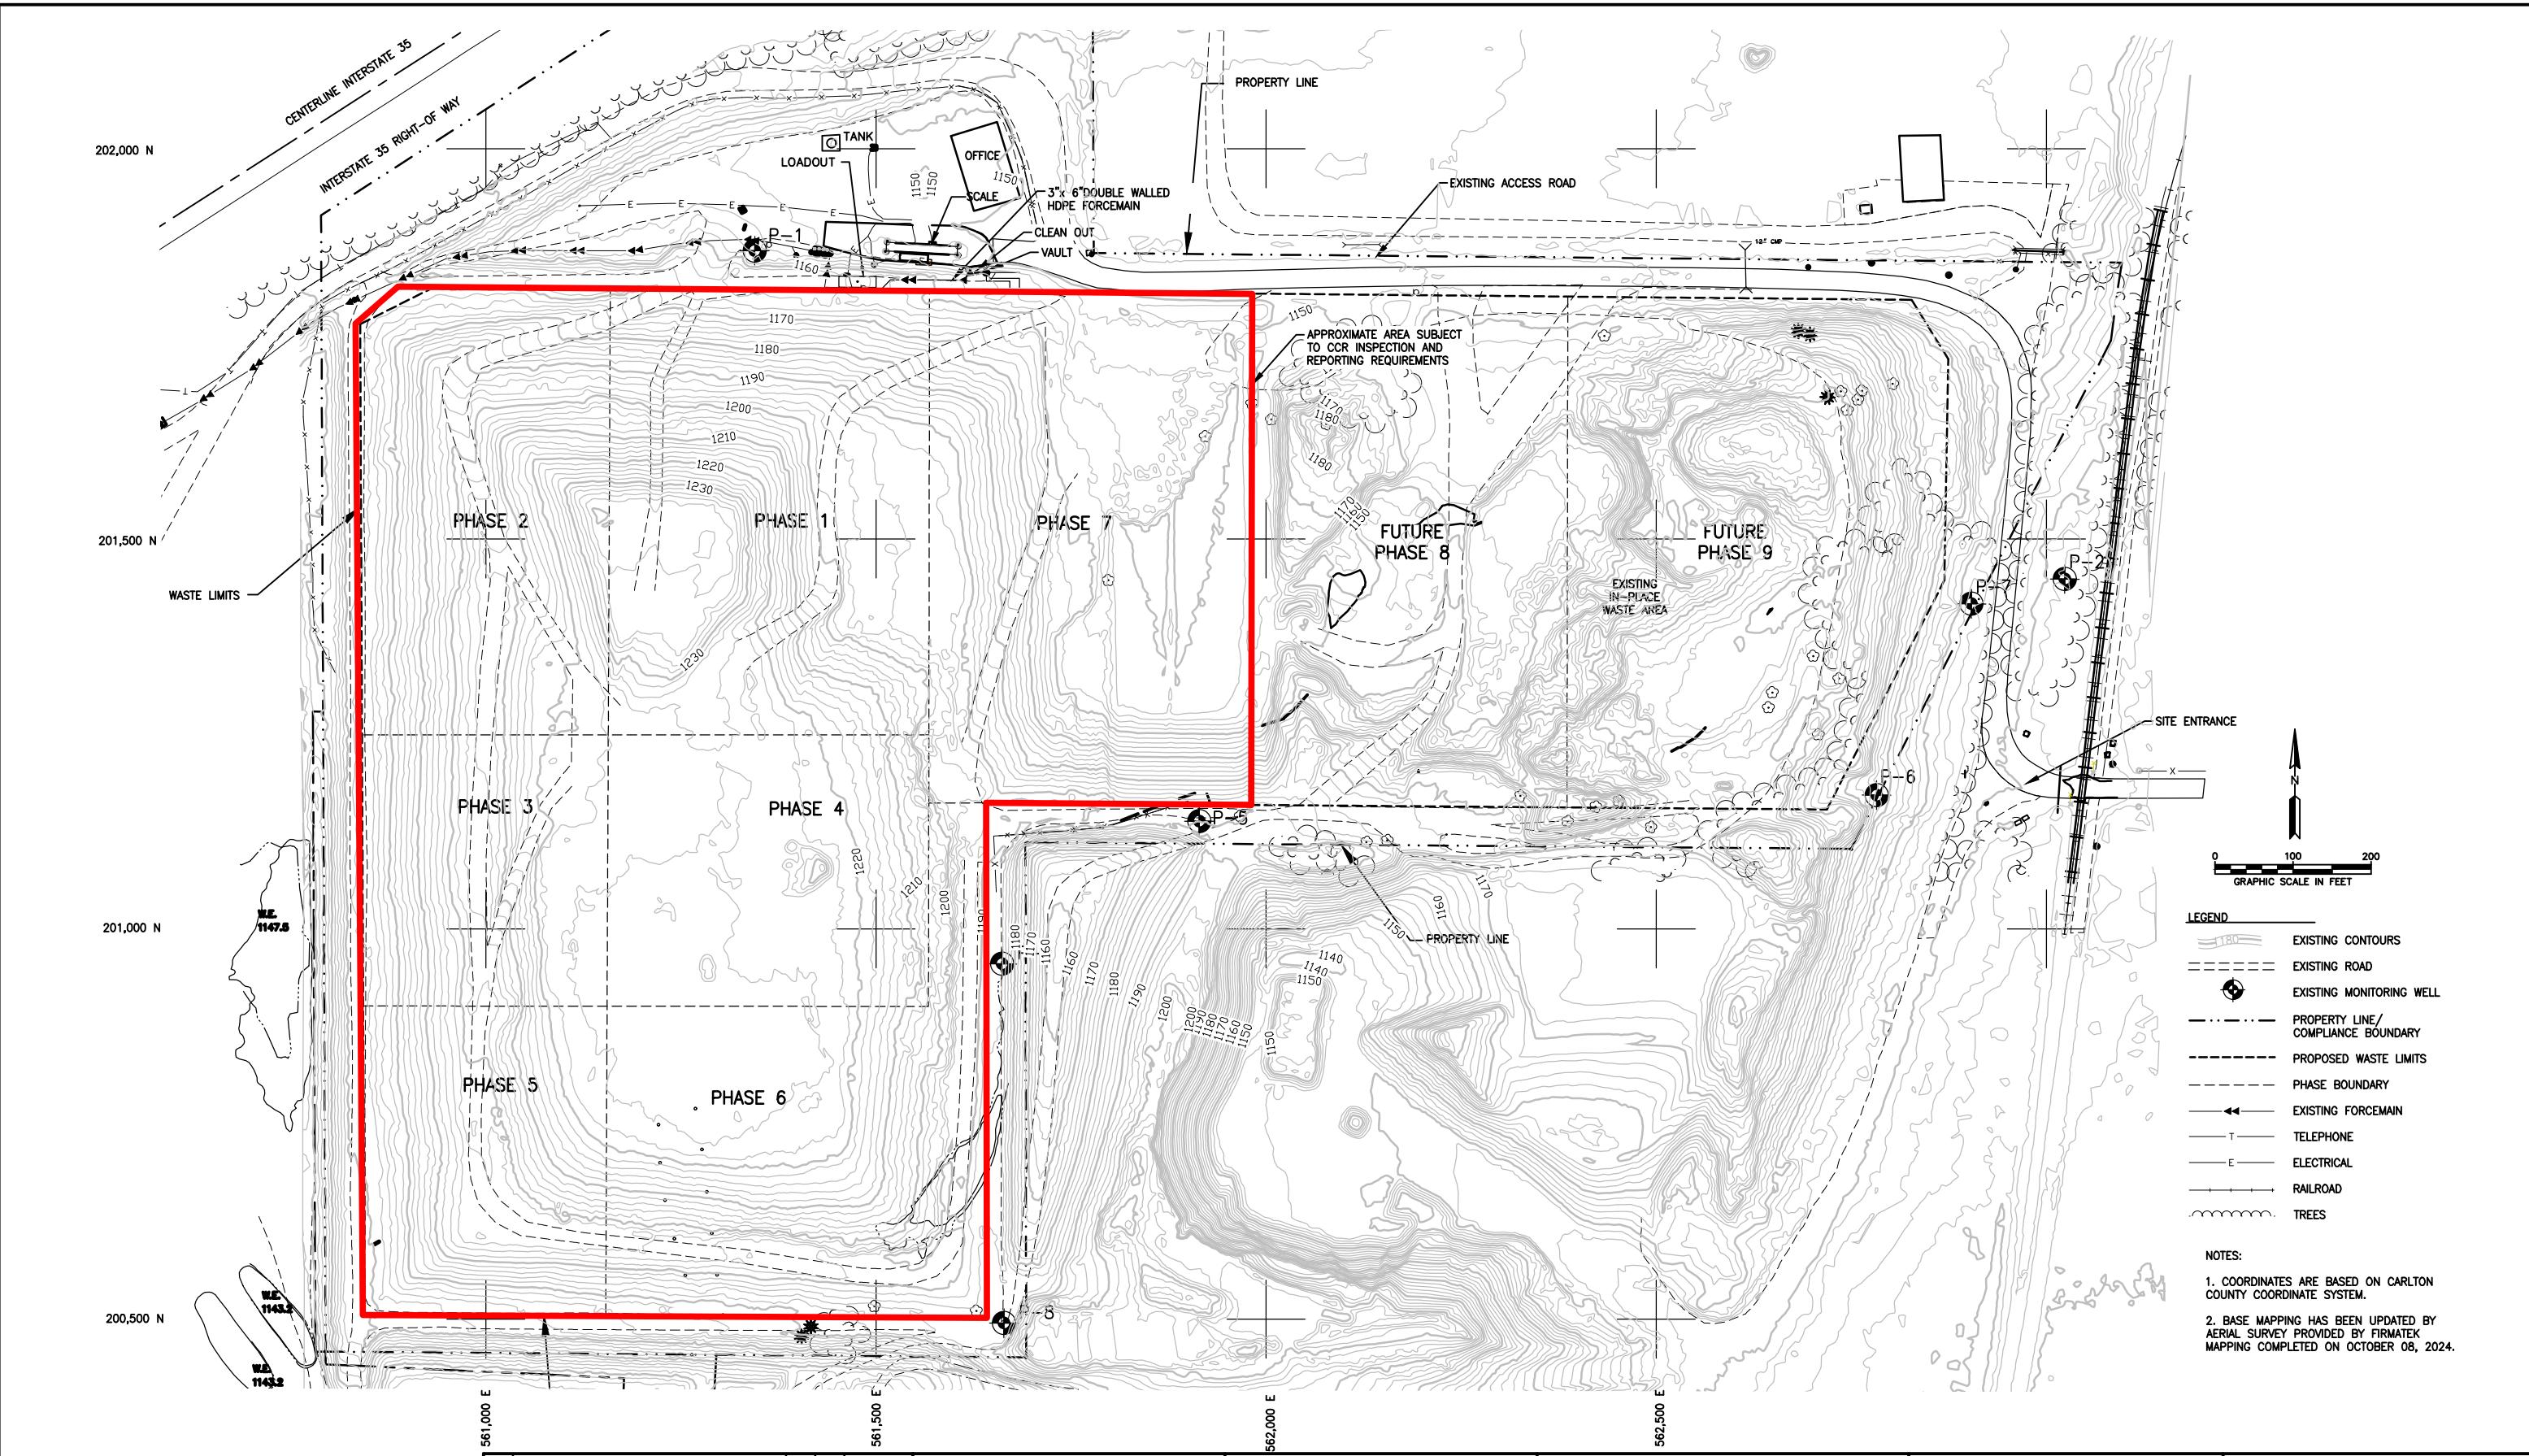
Other than the construction of Phase 7B-2, there were no apparent changes to the embankment geometry of Phases 1 through 7B-2 when compared to the permit drawings or the past inspection reports. The annual aerial photogrammetry survey was performed on October 8, 2024, which the estimated in-place volume of total waste (including all accepted wastes) is based on. A comparison 2024 and 2023 aerial survey confirm that the embankment and slope topography is substantially unchanged with no significant movement. The Existing Conditions Plan with the 2024 topographic survey is included as Figure 2.
