File: 227704387

Date: January 7, 2026

**Reference:** **SKB Environmental Cloquet Landfill, Inc. 2025 Annual CCR Inspection Report**

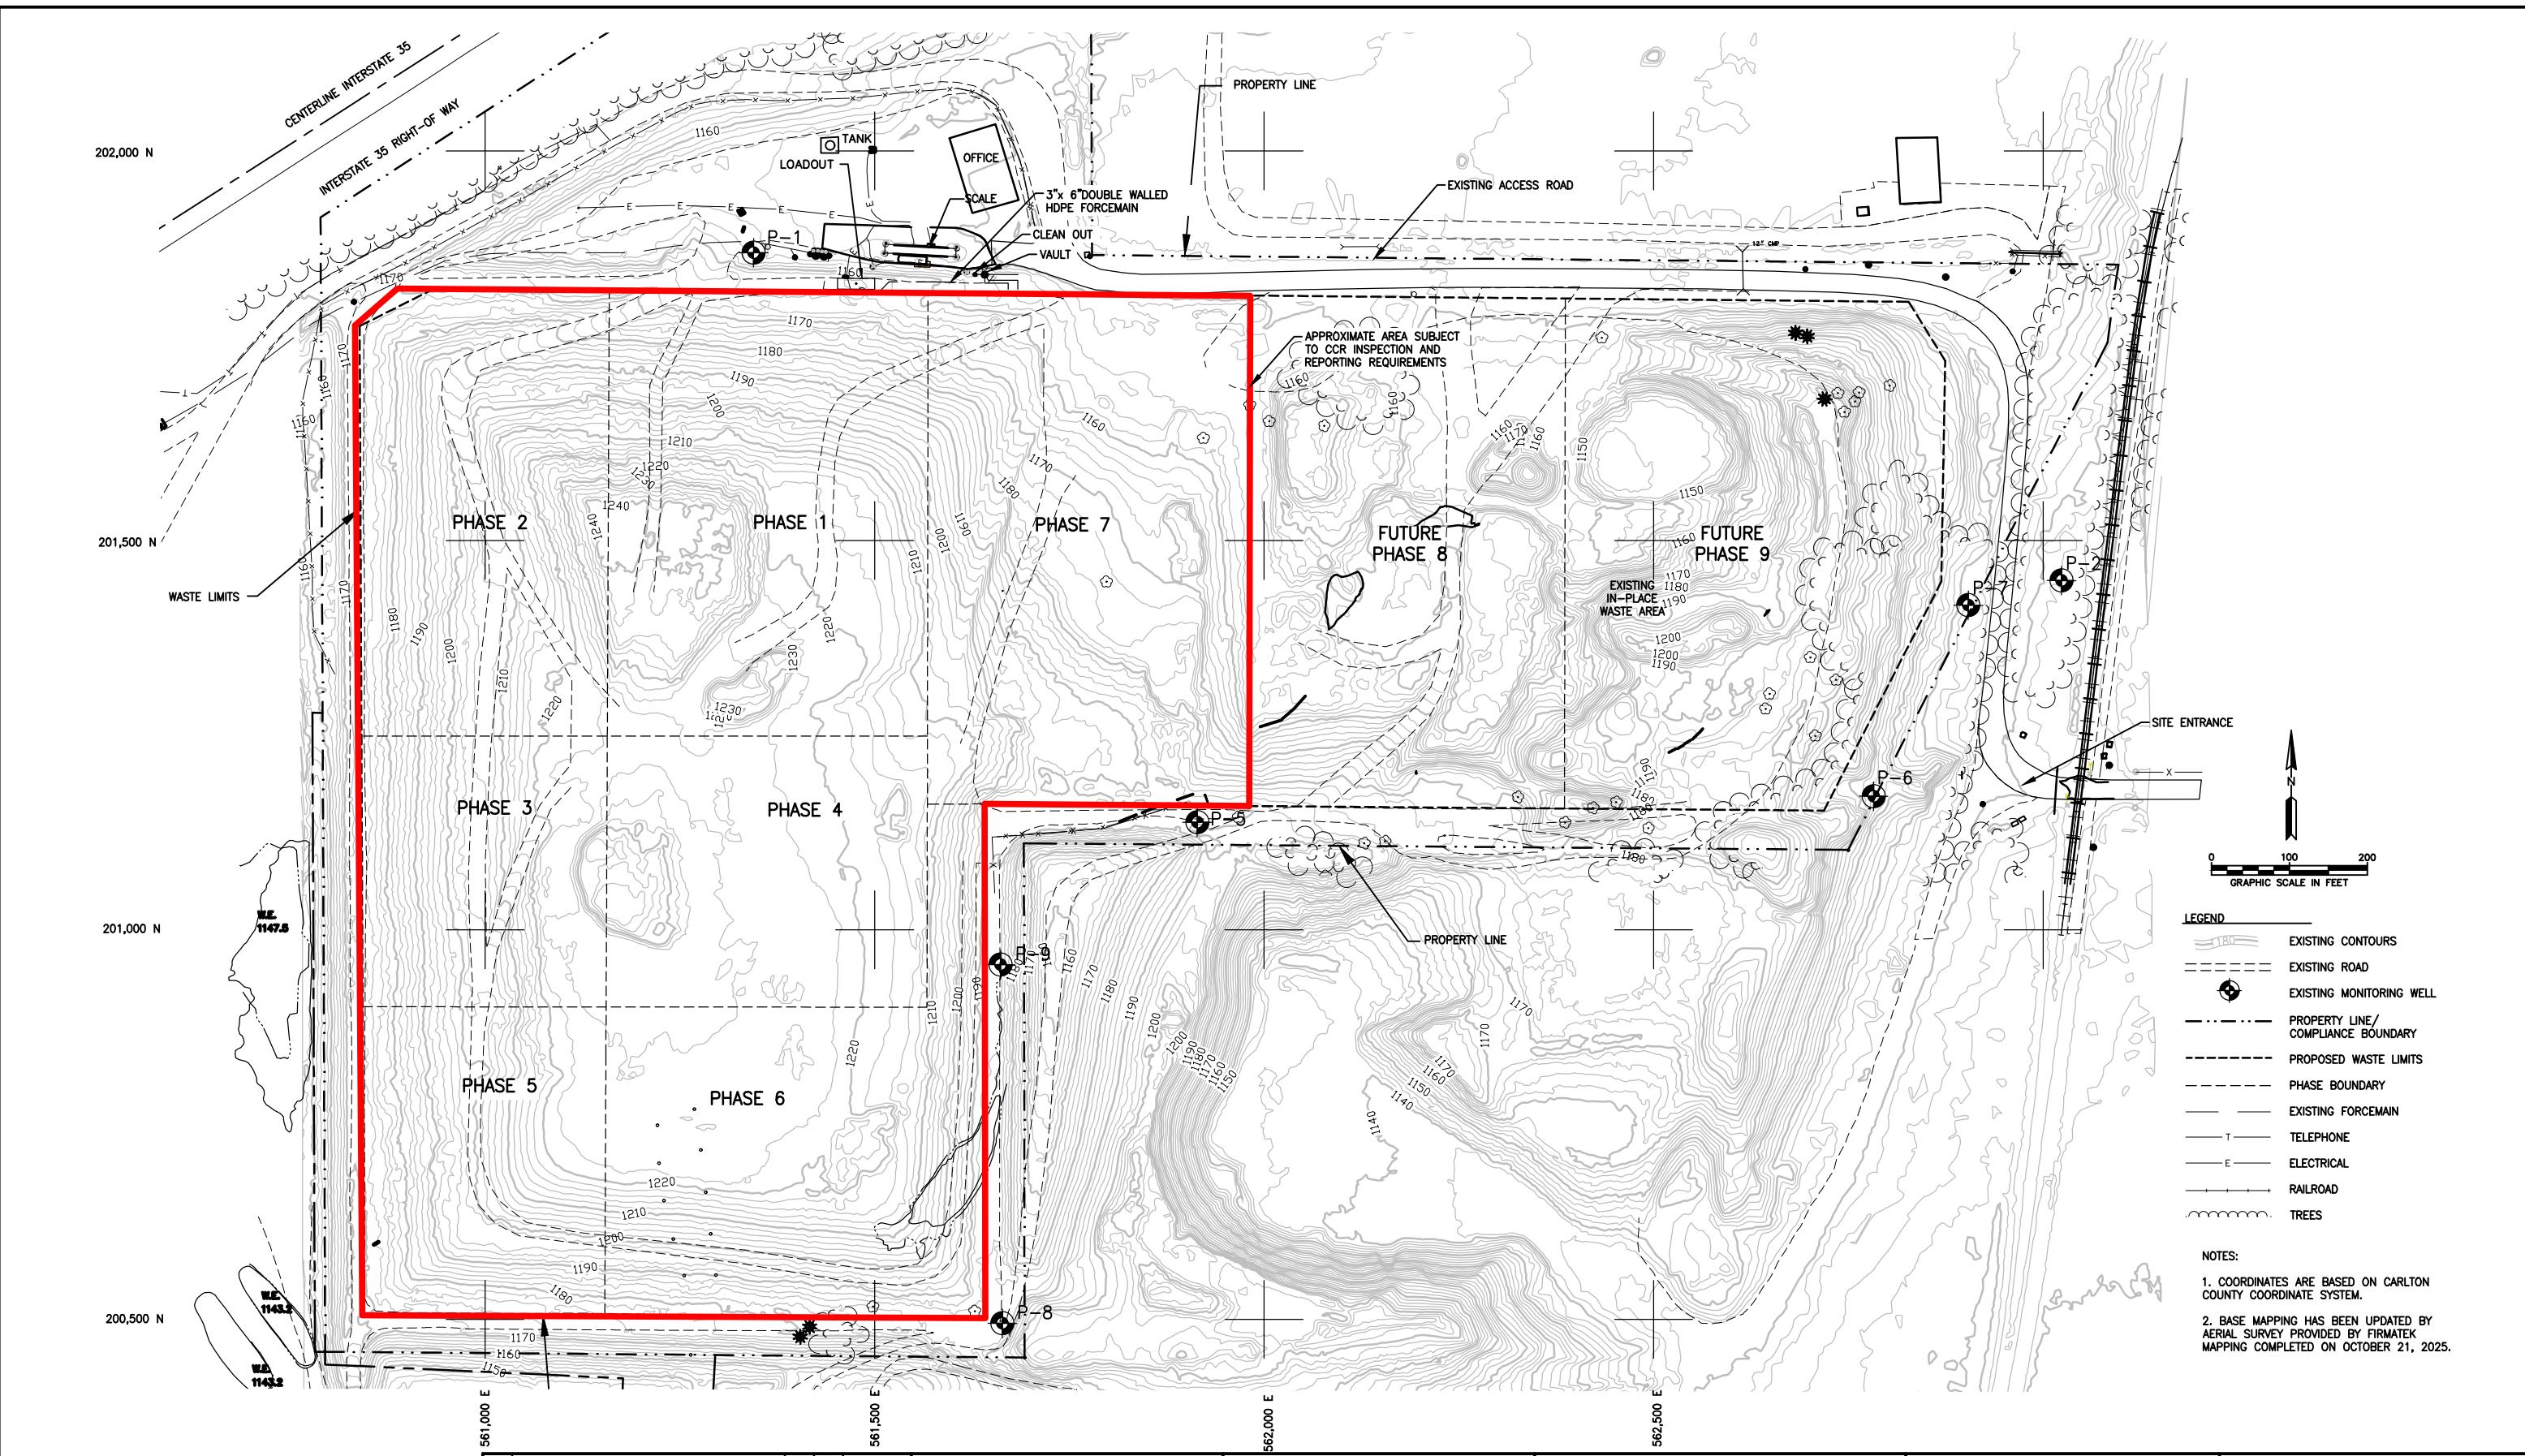
There were no apparent changes to the embankment geometry of Phases 1 through 7B-2 when compared to the permit drawings or the past inspection reports. The annual aerial photogrammetry survey was performed on October 21, 2025, which the estimated in-place volume of total waste (including all accepted wastes) is based on. A comparison between the 2025 and 2024 aerial survey confirm that the embankment and slope topography is substantially unchanged with no significant movement. The Existing Conditions Plan with the 2025 topographic survey is included as Figure 2.

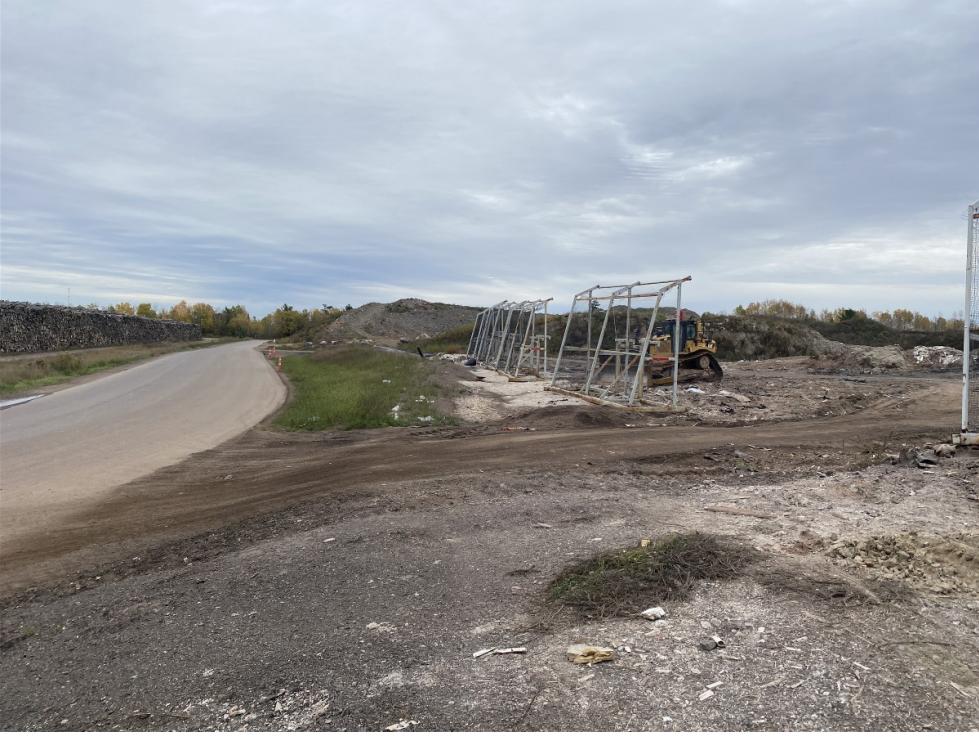
Client:	Waste Connections	Project:	227704387
Site Name:	SKB Cloquet CCR 2025	Site Location:	Cloquet, MN
<b>Photograph ID:</b> 1

<b>Photo Location:</b> Location 1			
<b>Direction:</b> Looking East			
<b>Survey Date:</b> 10/14/2025			
<b>Comments:</b> North Center of Phase 7			
<b>Photograph ID:</b> 2

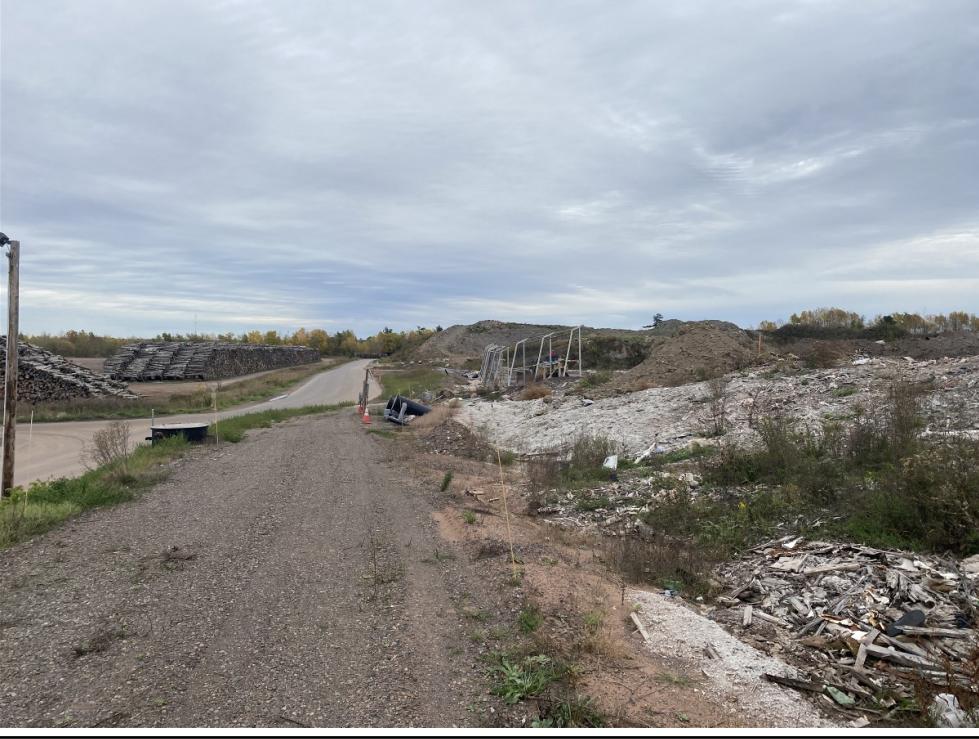
<b>Photo Location:</b> Location 2			
<b>Direction:</b> Looking East			
<b>Survey Date:</b> 10/14/2025			
<b>Comments:</b> Northwest Corner of Phase 7

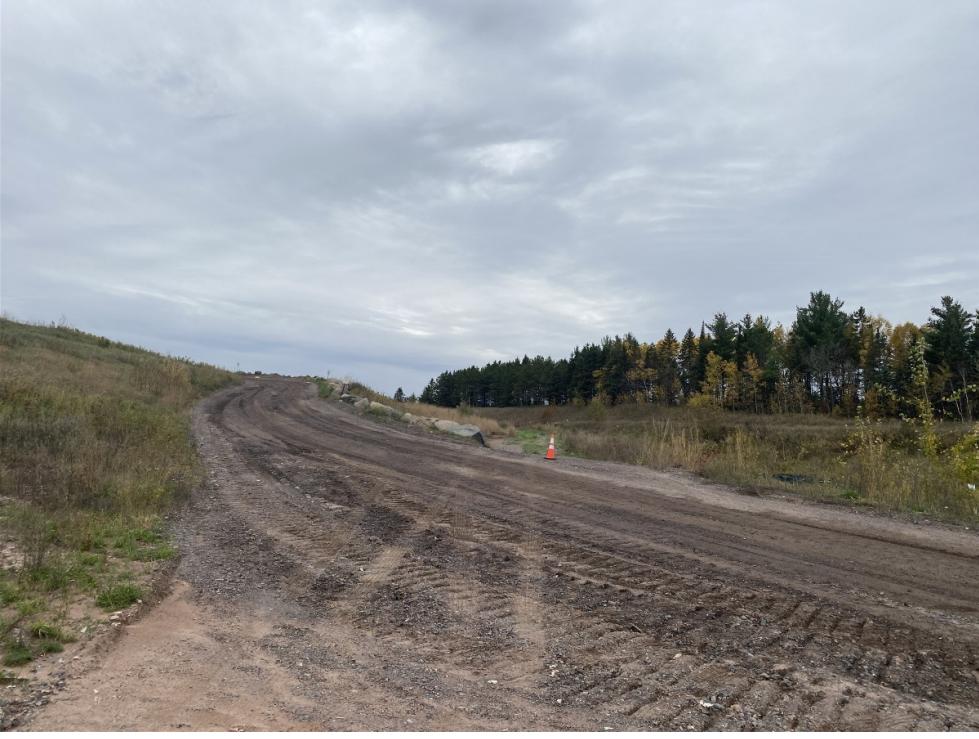
Client:	Waste Connections	Project:	227704387
Site Name:	SKB Cloquet CCR 2025	Site Location:	Cloquet, MN
<b>Photograph ID:</b> 3

<b>Photo Location:</b> Location 3			
<b>Direction:</b> Looking West			
<b>Survey Date:</b> 10/14/2025			
<b>Comments:</b> North Center of Phase 1			
<b>Photograph ID:</b> 4

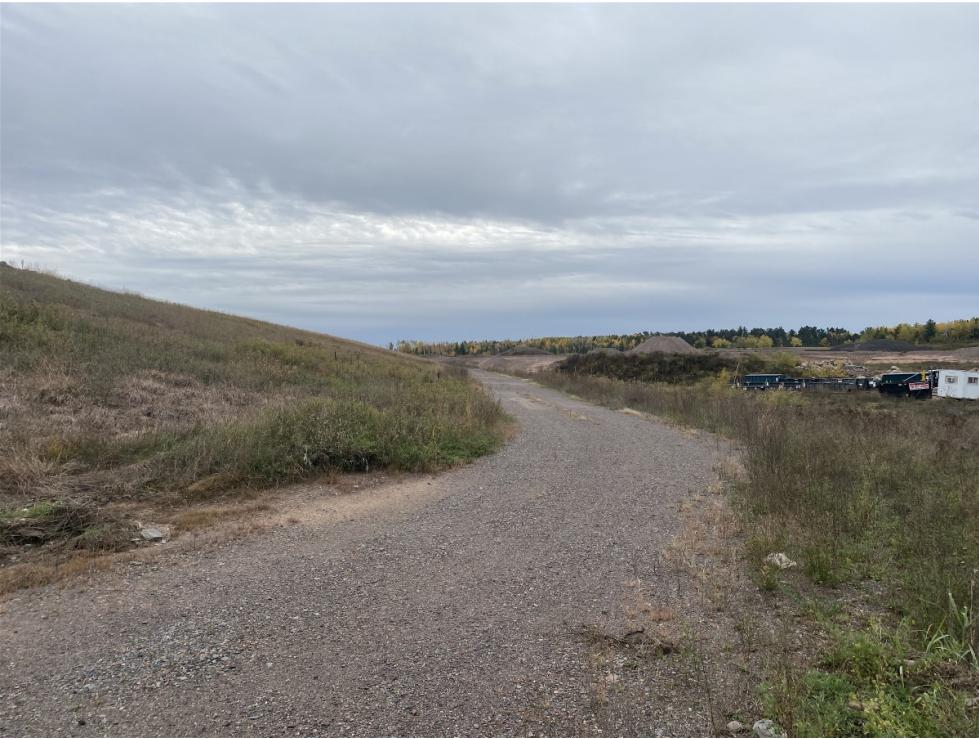
<b>Photo Location:</b> Location 4			
<b>Direction:</b> Looking South			
<b>Survey Date:</b> 10/14/2025			
<b>Comments:</b> Northwest Corner of Phase 2

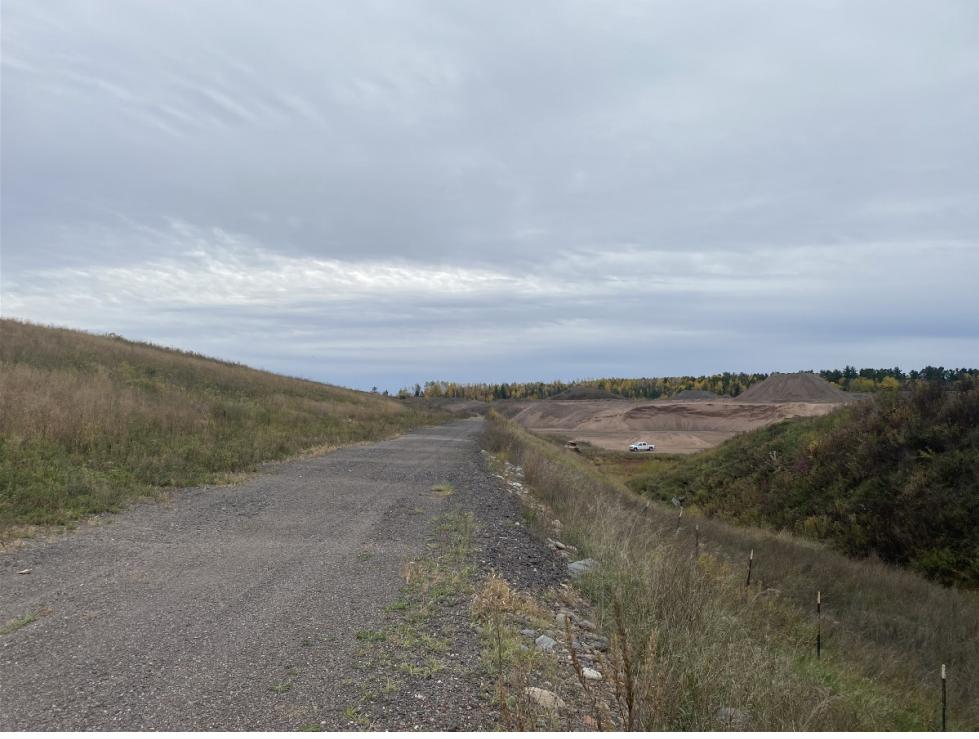
<b>Client:</b> Waste Connections	<b>Project:</b> 227704387
<b>Site Name:</b> SKB Cloquet CCR 2025	<b>Site Location:</b> Cloquet, MN
<b>Photograph ID:</b> 5	
<b>Photo Location:</b> Location 5	
<b>Direction:</b> Looking South	
<b>Survey Date:</b> 10/14/2025	
<b>Comments:</b> Southwest Corner of Phase 2

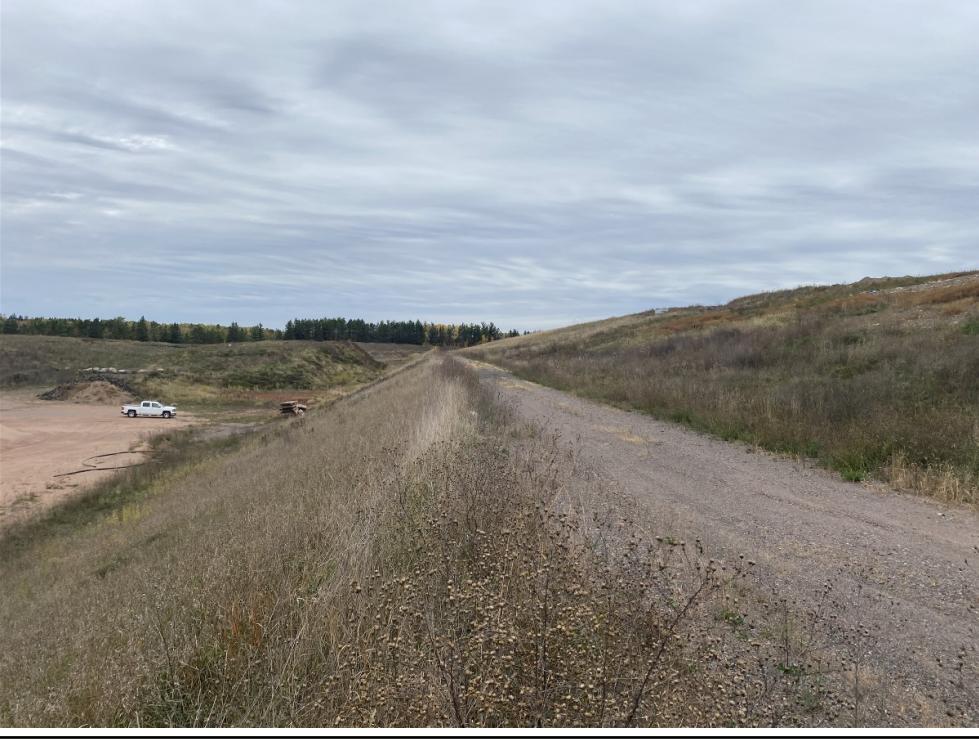
<b>Photograph ID:</b> 6	
<b>Photo Location:</b> Location 6	
<b>Direction:</b> Looking North	
<b>Survey Date:</b> 10/14/2025	
<b>Comments:</b> Southwest Corner of Phase 3

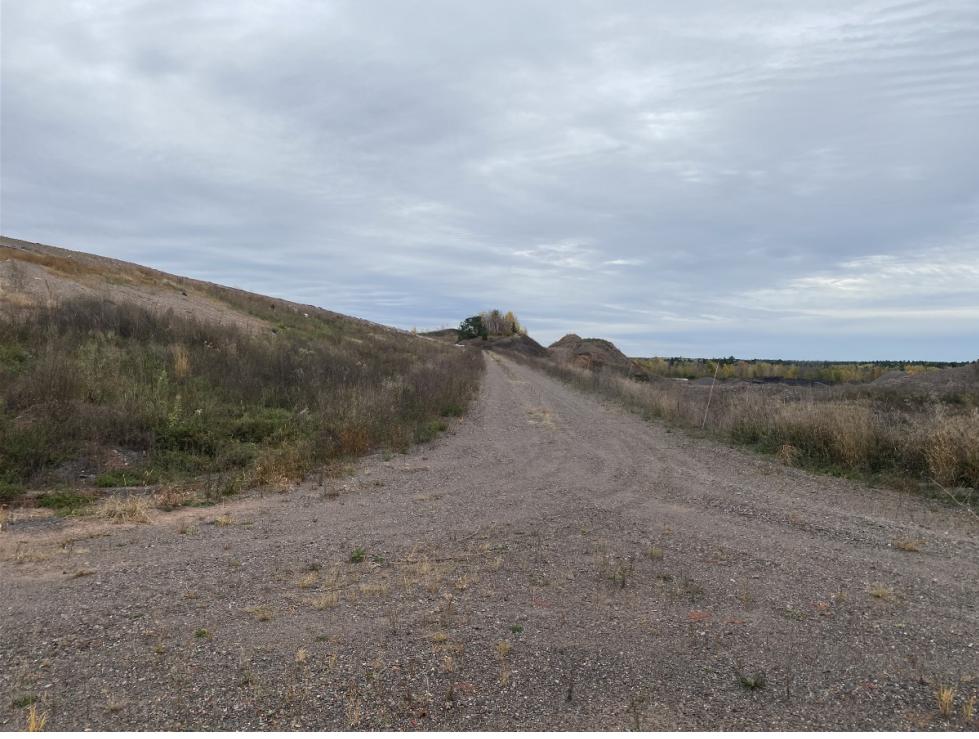
<b>Client:</b> Waste Connections	<b>Project:</b> 227704387
<b>Site Name:</b> SKB Cloquet CCR 2025	<b>Site Location:</b> Cloquet, MN
<b>Photograph ID:</b> 7	
<b>Photo Location:</b> Location 7	
<b>Direction:</b> Looking East	
<b>Survey Date:</b> 10/14/2025	
<b>Comments:</b> Southwest Corner of Phase 5

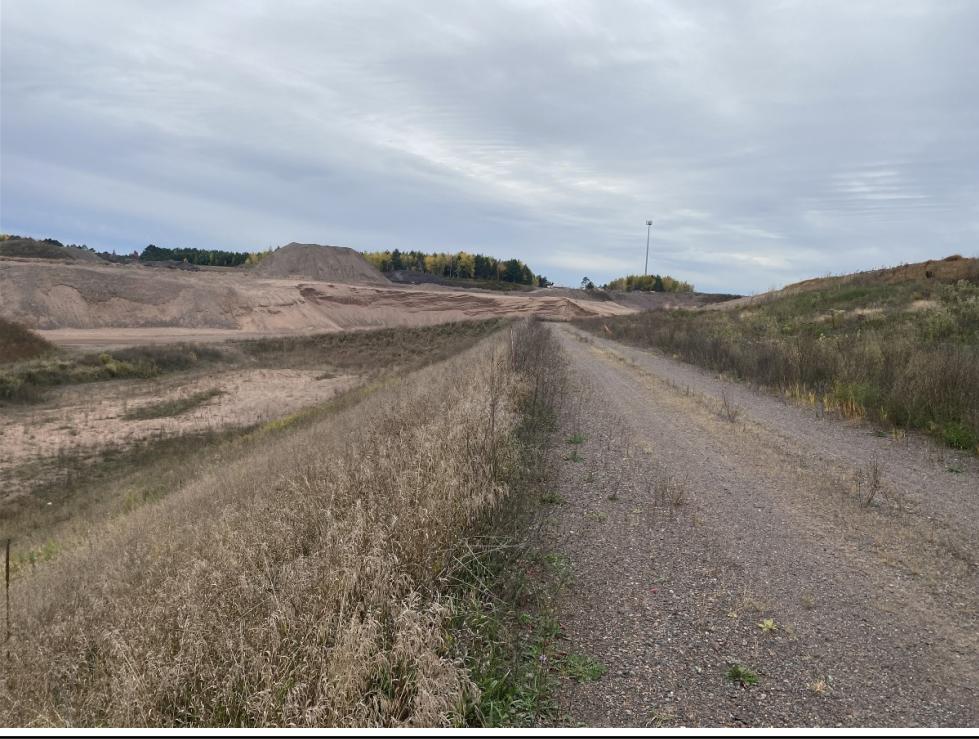
<b>Photograph ID:</b> 8	
<b>Photo Location:</b> Location 8	
<b>Direction:</b> Looking West	
<b>Survey Date:</b> 10/14/2025	
<b>Comments:</b> South Center of Phase 6

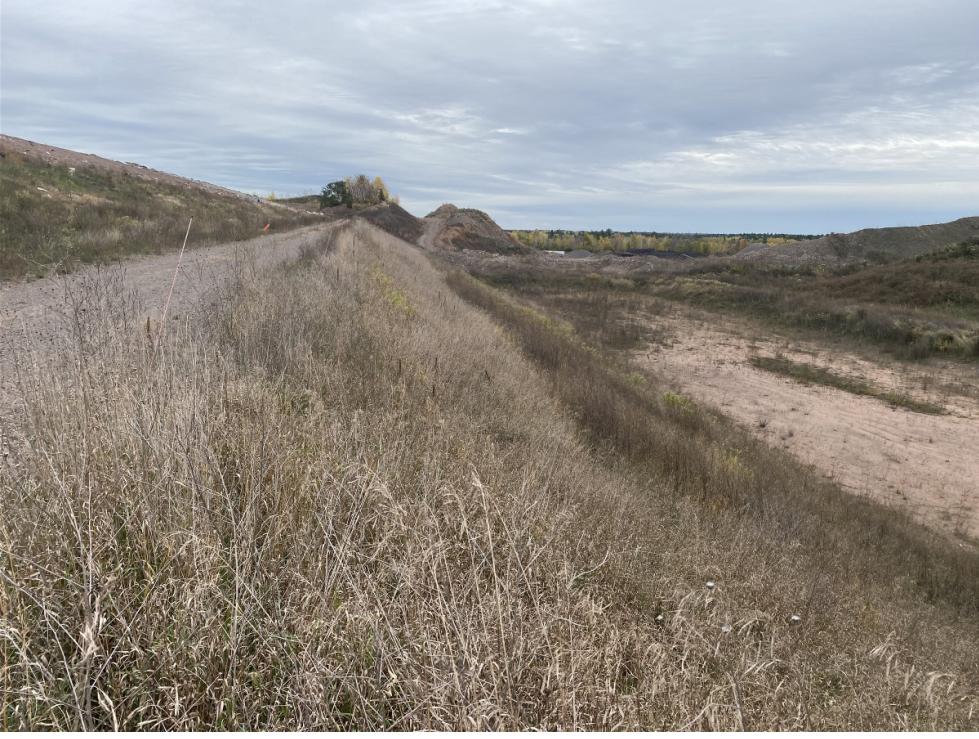
Client:	Waste Connections	Project:	227704387
Site Name:	SKB Cloquet CCR 2025	Site Location:	Cloquet, MN
<b>Photograph ID:</b> 9

<b>Photo Location:</b> Location 9			
<b>Direction:</b> Looking North			
<b>Survey Date:</b> 10/14/2025			
<b>Comments:</b> Southeast Corner of Phase 6			
<b>Photograph ID:</b> 10

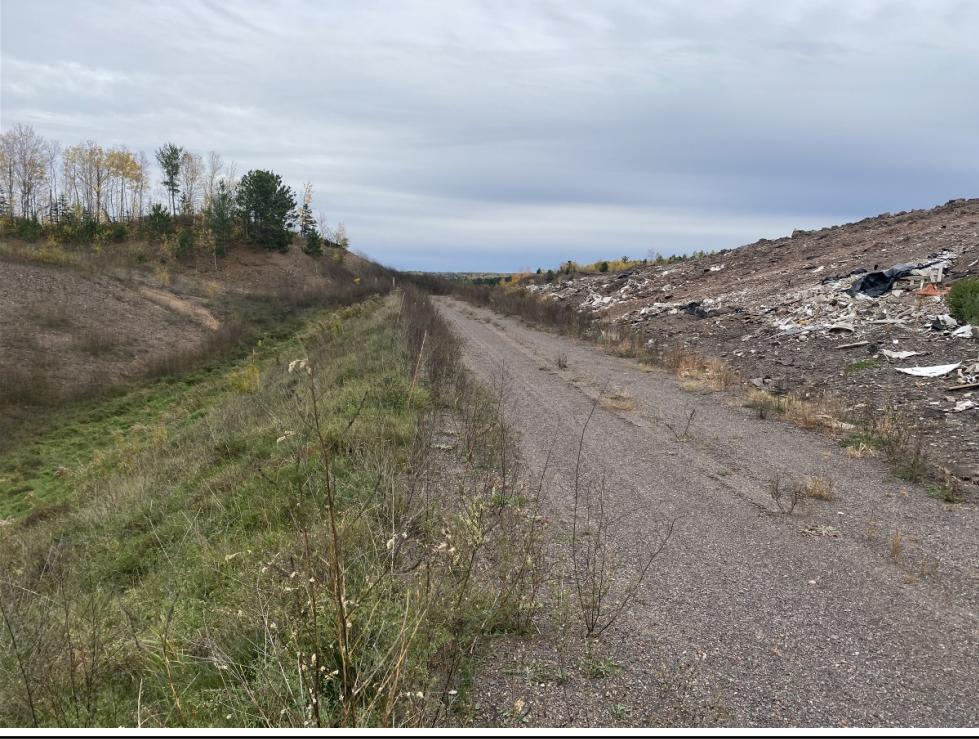
<b>Photo Location:</b> Location 10			
<b>Direction:</b> Looking South			
<b>Survey Date:</b> 10/14/2025			
<b>Comments:</b> East Center of Phase 6

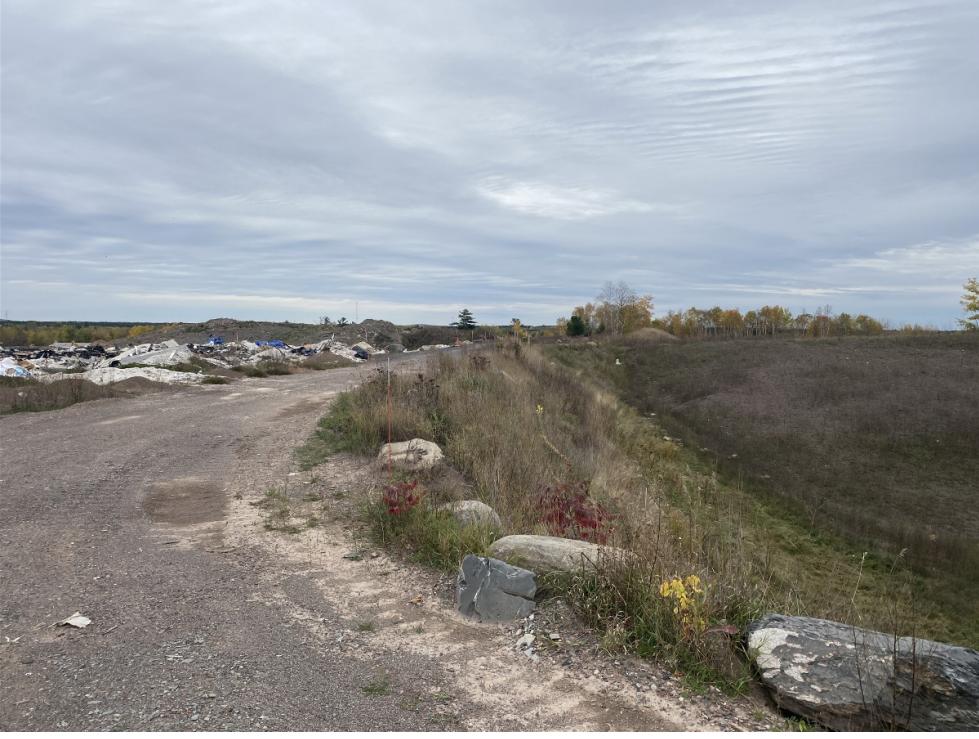
Client:	Waste Connections	Project:	227704387
Site Name:	SKB Cloquet CCR 2025	Site Location:	Cloquet, MN
<b>Photograph ID:</b> 11

<b>Photo Location:</b> Location 11			
<b>Direction:</b> Looking East			
<b>Survey Date:</b> 10/14/2025			
<b>Comments:</b> Southwest Corner of Phase 7			
<b>Photograph ID:</b> 12

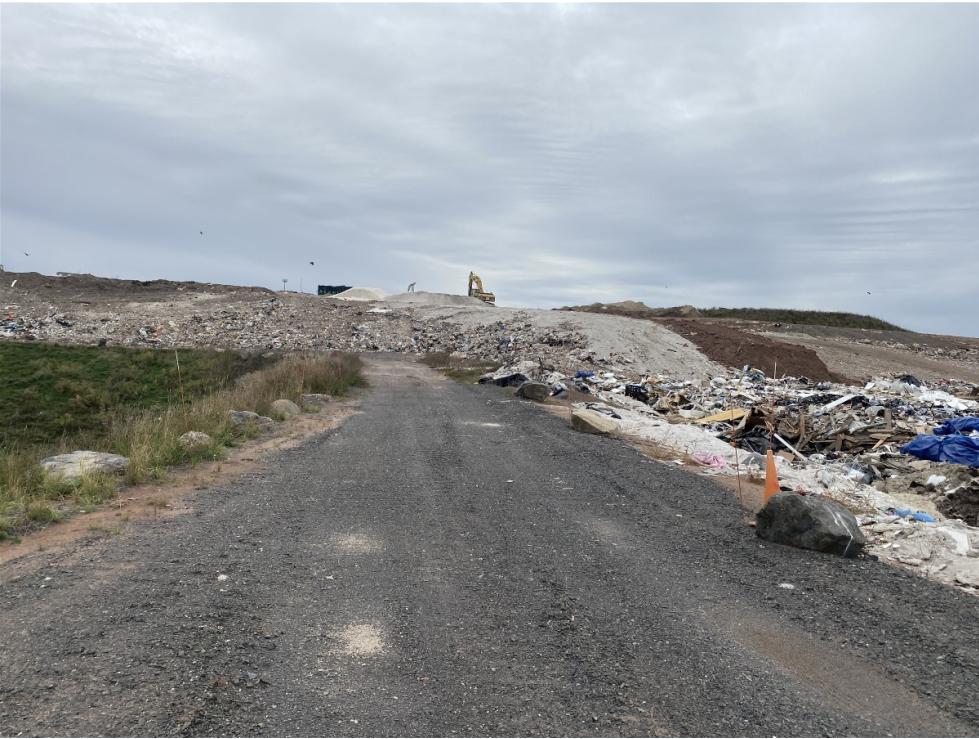
<b>Photo Location:</b> Location 12			
<b>Direction:</b> Looking West			
<b>Survey Date:</b> 10/14/2025			
<b>Comments:</b> South Center of Phase 7

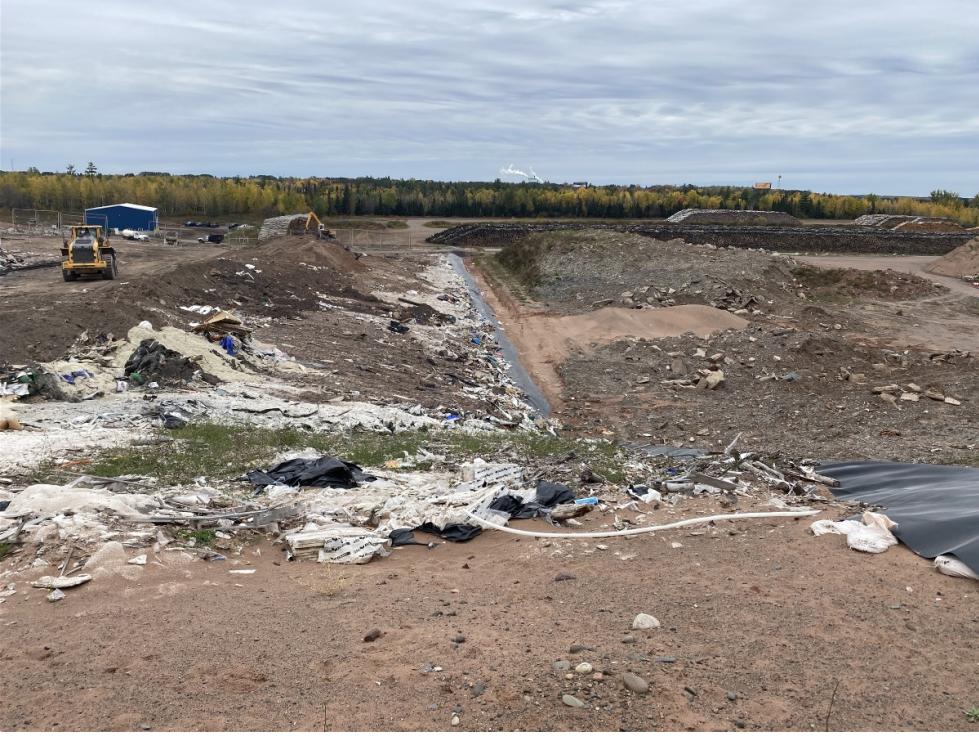
Client:	Waste Connections	Project:	227704387
Site Name:	SKB Cloquet CCR 2025	Site Location:	Cloquet, MN
<b>Photograph ID:</b> 13

<b>Photo Location:</b> Location 13			
<b>Direction:</b> Looking North			
<b>Survey Date:</b> 10/14/2025			
<b>Comments:</b> Southeast Corner of Phase 7			
<b>Photograph ID:</b> 14

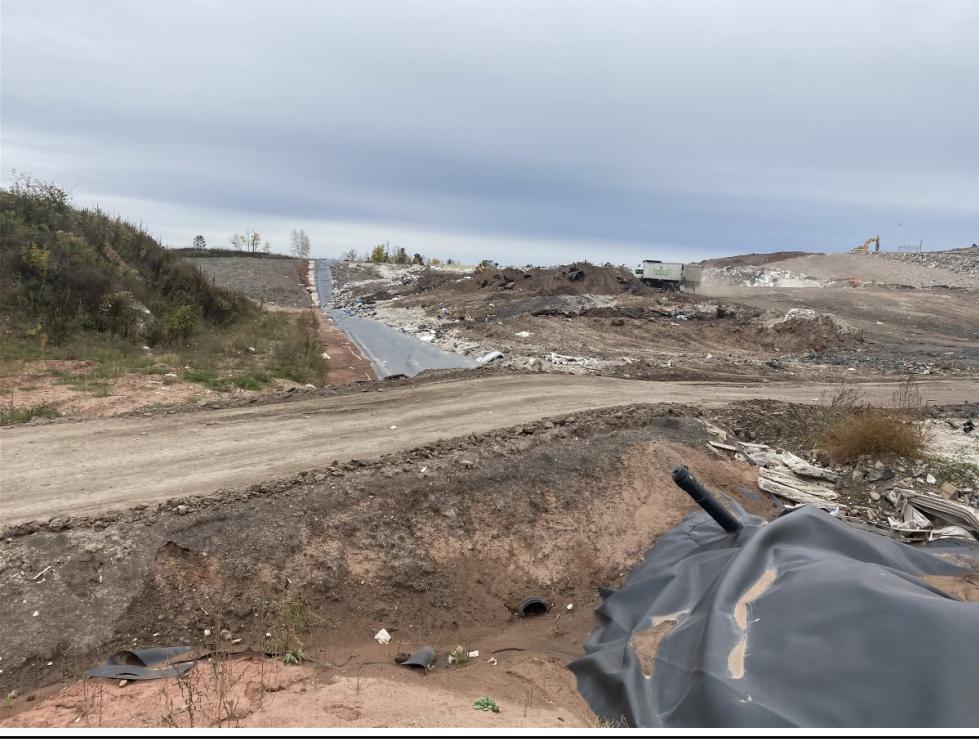
<b>Photo Location:</b> Location 14			
<b>Direction:</b> Looking South			
<b>Survey Date:</b> 10/14/2025			
<b>Comments:</b> Northeast Corner of Phase 7
