Technical Memo

Date: January 13, 2017

Subject: Annual Inspection SKB Environmental, Cloquet Landfill Inc., f/n/a Shamrock Landfill, Inc.- Report of CCR Landfill Inspection
Wenck Project # B3053-0058

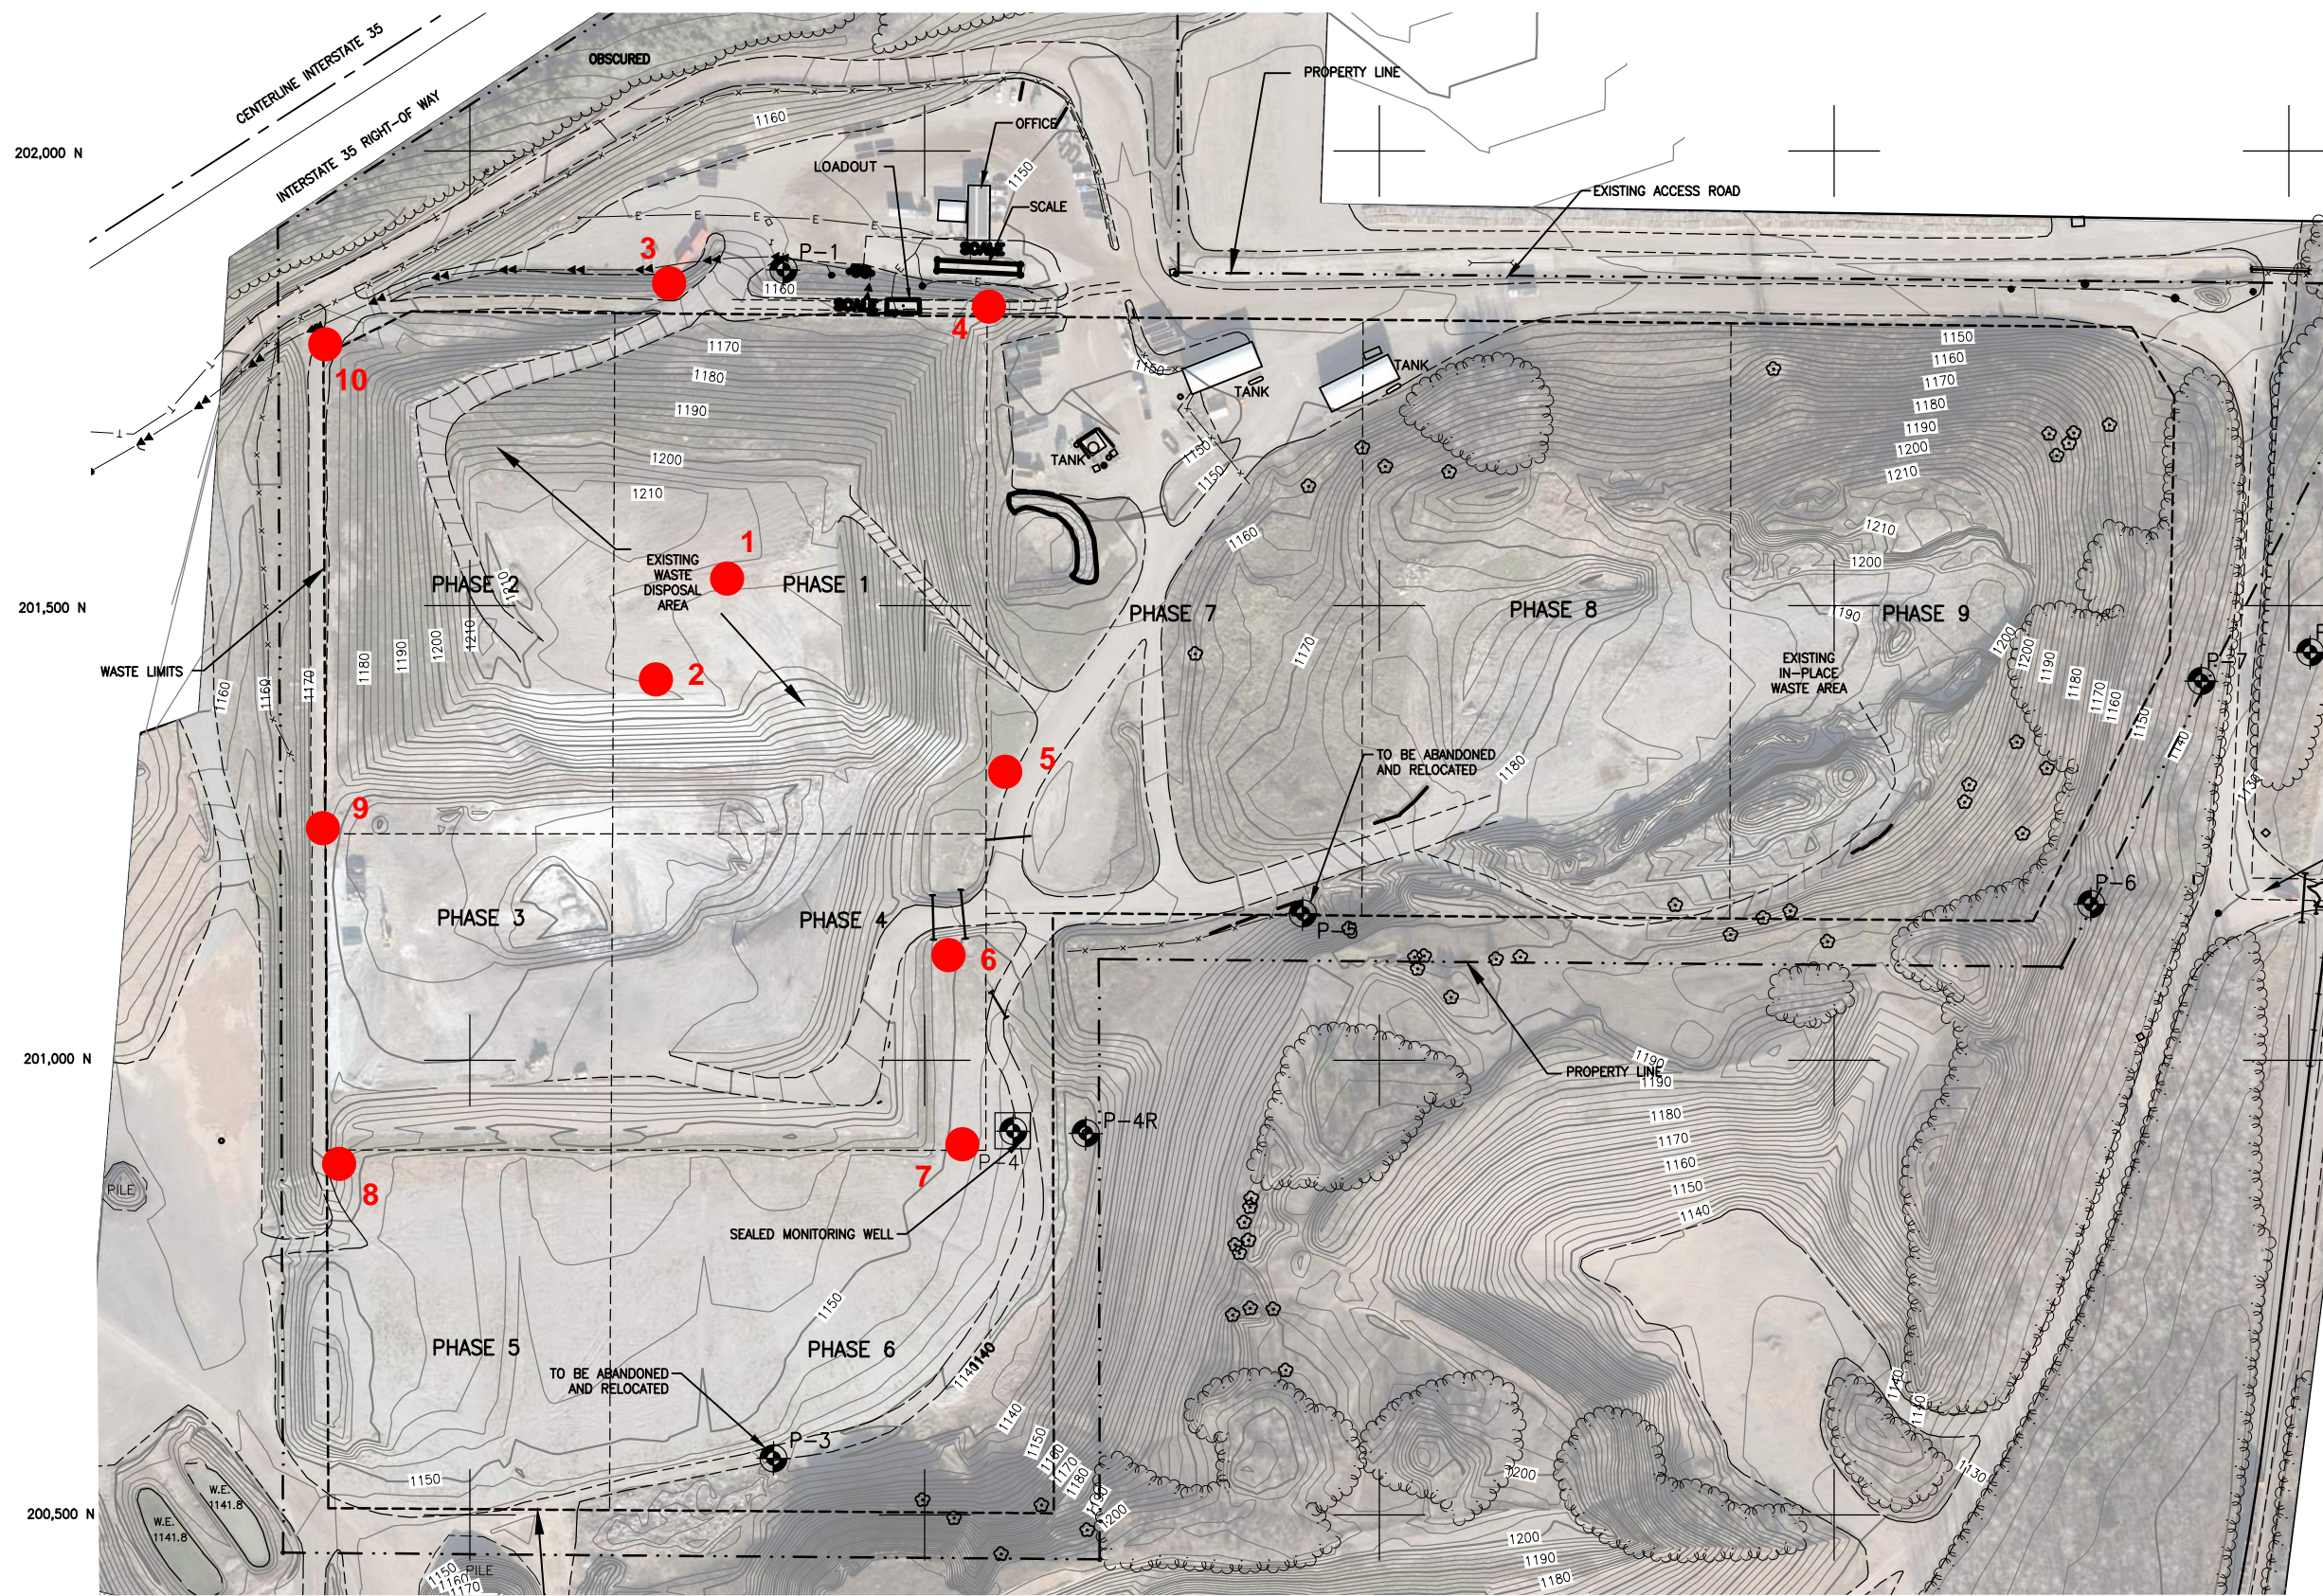
DWN BY	CHK'D	APP'D	DWG DATE	DEC. 2016
JVB	SH	TJS	SCALE	AS NOTED
PROJECT NO.	SHEET NO.	REV NO.		
3053-0058	FIGURE 2

Photos were taken during the inspection. Figure 2 presents the photo locations, and Attachment 1 contains a photo log and the photos taken.
