Reference: SKB Environmental Cloquet Landfill, dba Shamrock Landfill, Inc. 2022 Annual CCR Inspection Report

CCR Landfill Inspection Report

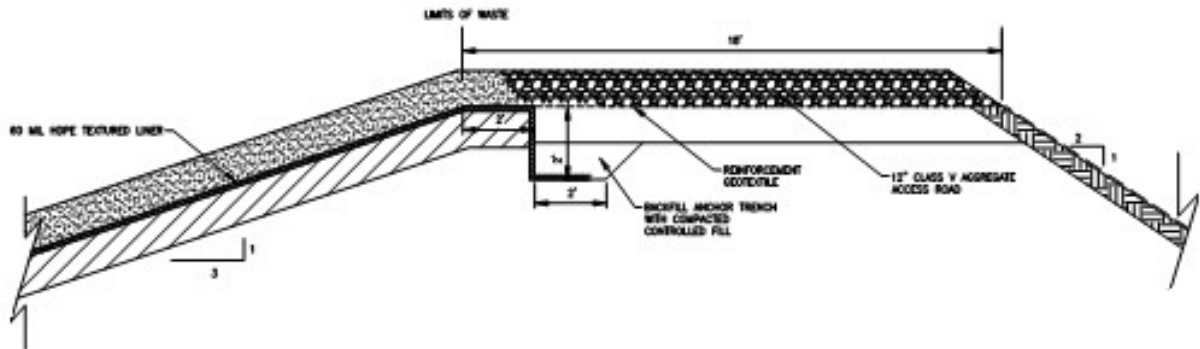
Typical Landfill Berm Detail

During the inspection, no signs of landfill cell embankment distress, no signs of waste slope instability, or other CCR landfill issues were observed. The landfill embankments and interim covered slopes were generally in good condition with a well-established vegetation cover and no signs of significant erosion.

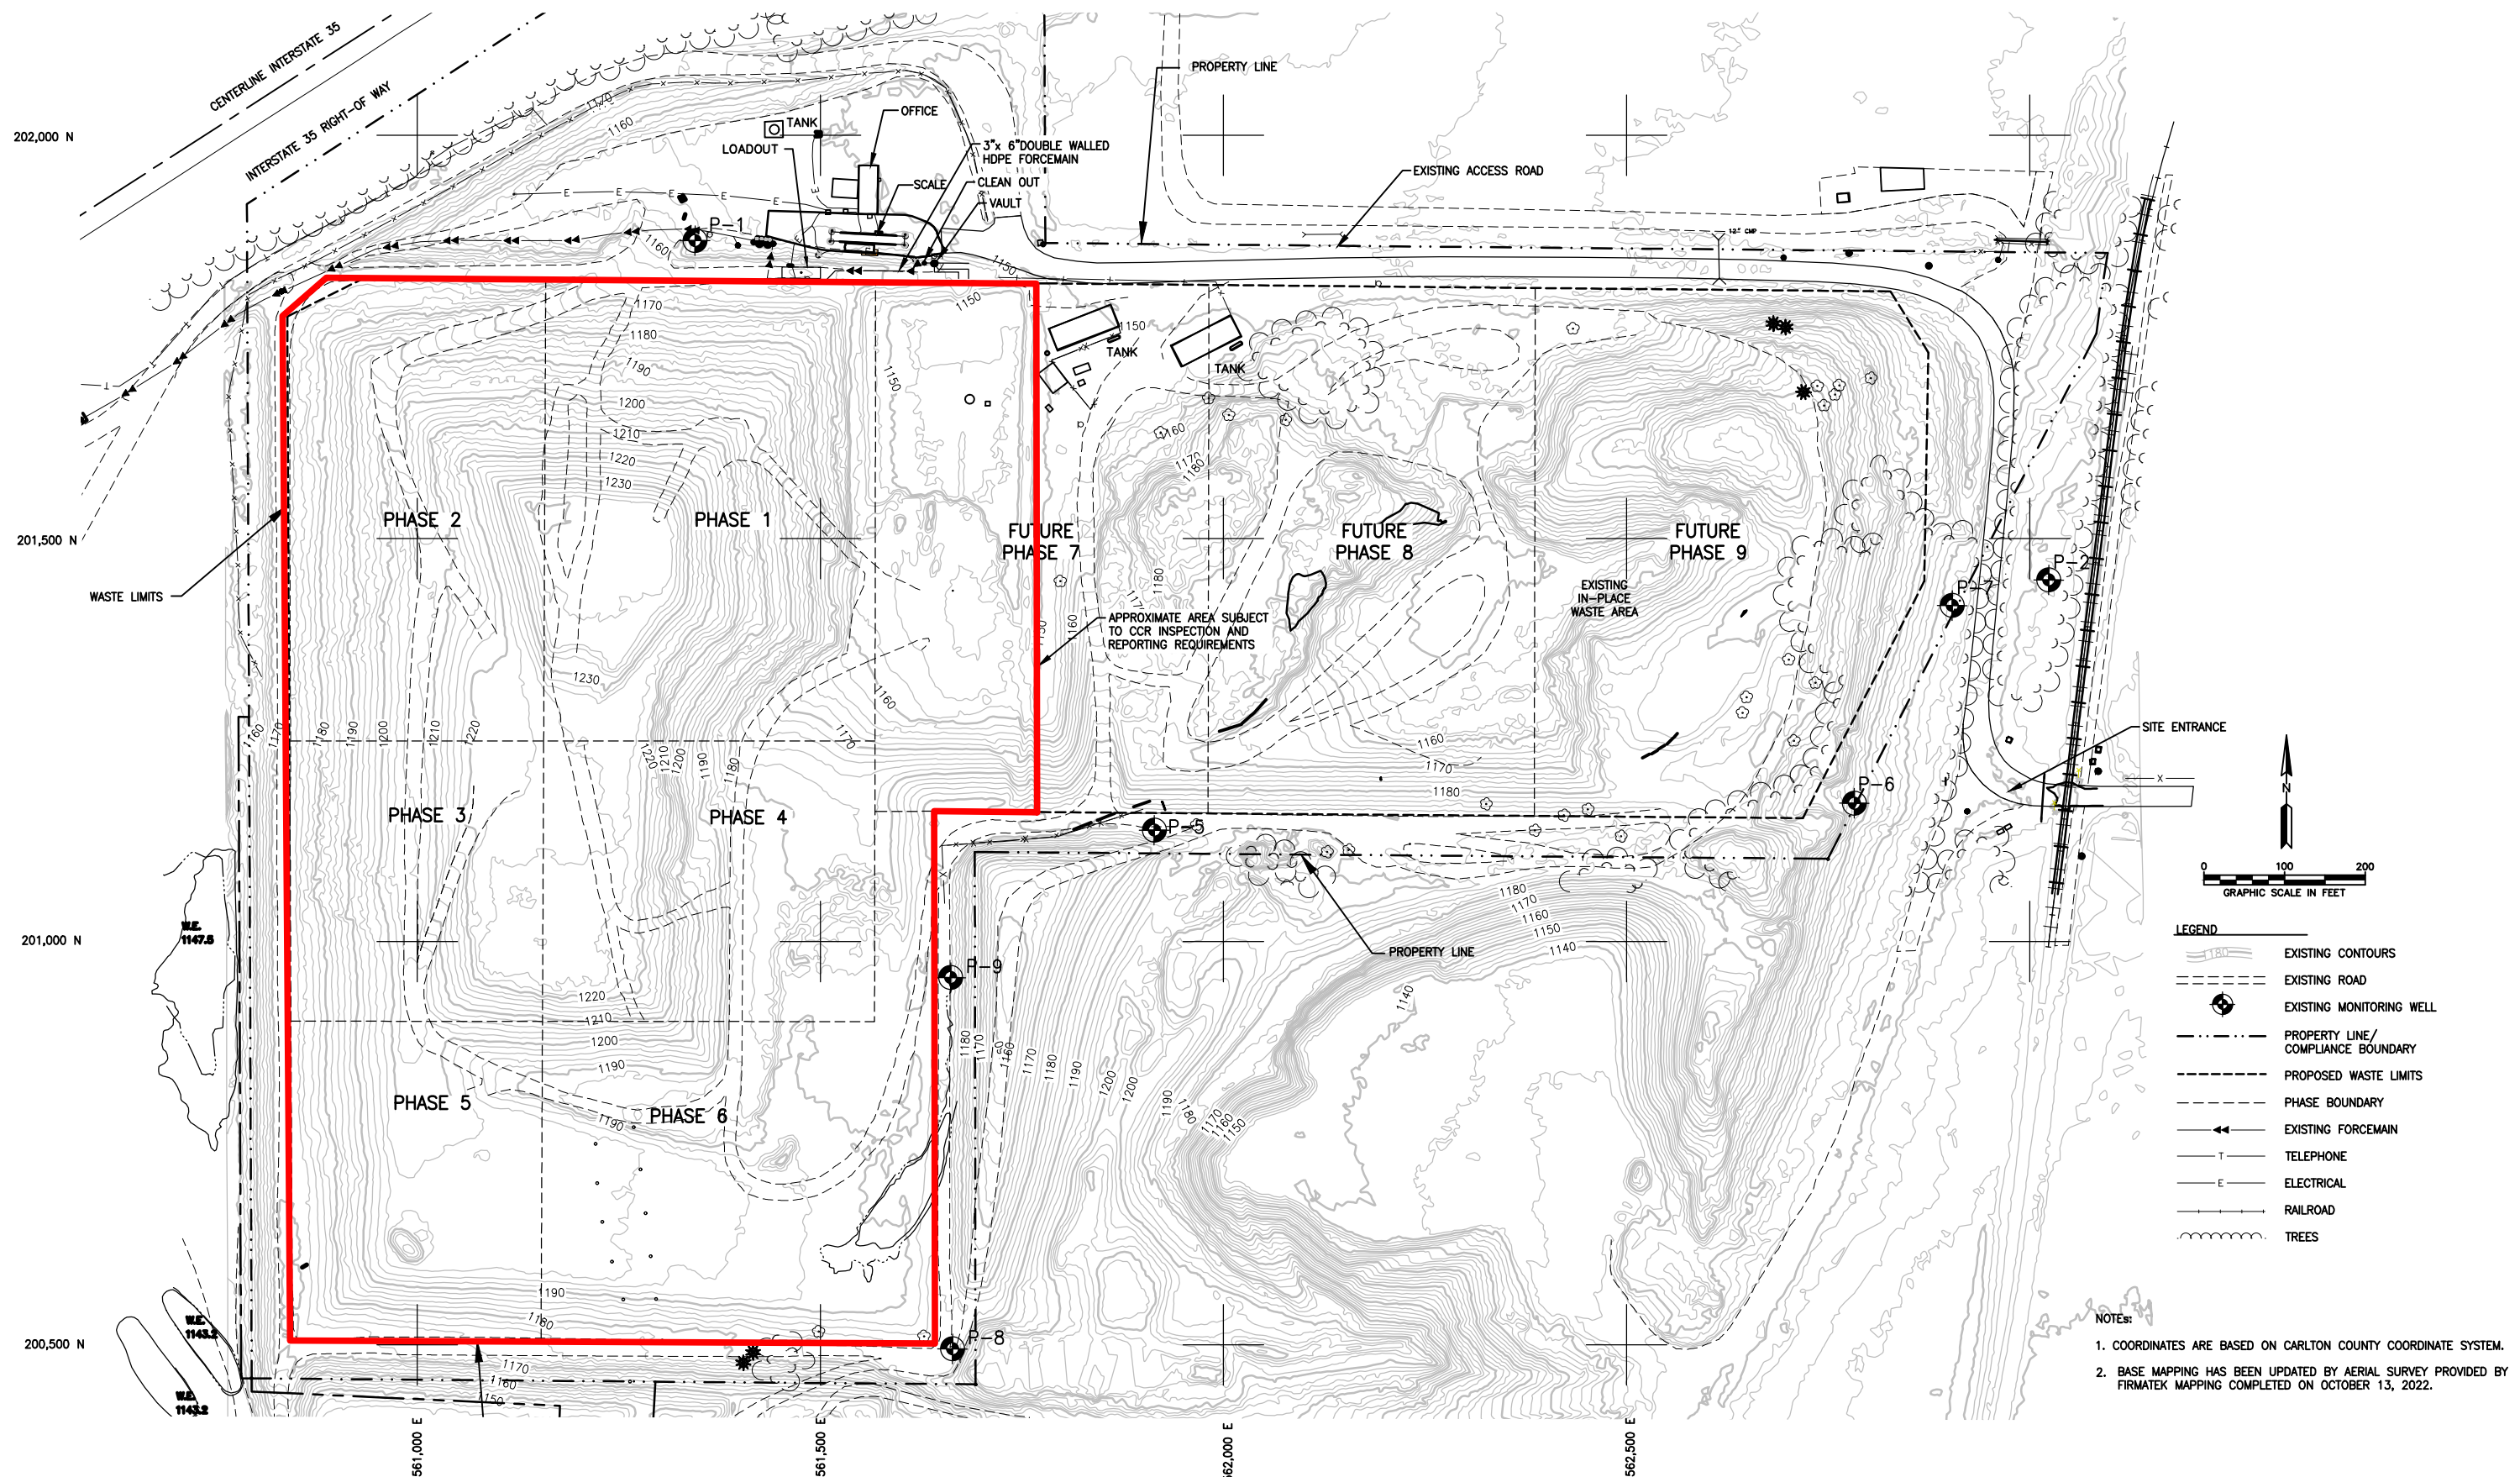
DWN BY JJT	CHK'D SH	APP'D TJS	DWG DATE JAN. 2023
PROJECT NO. 227704387	SHEET NO. FIGURE 2	SCALE AS NOTED	REV NO. 0

Other than the construction of Phase 7A, there were no apparent changes to the embankment geometry of Phases 1 through 7A when compared to the permit drawings or the past inspection reports. The annual aerial photogrammetry survey was performed on October 13, 2022, which the estimated in-place volume of total waste (including all accepted wastes) is based on. A comparison 2022 and 2021 aerial survey confirm that the embankment and slope topography is substantially unchanged with no significant movement. The 2022 aerial survey is included as Figure 2.
