File: 227704387

Date: January 7, 2026

**Reference:** **SKB Environmental Cloquet Landfill, Inc. 2025 Annual CCR Inspection Report**

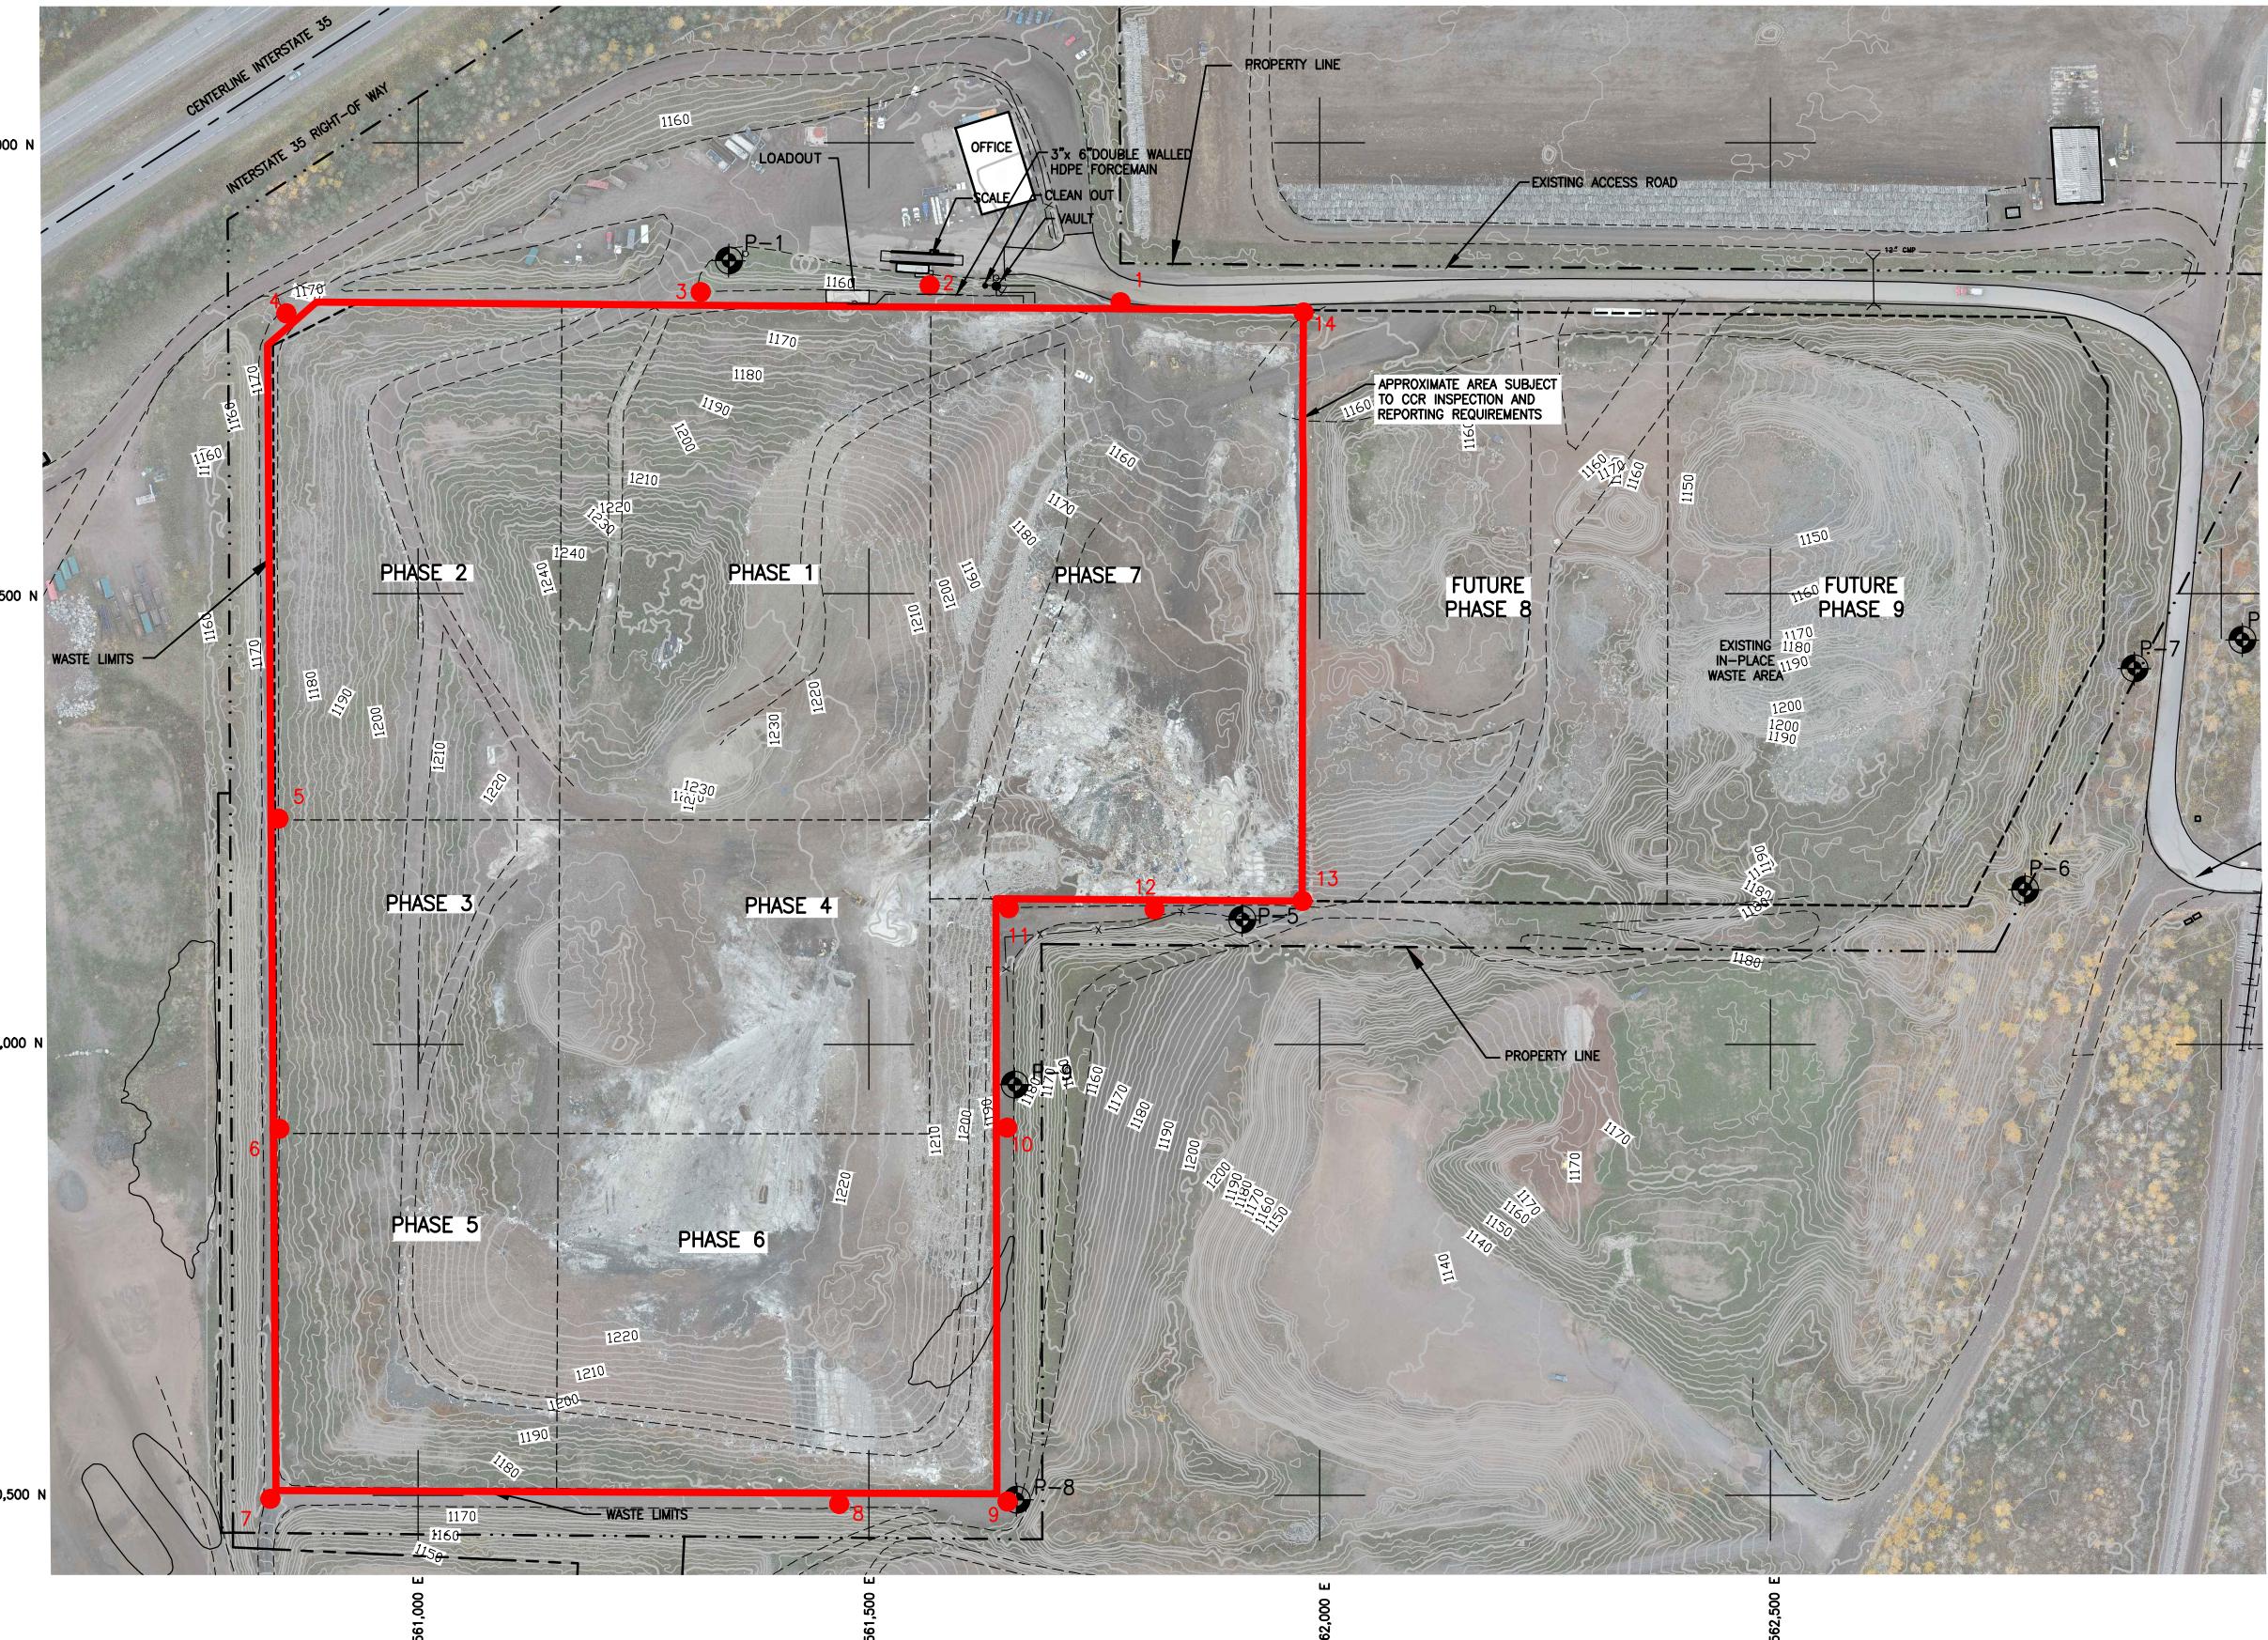
PROJECT NO. SHEET NO. REV NO.  
227704387 FIGURE 2 0

There were no apparent changes to the embankment geometry of Phases 1 through 7B-2 when compared to the permit drawings or the past inspection reports. The annual aerial photogrammetry survey was performed on October 21, 2025, which the estimated in-place volume of total waste (including all accepted wastes) is based on. A comparison between the 2025 and 2024 aerial survey confirm that the embankment and slope topography is substantially unchanged with no significant movement. The Existing Conditions Plan with the 2025 topographic survey is included as Figure 2.
