Technical Memo

Subject: Annual Inspection Shamrock Environmental Landfill - Report of CCR Landfill

Wenck Project # B3053-0033

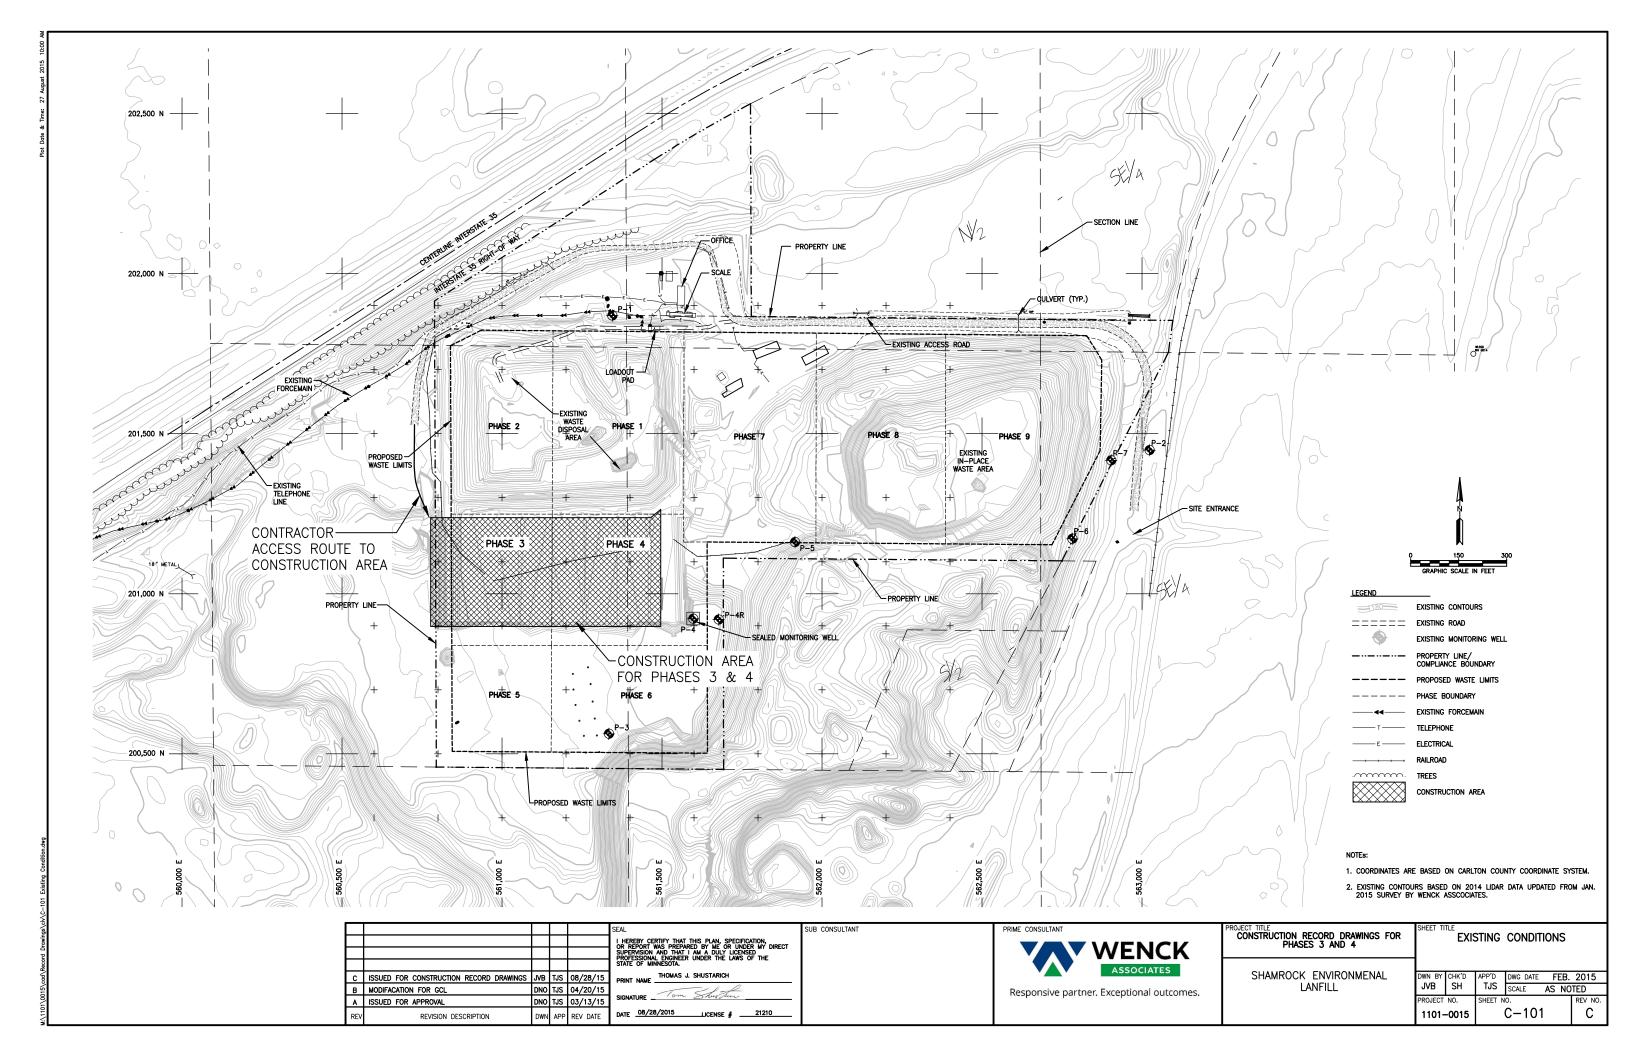
The attached Figure 1 presents a site location and a site layout is provided on Figure 2.
